APPENDIX A
PLANS, PROFILES & TYPICAL SECTIONS

FOREST HOME DRIVE OVER FALL CREEK

B.I.N. 3047450

In-Depth Inspection Report

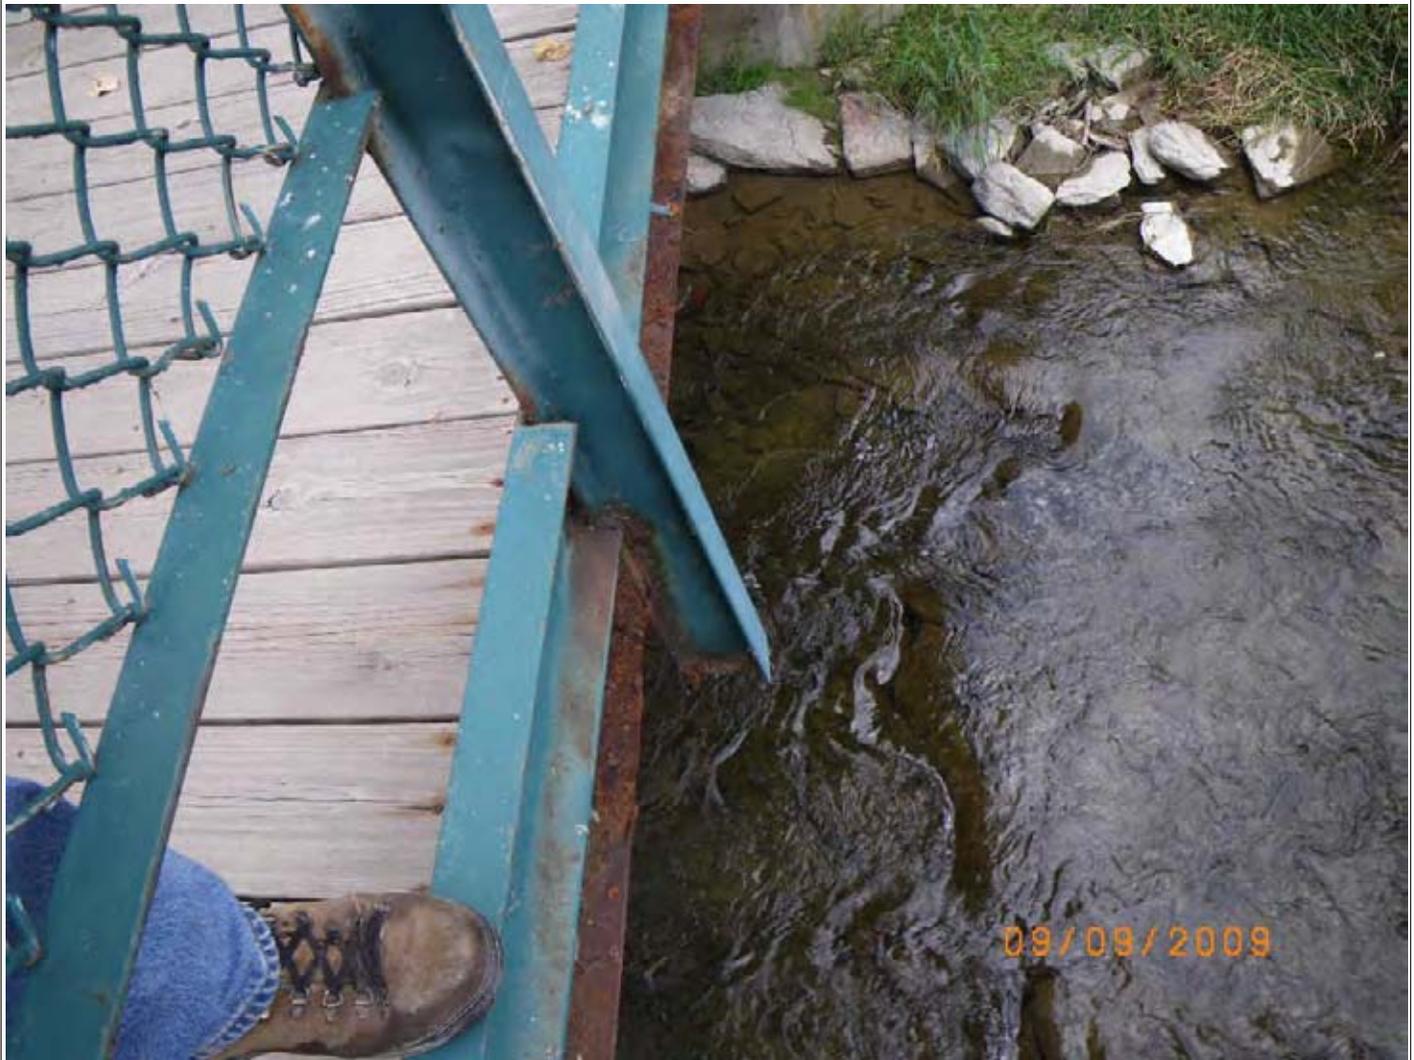
09IMGP0460.JPG - Attached to Safety Flag 3X090011

Right railing near end

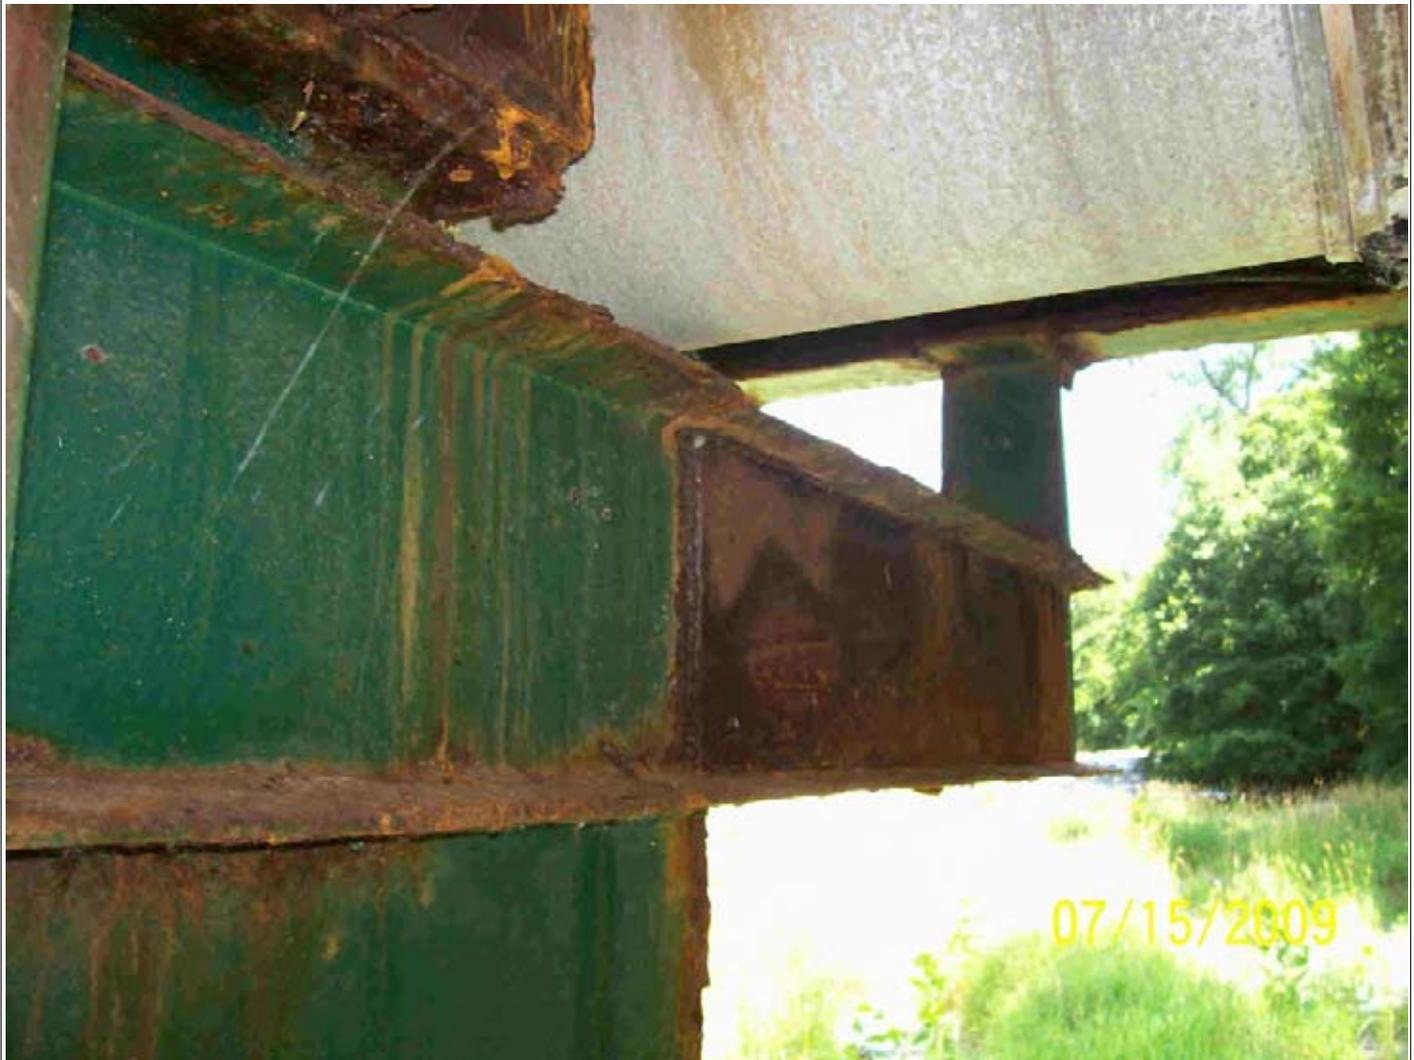
09100_0660.JPG - Attached to Safety Flag 3X090012

Floorbeam #2 cantilever, right side, begin channel

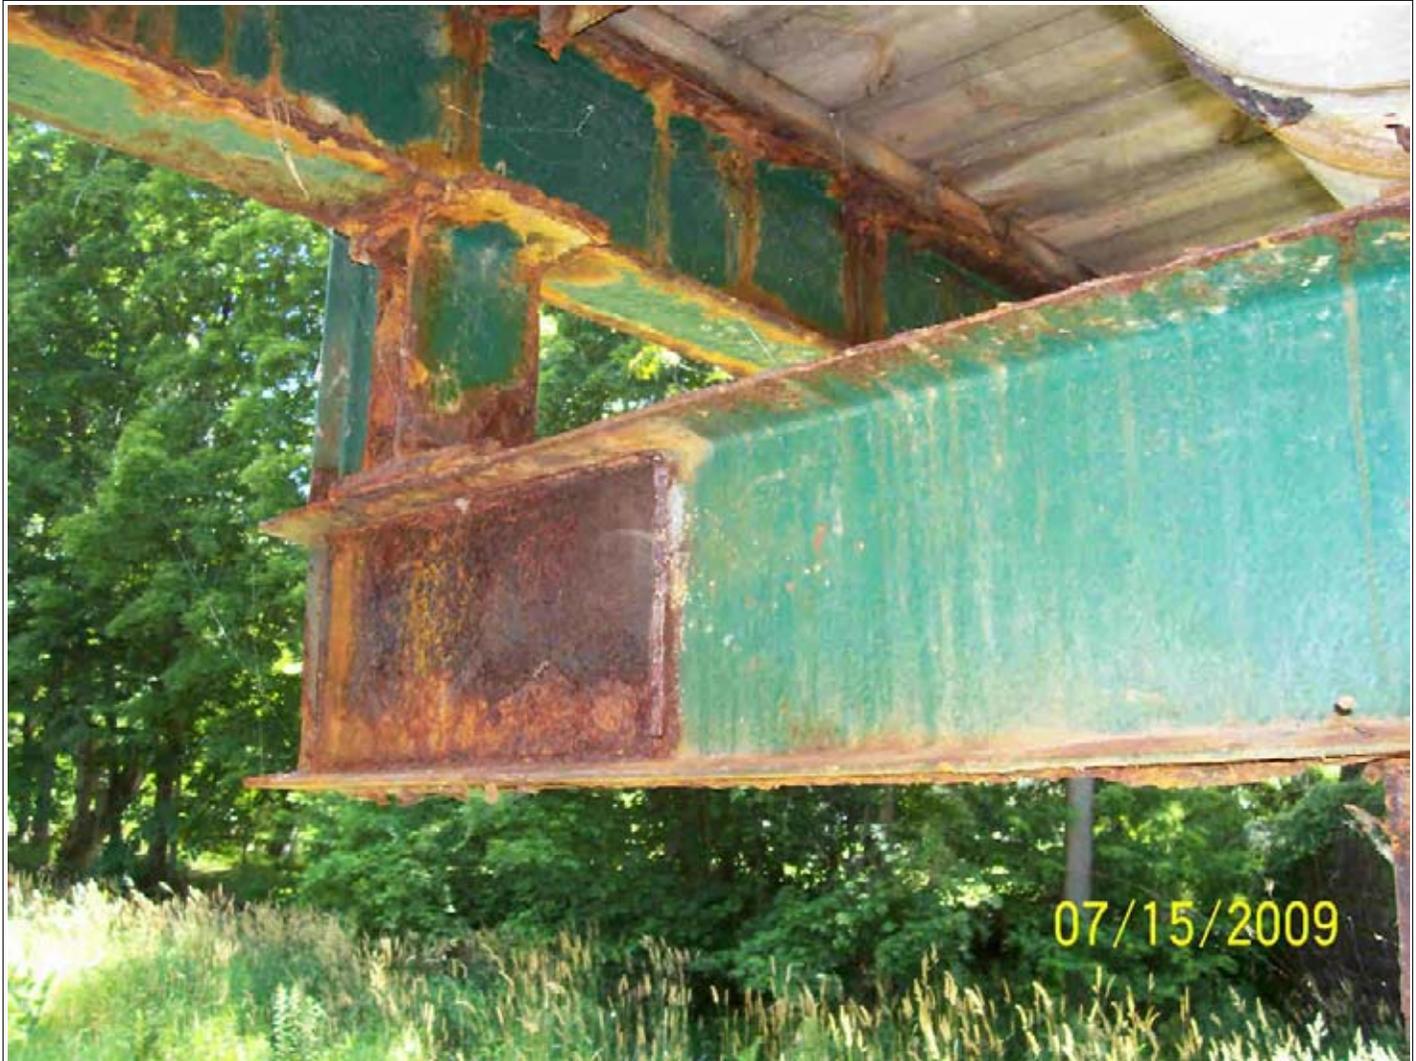
09100_0663.JPG - Attached to Safety Flag 3X090012

Floorbeam #3 cantilever, right side, end channel

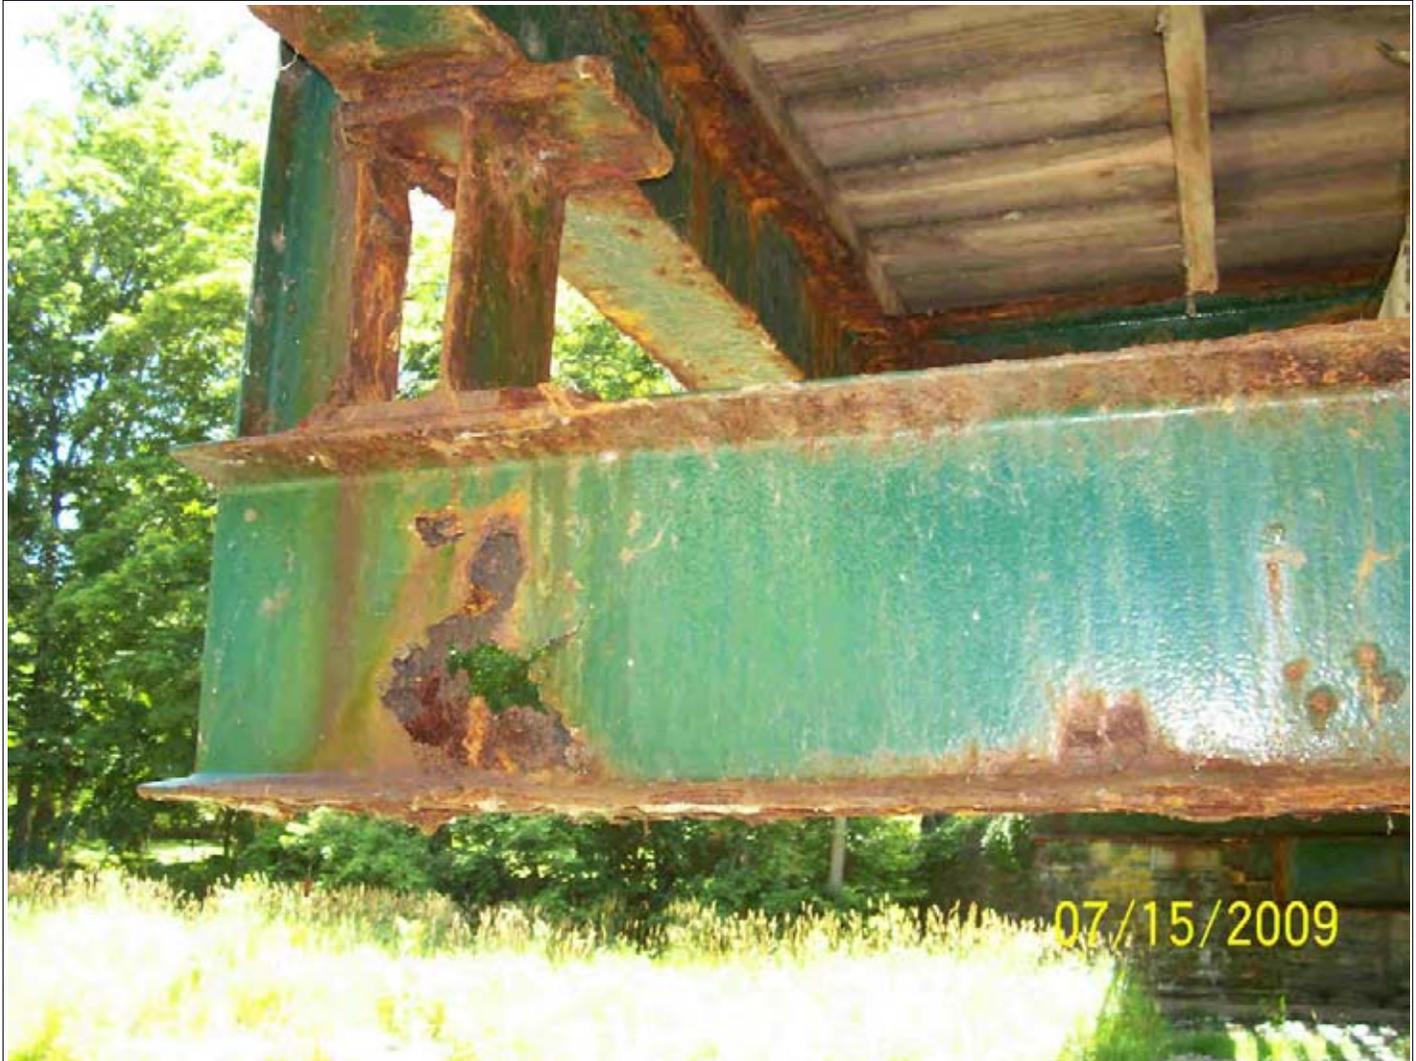
09100_0669.JPG - Attached to Safety Flag 3X090012

Floorbeam #6 cantilever, right side, end channel

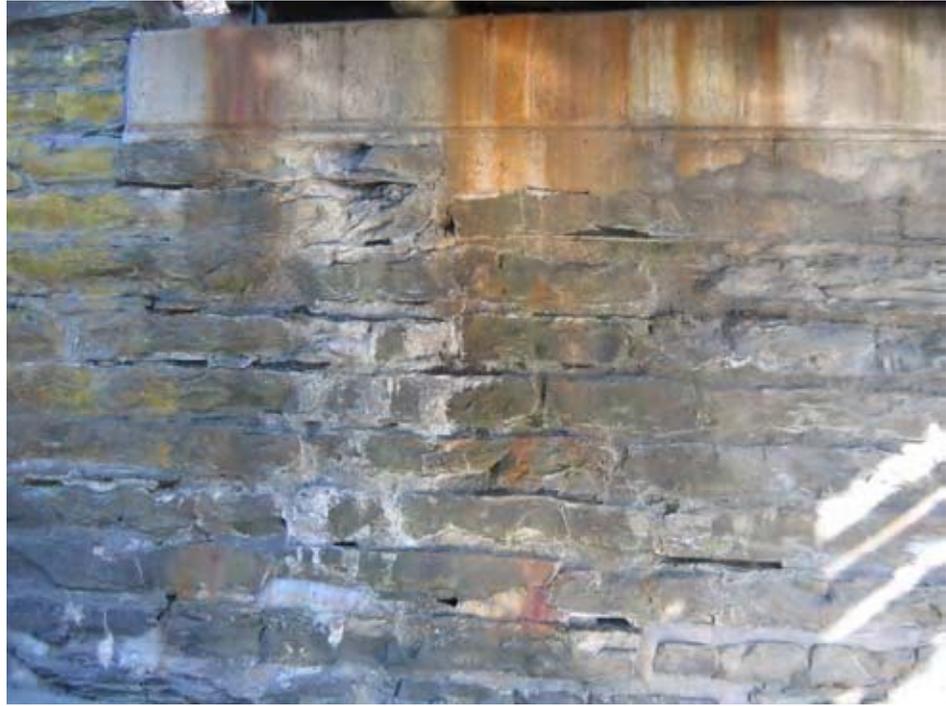
Description:
Stone masonry has broken stones with missing mortar and heavy efflorescence.

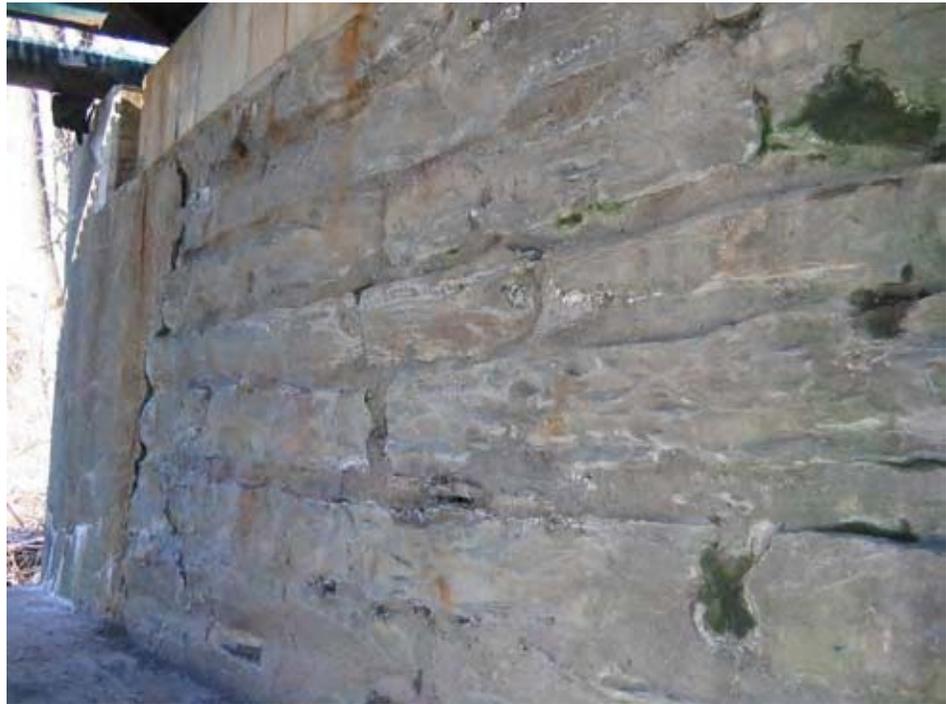
PHOTO NO. 14

Location:
End Abutment

Description:
Stone masonry with areas of cracked stones and missing mortar with areas of seepage.

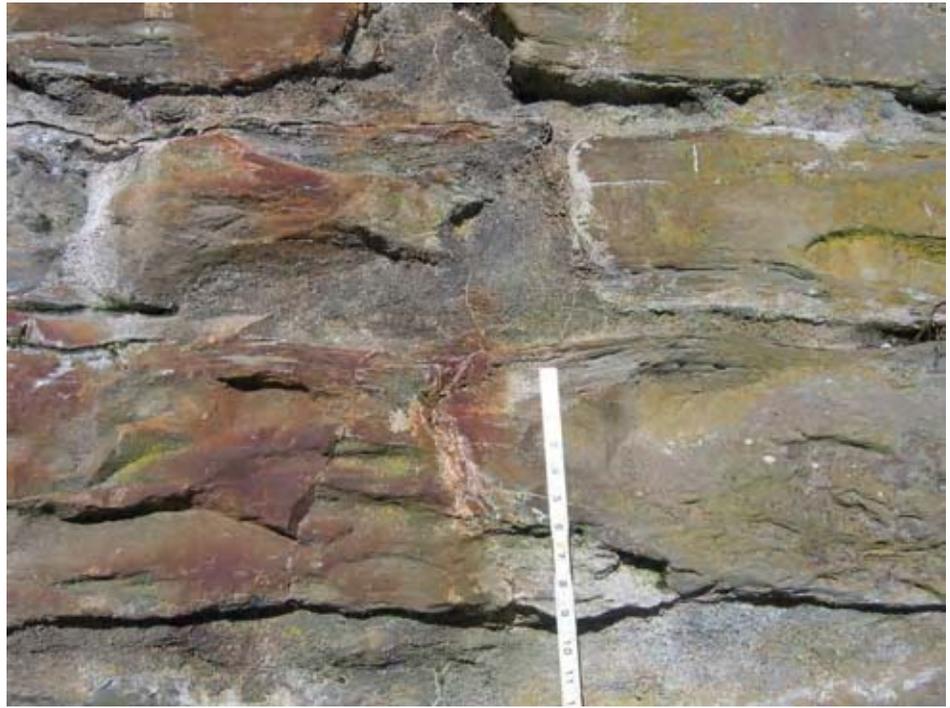
Description:
Example of crack through height of stone in stone masonry substructures.

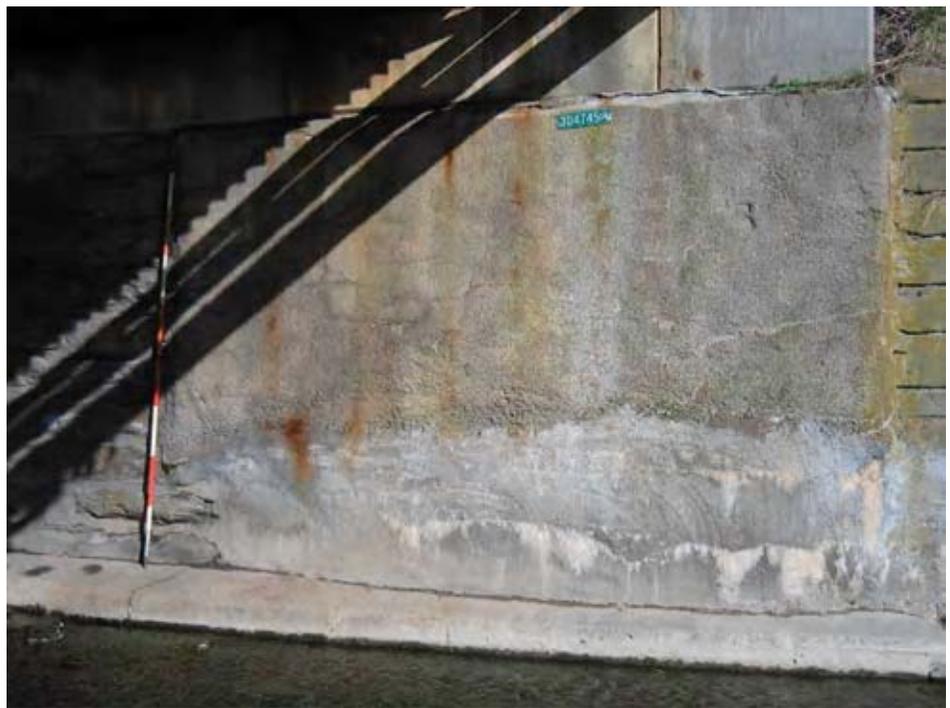
PHOTO NO. 16

Location:
In Fall Creek looking toward Begin Abutment.

Description:
Shotcrete portion of Begin Abutment exhibits heavy cracking with efflorescence and rust stains.

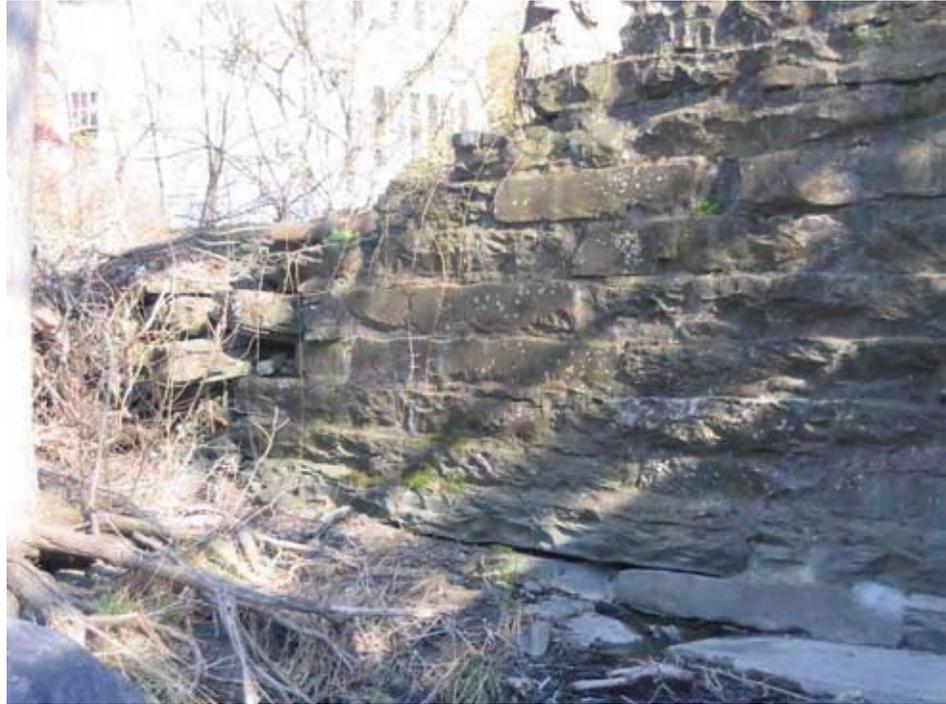
Description:
There are loose and
broken stones at the
end of the wingwall.

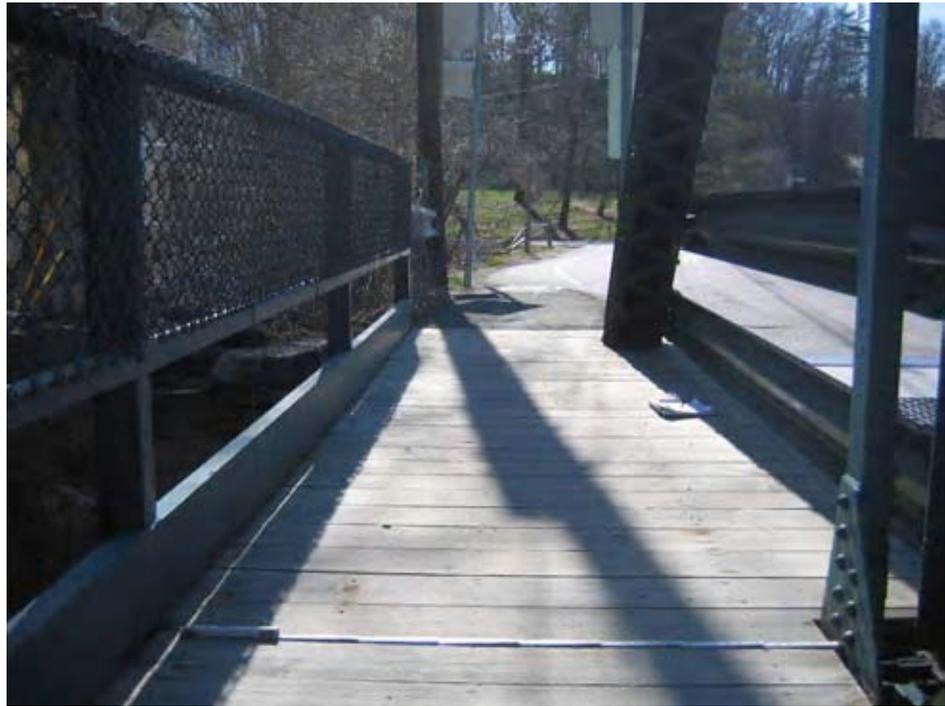
Description:
Typical sidewalk condition.

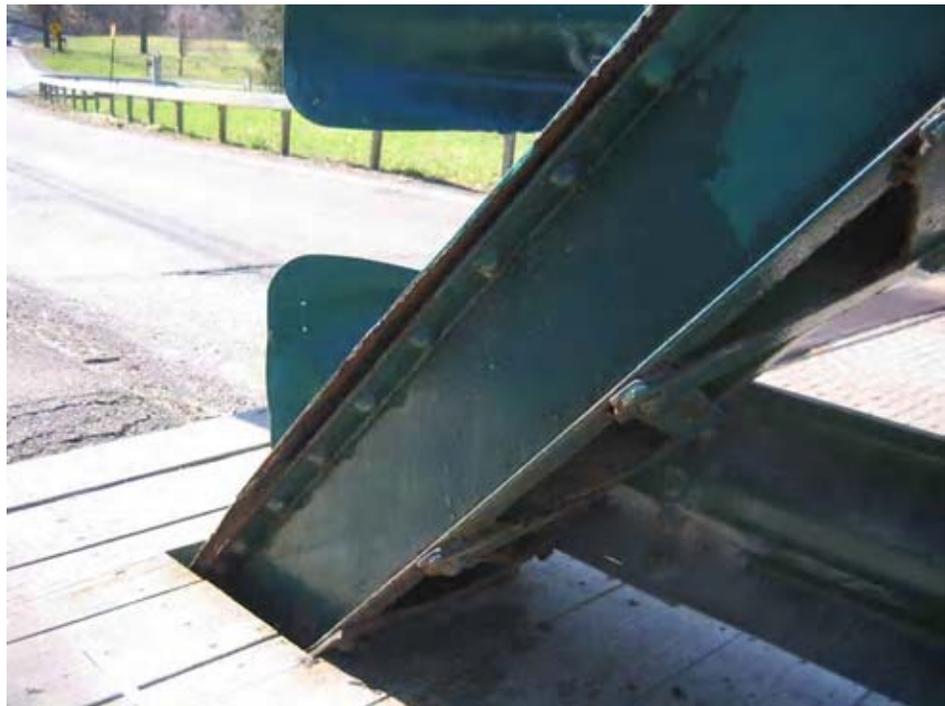
PHOTO NO. 20

Location:
Right truss member L0-L1 near L0.

Description:
1" separation between top plate and channel due to pack rust.

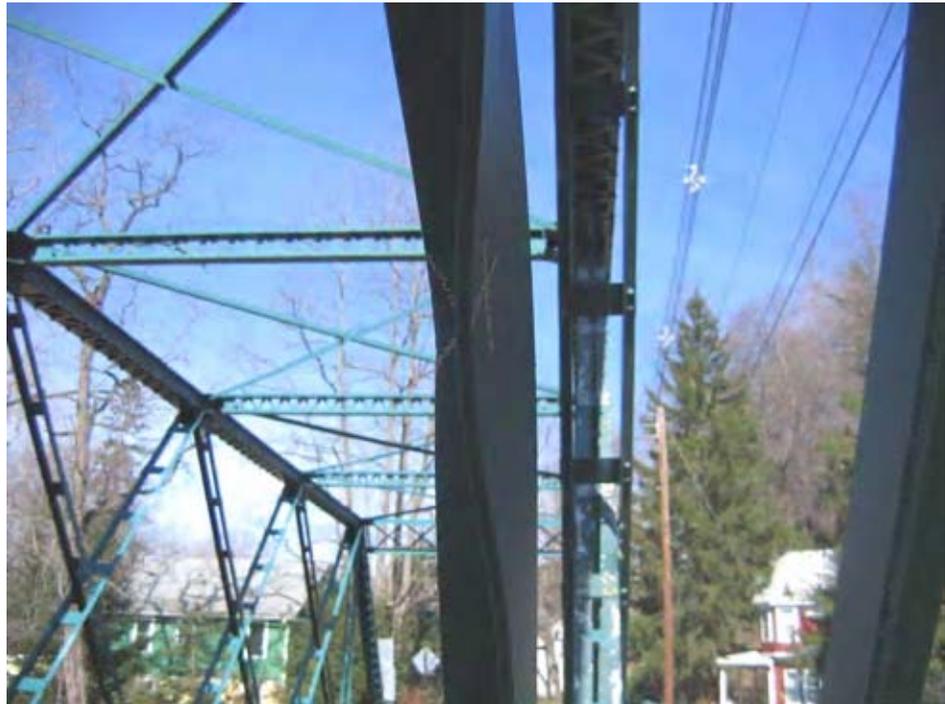
Description:
Impact damage to
angle on roadway
side 2 ft from center
of 'X'.

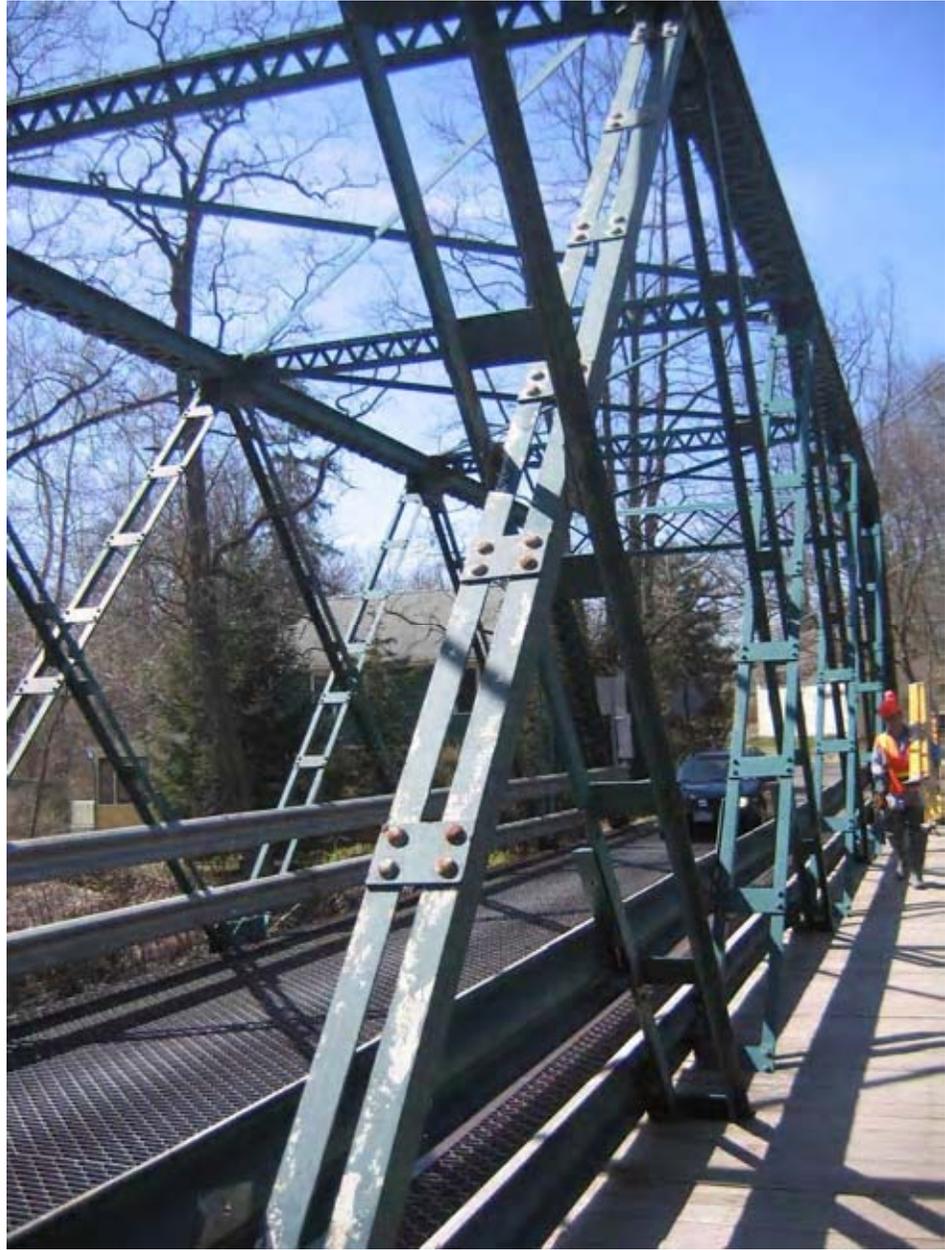
Description:
Typical condition of truss members above the bridge deck.

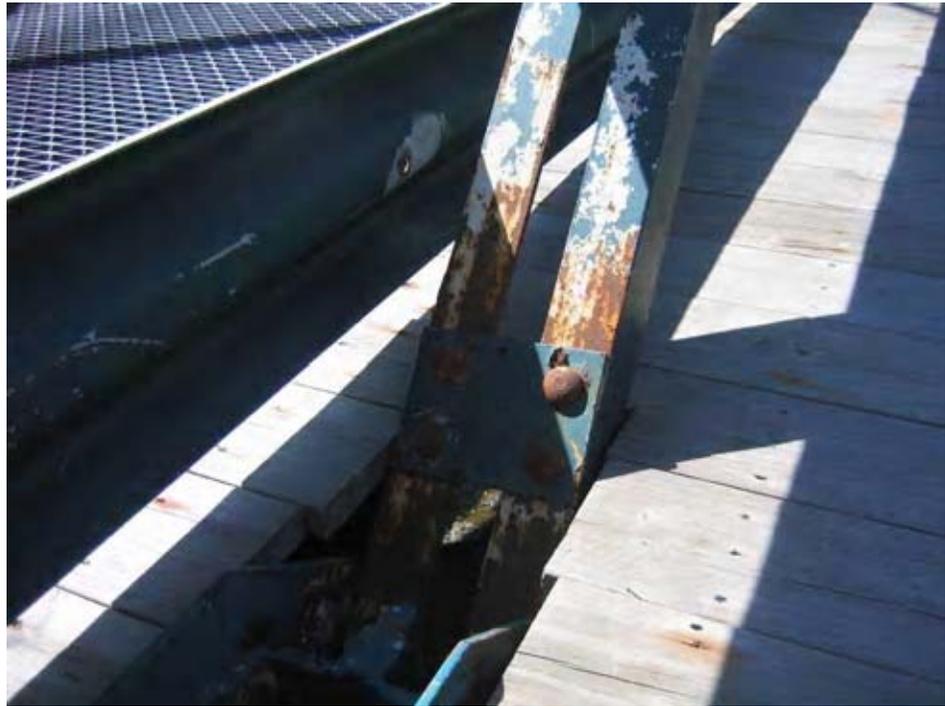
Description:
Typical condition of
diagonal truss
members at lower
panel points –
moderate to heavy
surface rust.

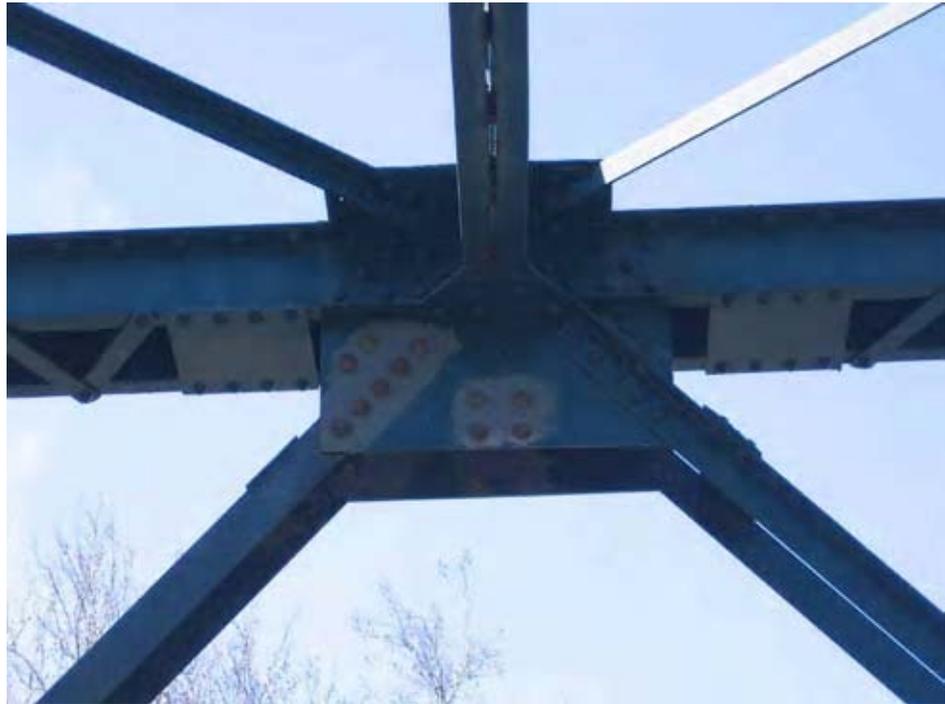
PHOTO NO. 25

Location:
Left truss – Upper
panel point U2.

Description:
Typical condition of
upper panel points
on both trusses.

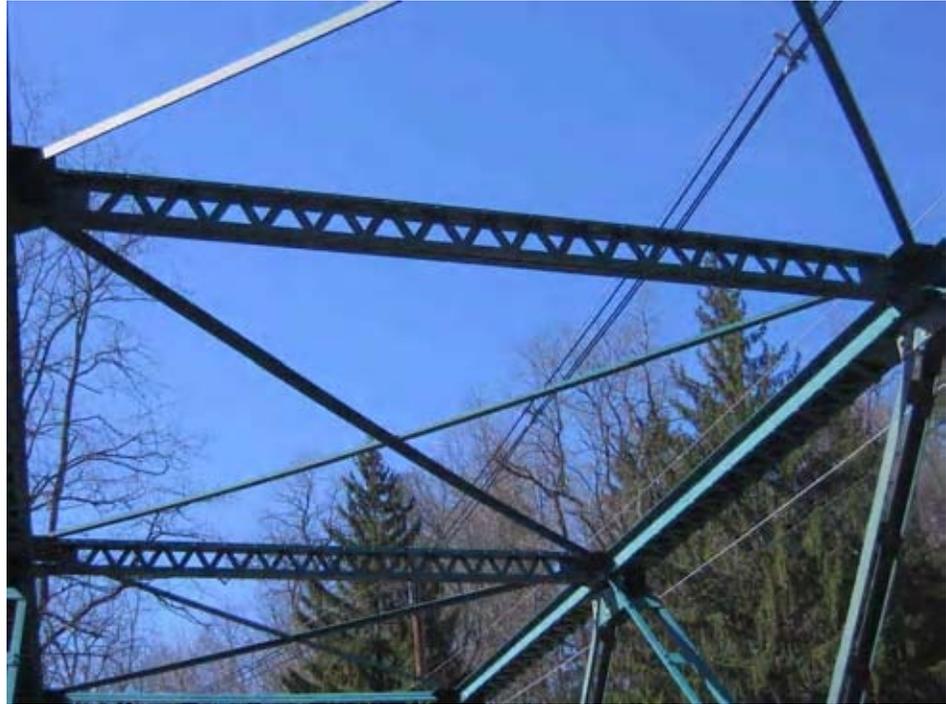
Description:
Typical condition of upper truss members.

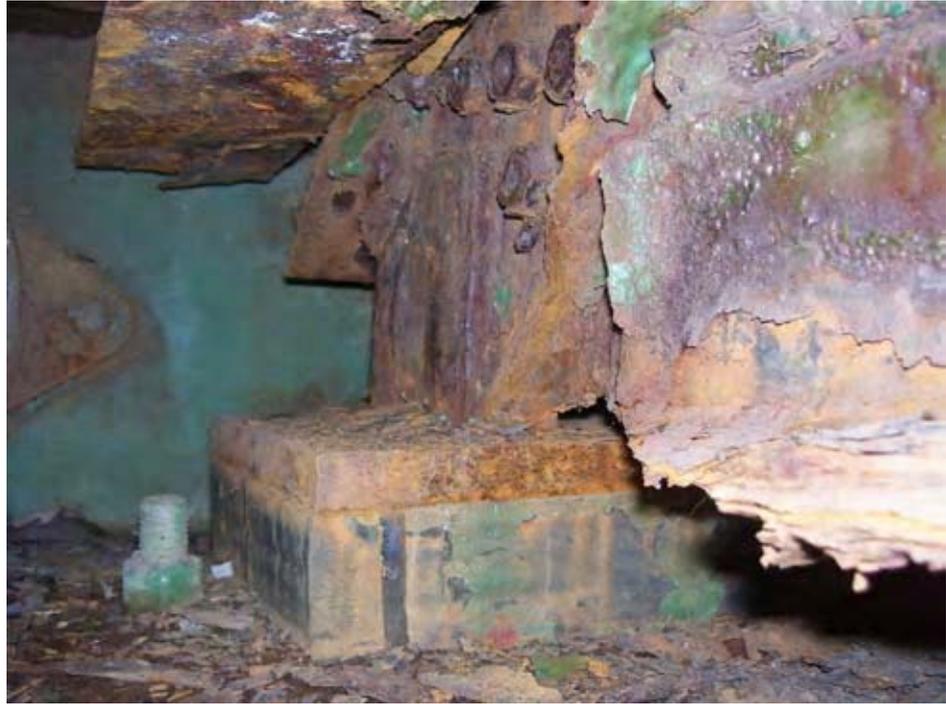
Description:
Heavy deterioration
with areas of 100%
section loss.

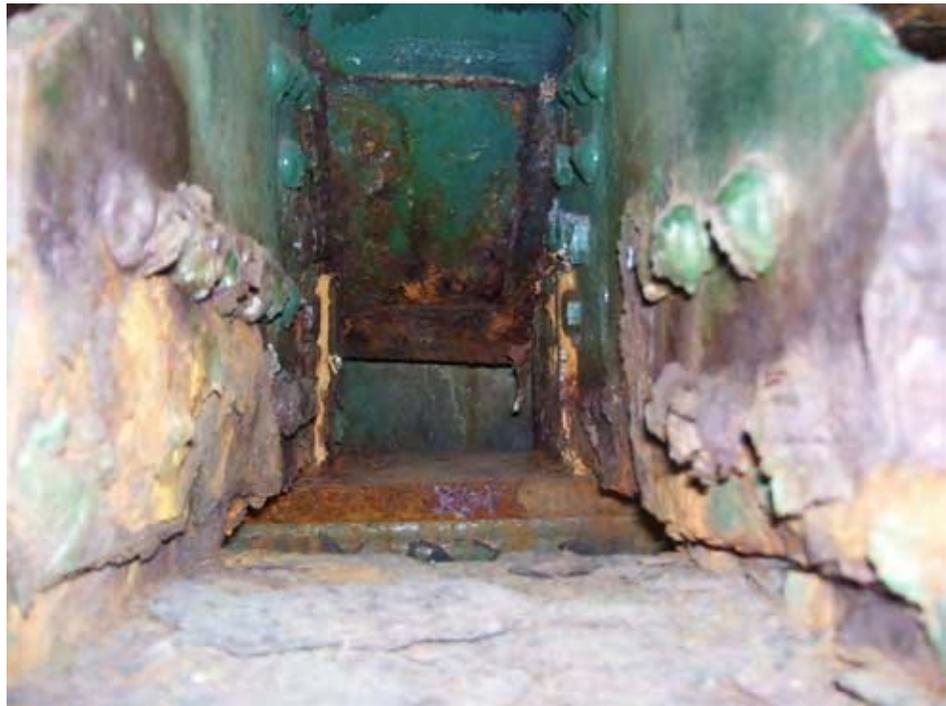
PHOTO NO. 29

Location:
Right truss bearing
at Begin Abutment.

Description:
Heavy deterioration
inside of bottom
chord member at L0.

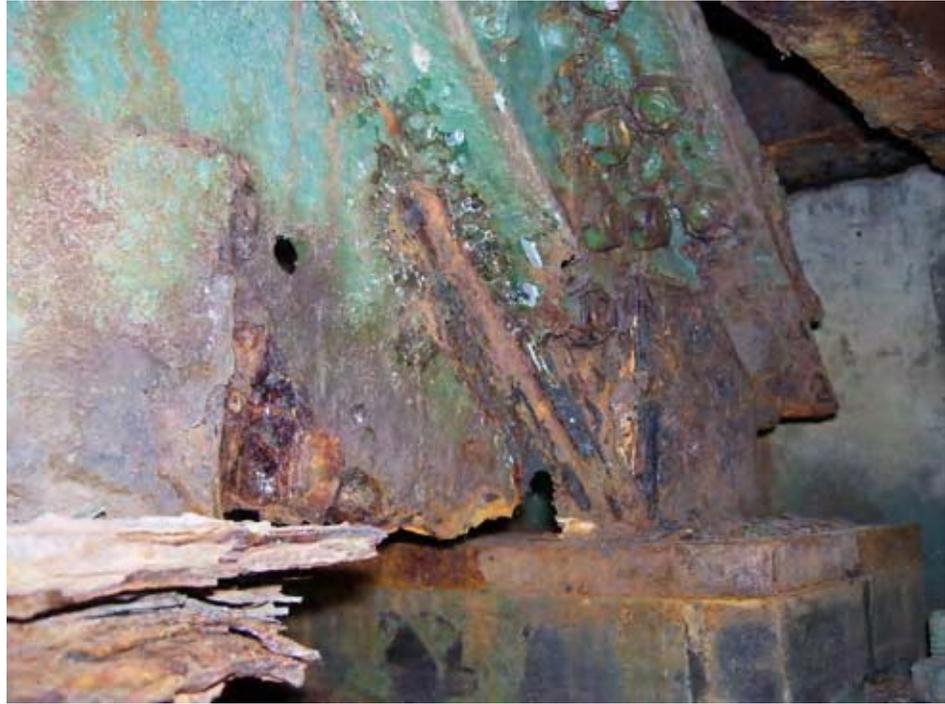
Description:
Gusset plate exhibits heavy deterioration with areas of 100% section loss.

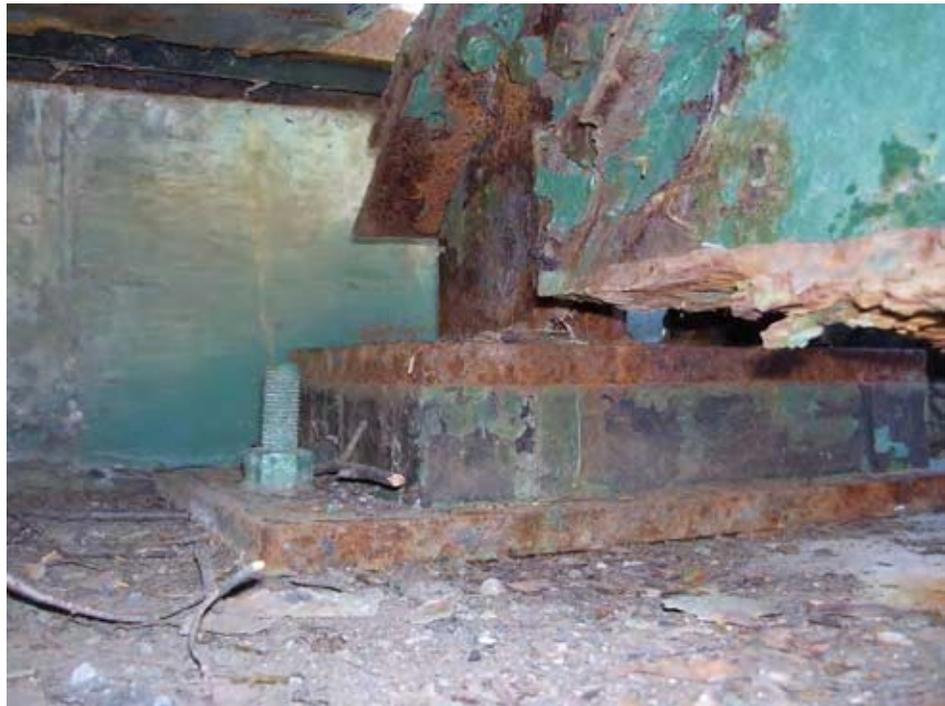
PHOTO NO. 31

Location:
Left truss bearing at Begin Abutment.

Description:
Heavy deterioration at L0.

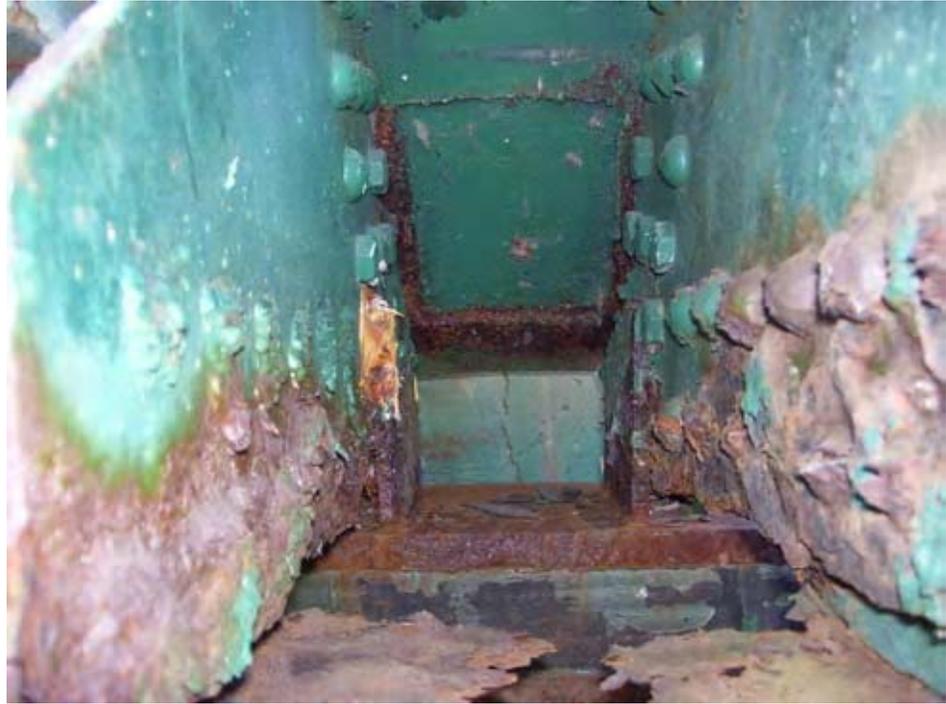
Description:
Heavy deterioration inside of bottom chord member at L0. Bottom plate exhibits 100% section loss. Rivets and bolts are heavily deteriorated with section loss.

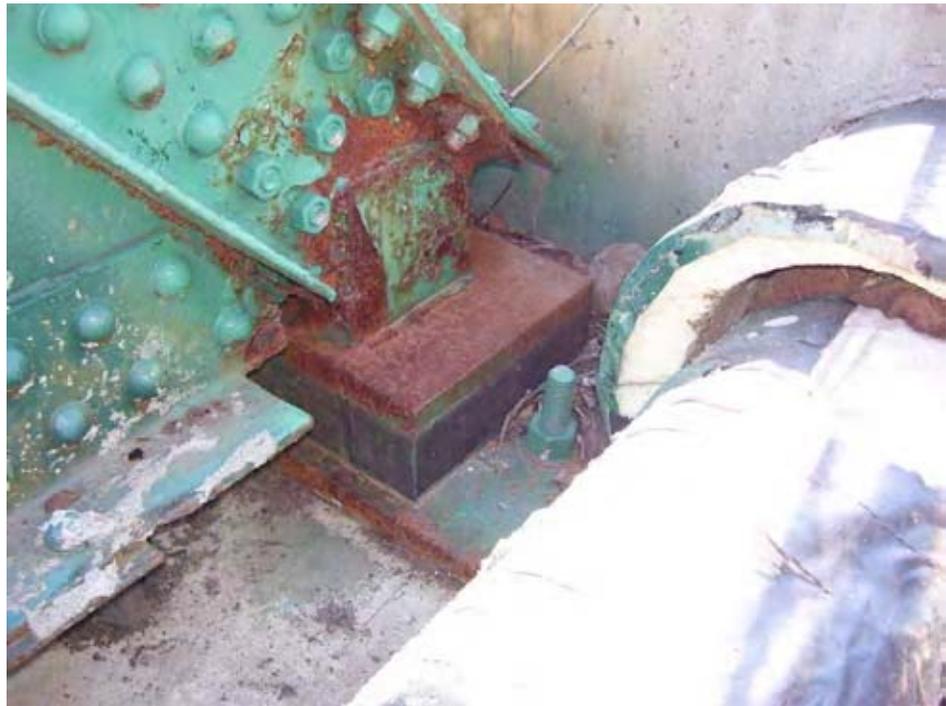
PHOTO NO. 33

Location:
Left truss bearing adjacent to utility.

Description:
Heavy surface rust on left truss bearing adjacent to utility.

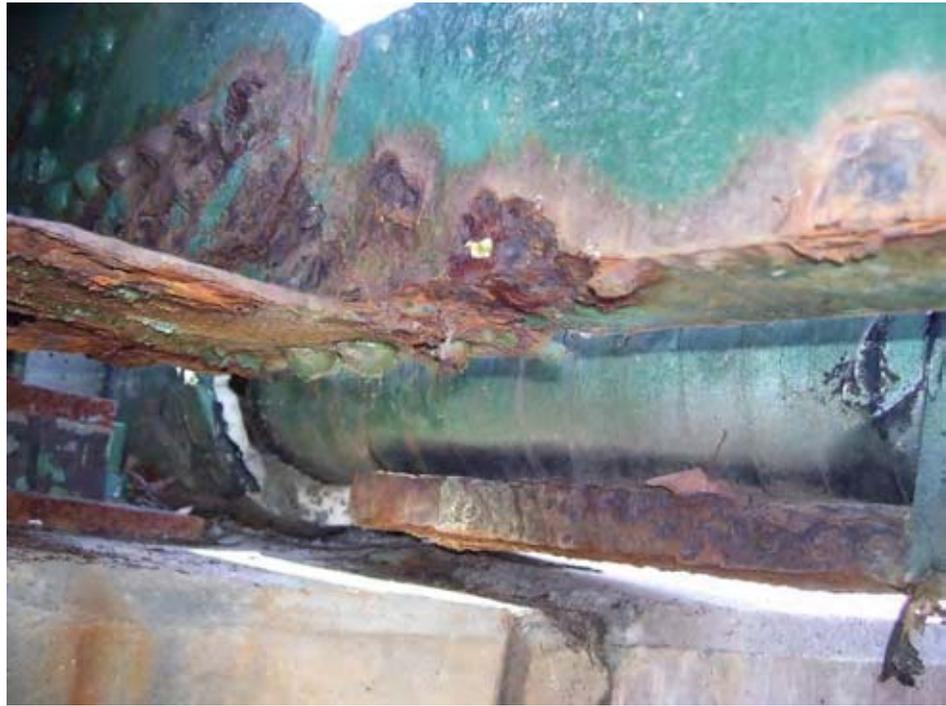
Description:
Heavy deterioration and section loss to outside channel of member L0-L1.

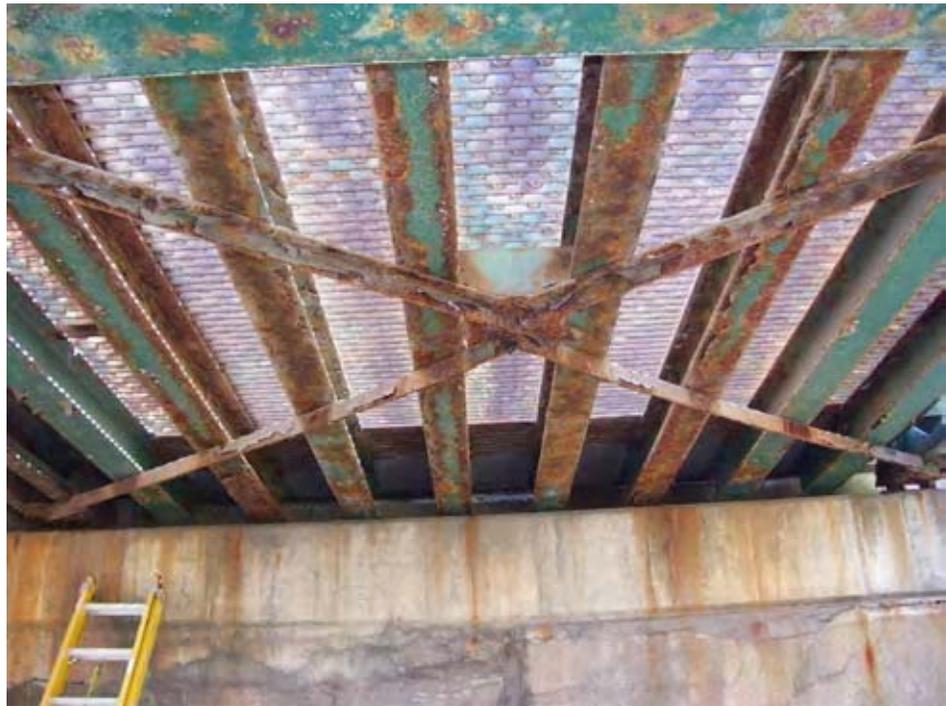
PHOTO NO. 35

Location:
Bay 1 looking toward Begin Abutment.

Description:
General condition of stringers and bracing – heavy surface rust with moderate to heavy delamination. Typical in Bays 1, 3, 5, and 7.

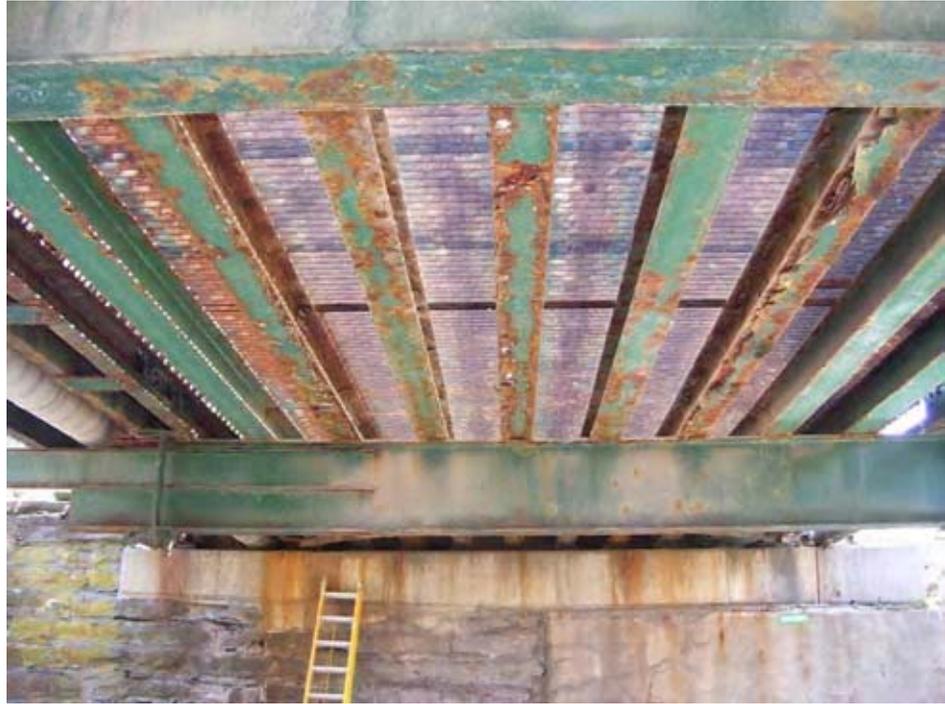
Description:
Typical stringer
condition in Bays 2,
4, and 6.

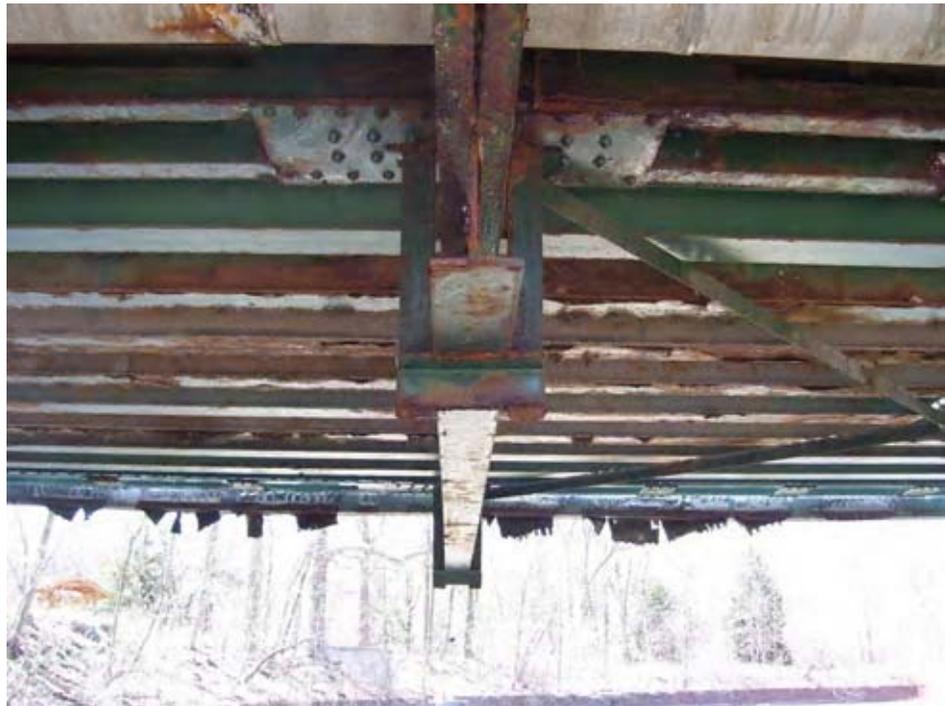
PHOTO NO. 37

Location:
Right side of
Floorbeam 1.

Description:
Typical condition of
floorbeam hanger.

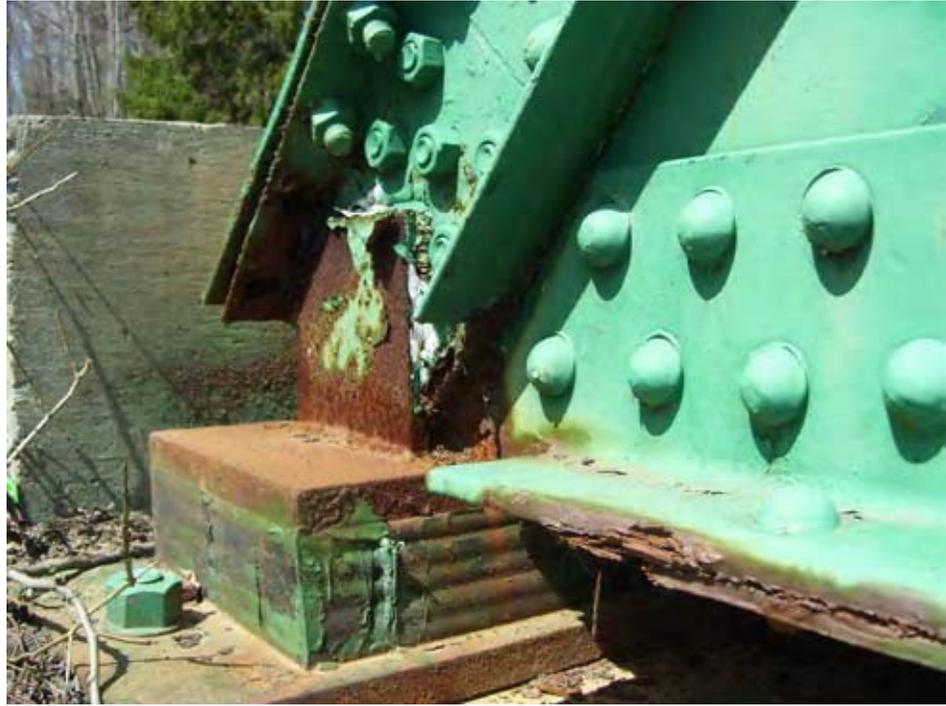
Description:
Heavy surface rust with delamination on bottom flange of low chord member.

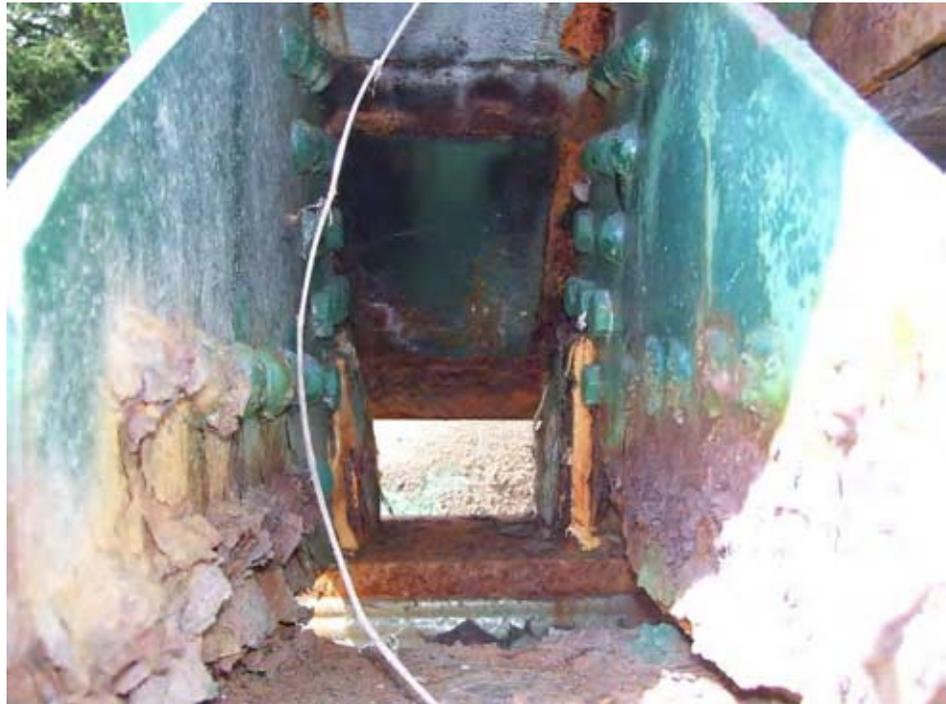
PHOTO NO. 39

Location:
Left truss bearing at End Abutment.

Description:
Heavy deterioration to rivets and bottom plate with areas of 100% section loss.
