APPENDIX A
PLANS, PROFILES & TYPICAL SECTIONS

FOREST HOME DRIVE OVER FALL CREEK

B.I.N. 3047450

In-Depth Inspection Report

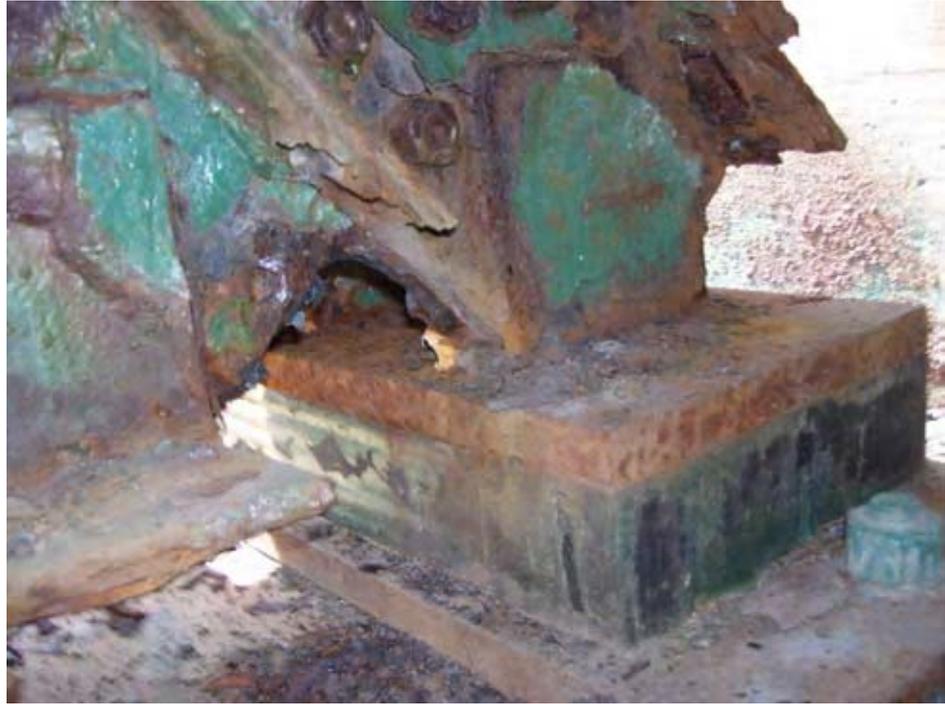
Description:
Heavy surface rust
with delamination
and section loss.

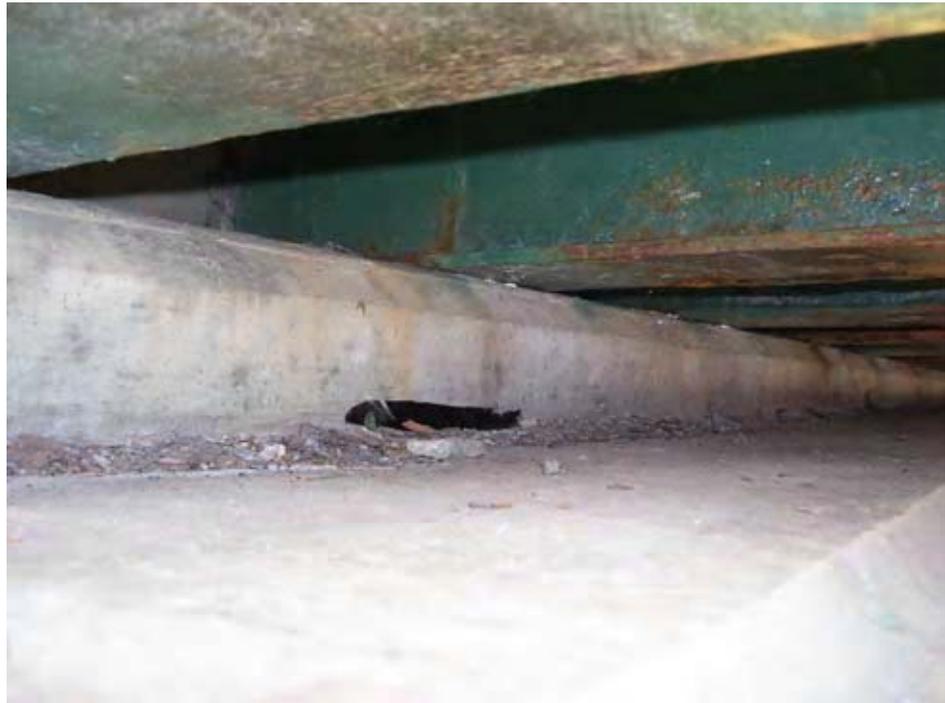
PHOTO NO. 41

Location:
Stringer bearings at
End Abutment.

Description:
General condition of
bearing seat
beneath stringers.

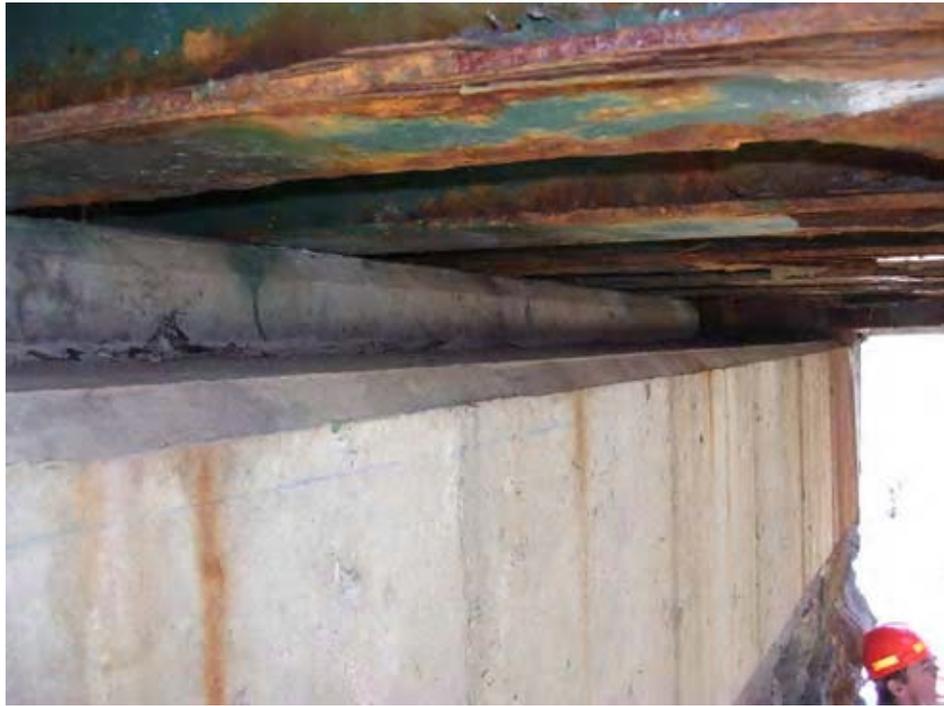
Description:
General condition of stringers - heavy surface rust and delamination.

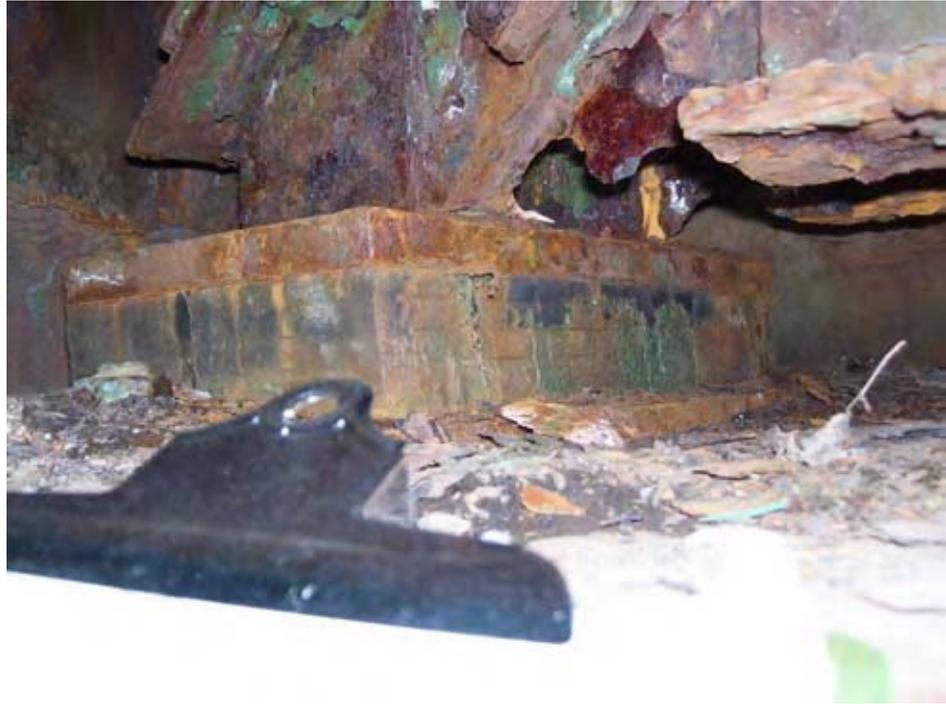
Description:
Severe deterioration.
