# Cayuga Coal Ash Disposal Facility

Mitigation & Remediation Options

John Dennis and Brian Eden

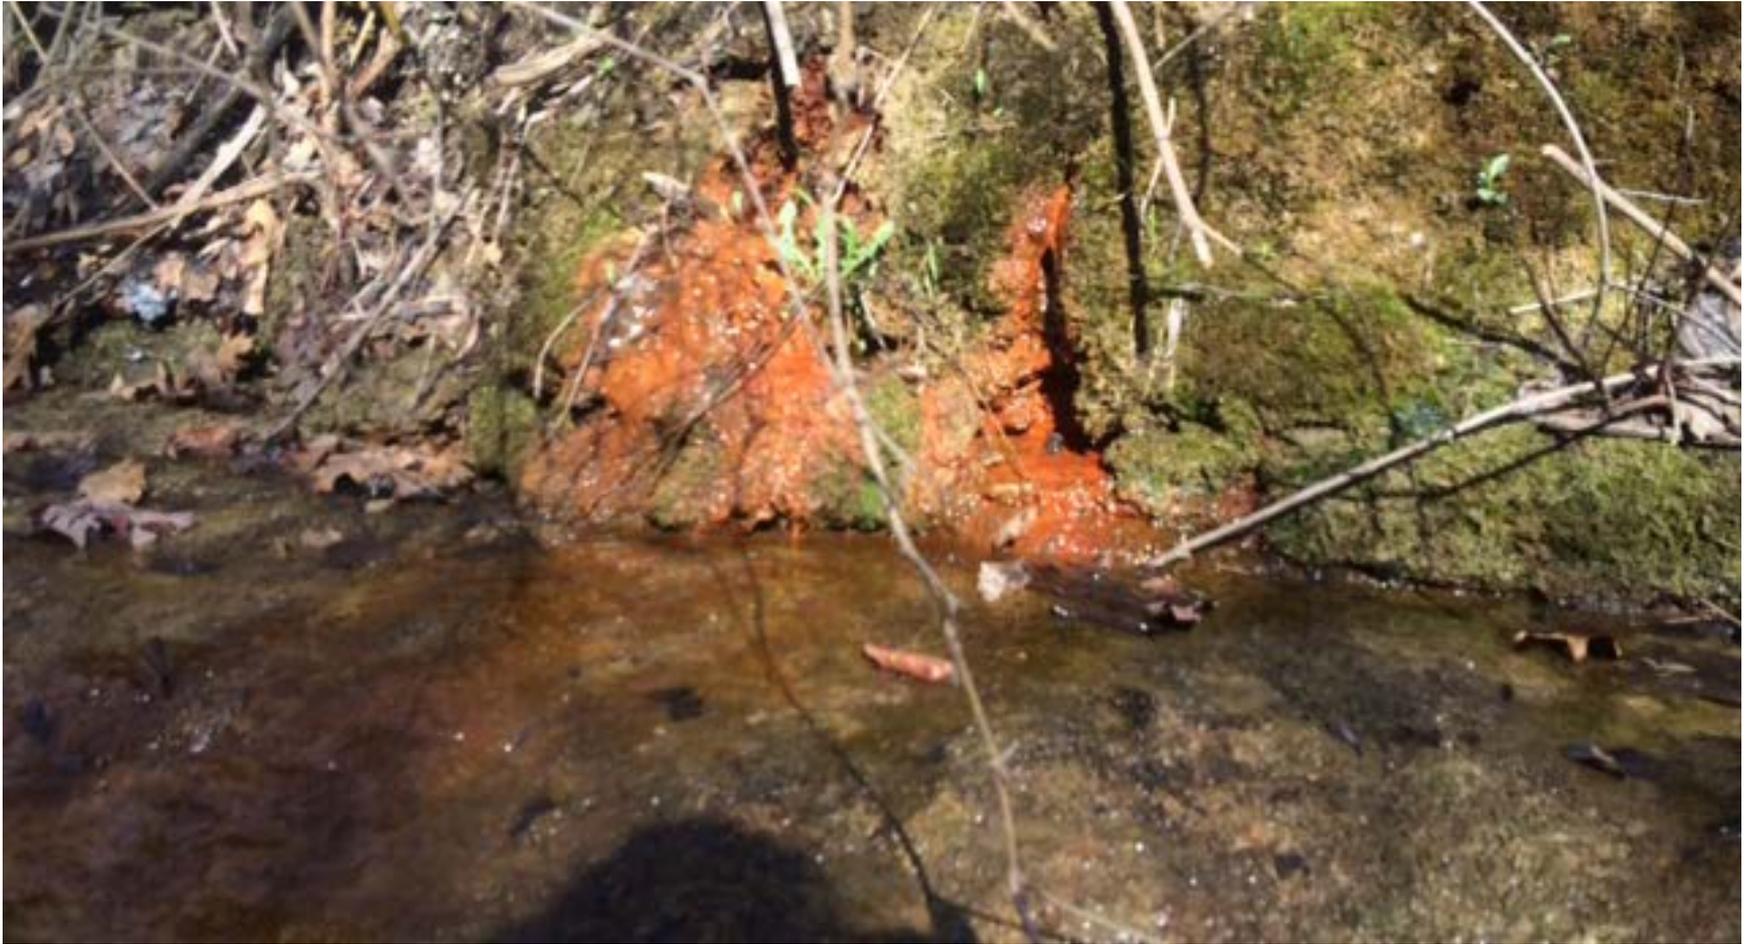
# Suspected Coal Ash Leachate Seep

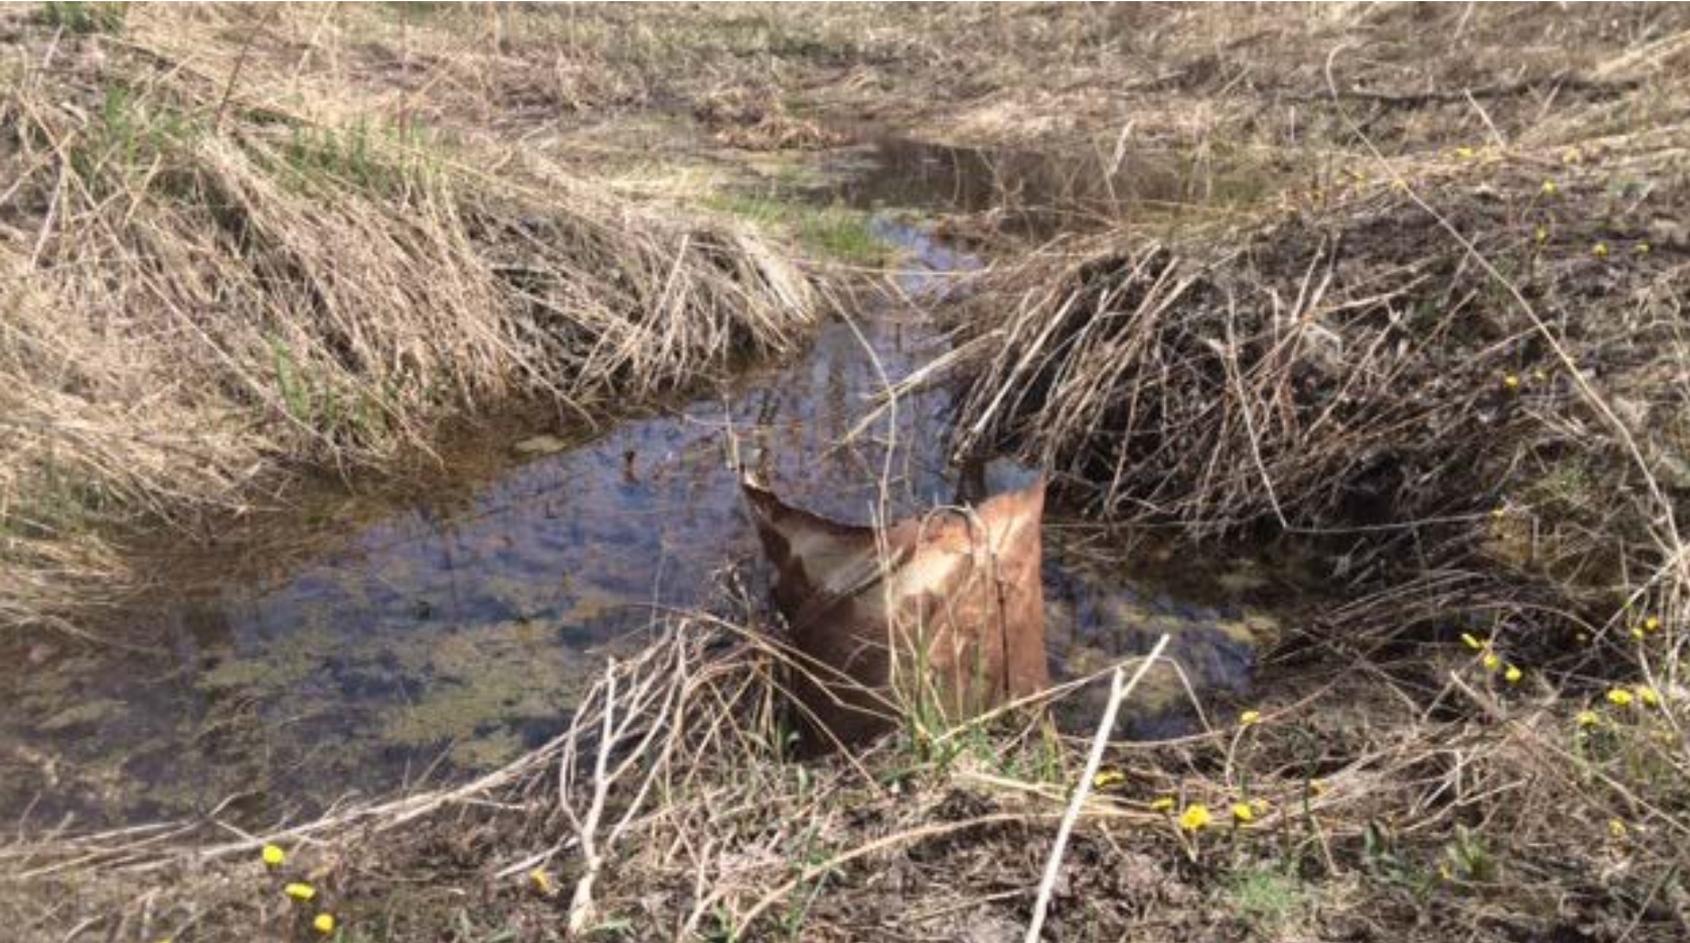
# Illegal Coal Pile Effluent Basin

John Dennis (see attached power point) went on to voice his concerns about an unpermitted coal pile run-off basin that is located approximately 100 yards from the facility. He further commented that according to a consulting geologist with national expertise on coal ash landfills, the chemical signatures found in ground water seeps to Milliken Creek indicate that these seep originate from the landfill ( i.e., it is leaking). Exceedances of drinking water standards found in these seeps and in some local wells are for chloride, iron, manganese, sodium, and total dissolved solids. In 2014, Cayuga Power Plant' owners proposed that the landfill's Financial Assurance Fund be decreased from \$6,200,000 to \$5,200,000. However, subsequent to a delegation of concerned citizens from Ithaca meeting with the NYSDEC in Syracuse, this fund was increased to \$7,500,000.

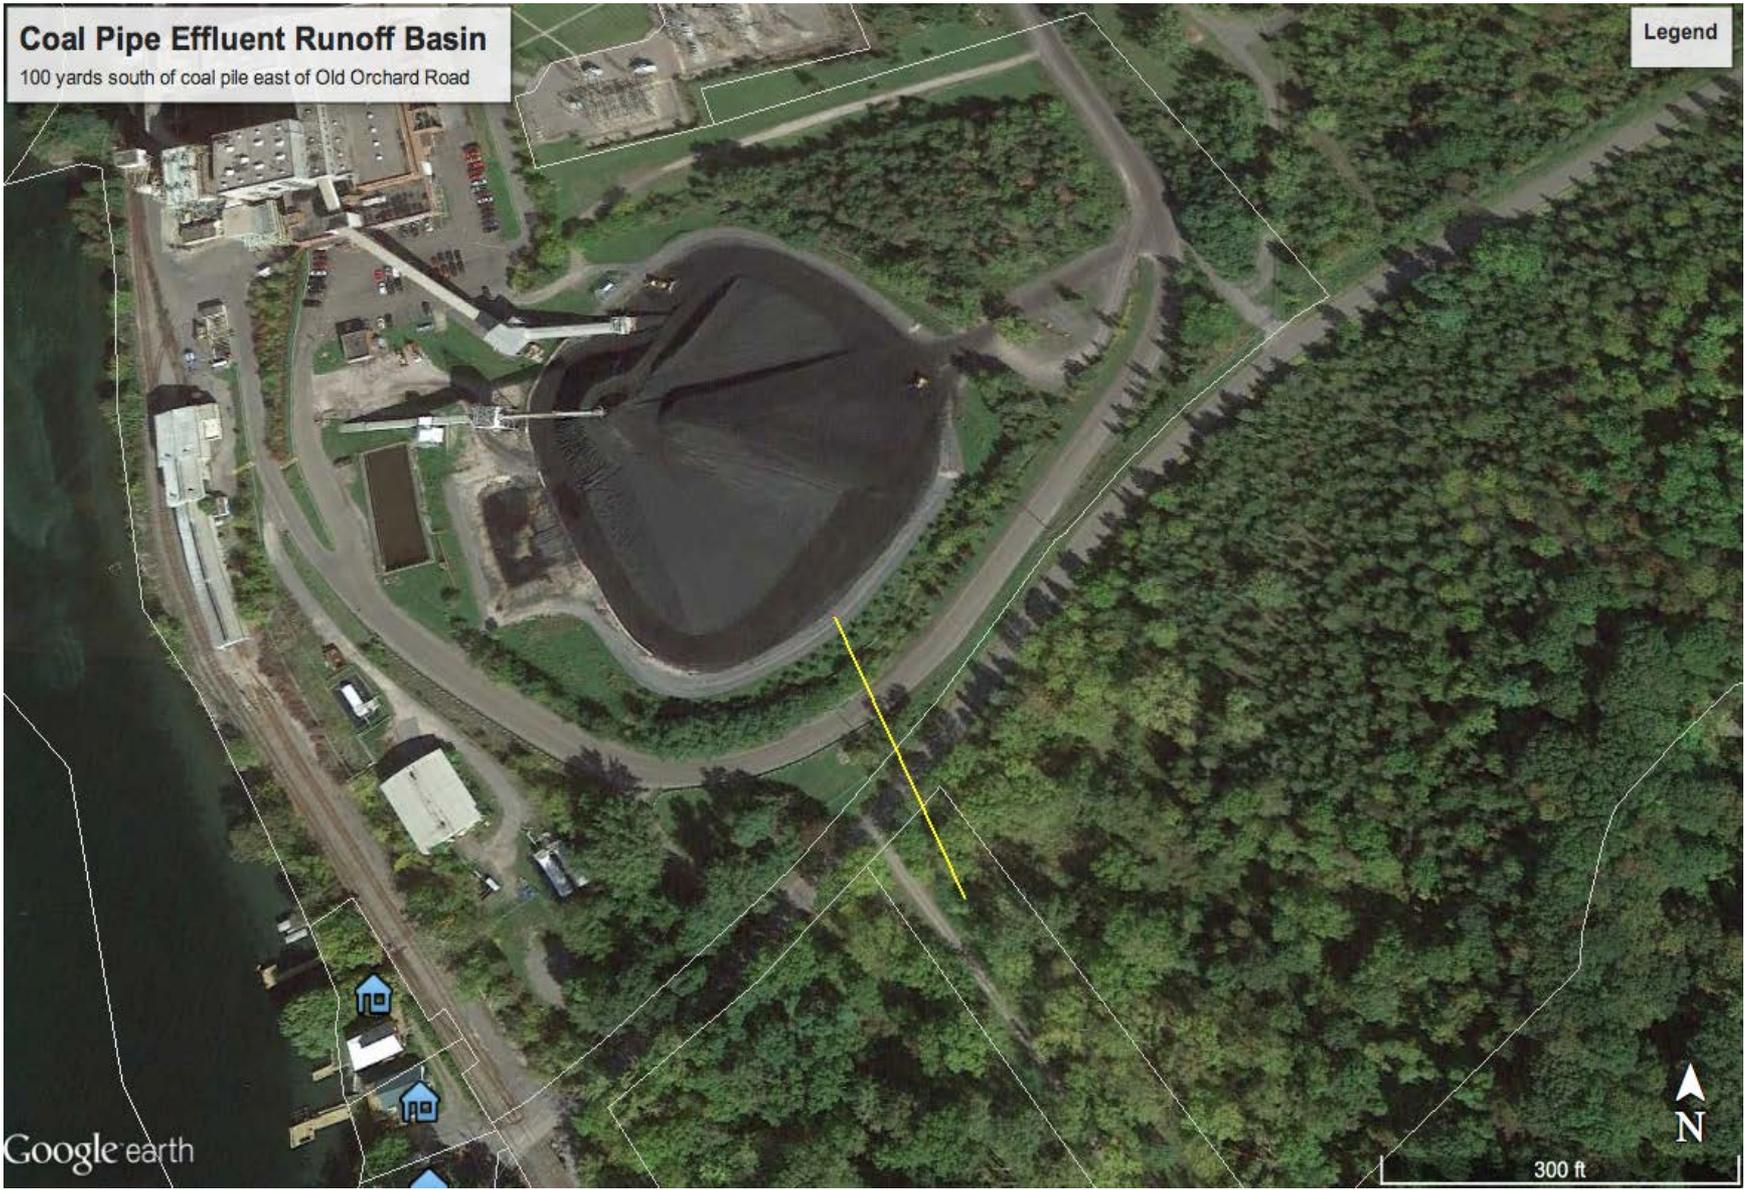
# Coal Pipe Effluent Runoff Basin

100 yards south of coal pile east of Old Orchard Road

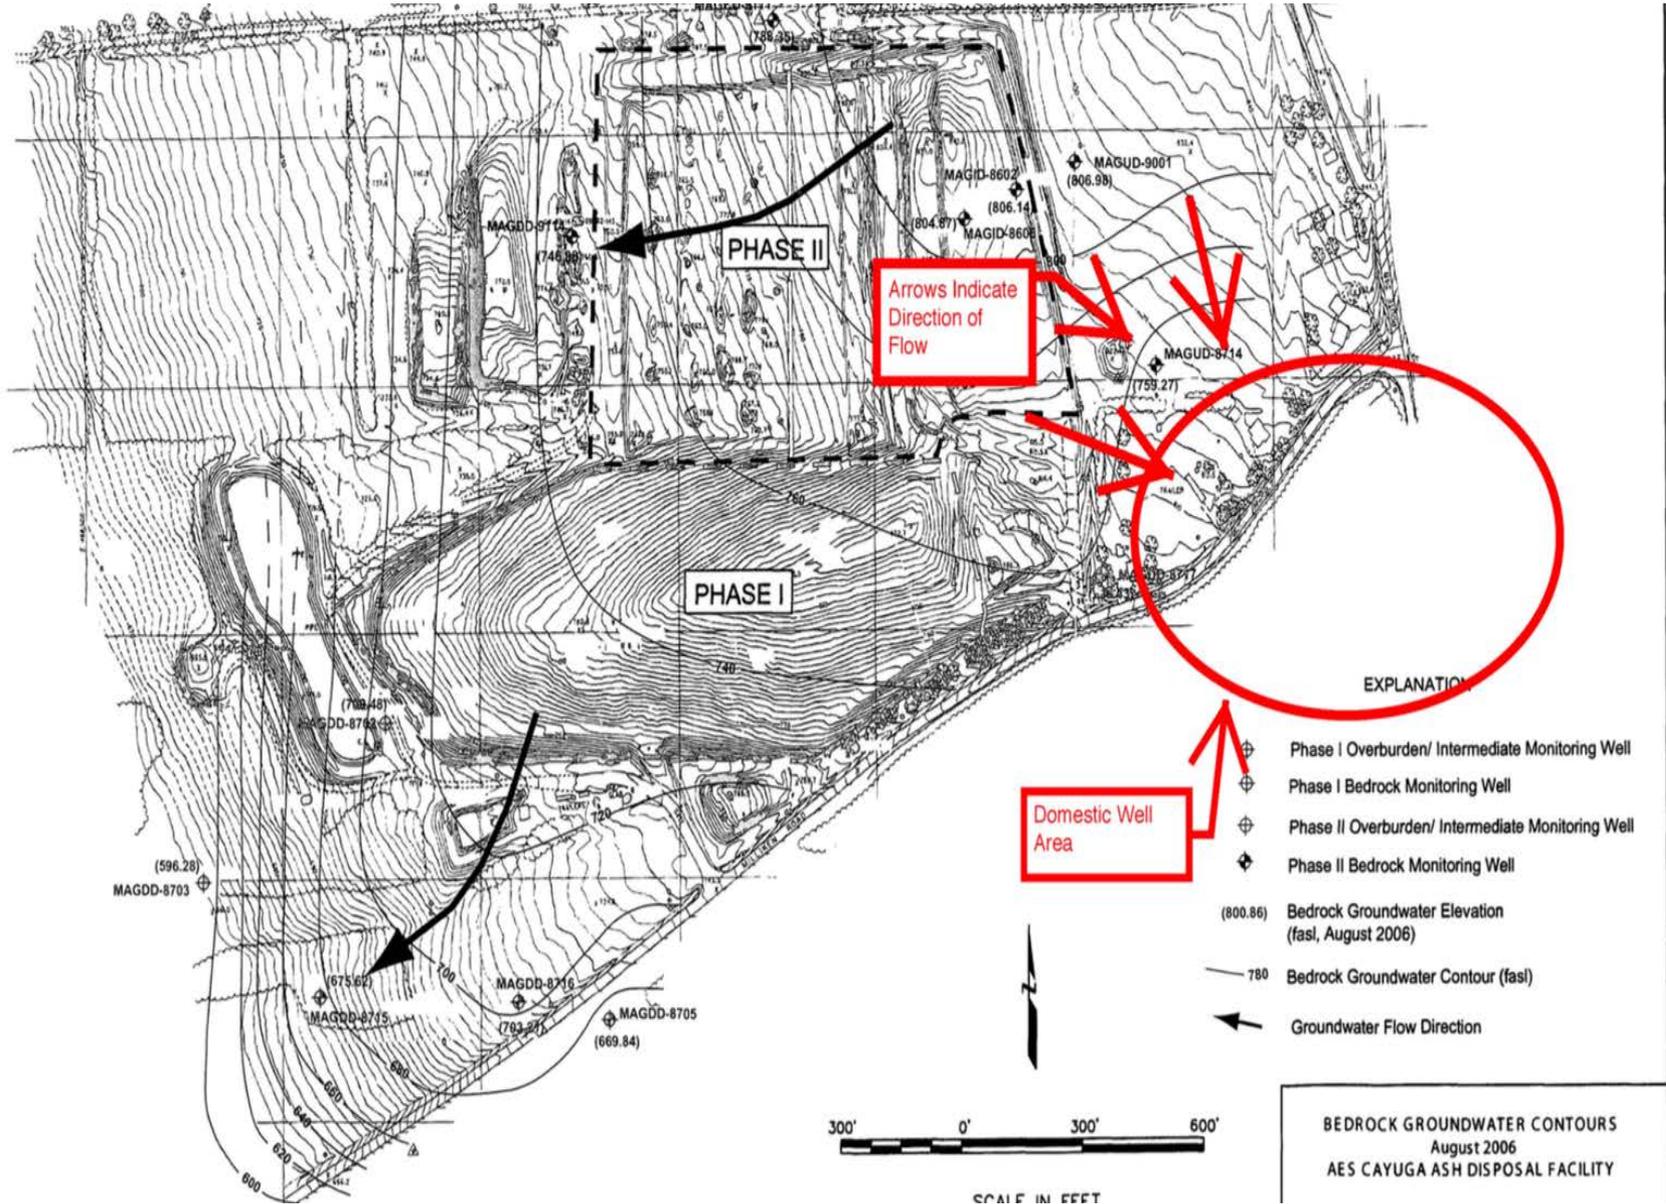
# Exceedances in Monitoring Wells

Well Name	Arsenic (mg/L)	Ammonia (mg/L)	Barium (mg/L)	Boron (mg/L)	TDS (mg/L)	Sodium (mg/L)	Sulfate (mg/L)	Chloride (mg/L)	Iron (mg/L)	Manganese (mg/L)	pH
<b>Standard</b>	<b>0.01 (MCL)</b>	<b>2.0</b>	<b>1.0</b>	<b>1.0</b>	<b>500</b>	<b>20</b>	<b>250</b>	<b>250</b>	<b>0.3</b>	<b>0.3</b>	<b>6.5- 8.5</b>
8105	<b>0.0134</b>	-	-	<b>8.33</b>	<b>1,380</b>	<b>60.3</b>	<b>560</b>	-	-	-	-
8703 SH	0.009	-	-	0.36	<b>500</b>	19.2	107	-	-	-	-
8703 DI	0.008	1.6	-	0.633	<b>950</b>	<b>275</b>	102	216	-	-	-
8703 DD	<b>0.0139</b>	1.4	<b>1.2</b>	0.785	<b>2,060</b>	-	-	<b>1,830</b>	<b>0.522</b>	-	-
8715 DI	-	-	-	-	<b>1,320</b>	<b>238</b>	-	<b>550</b>	-	-	-
8715 DD	0.0077	<b>4.3</b>	0.856	-	<b>1,580</b>	<b>234</b>	-	<b>664</b>	<b>1.45</b>	<b>0.336</b>	-
8716 DI	0.0078	-	-	-	415	15.9	-	-	<b>1.3</b>	-	-
8716 DD	0.005	<b>1.6</b>	-	-	-	-	-	-	-	-	-
8705 SH	0.0067	<b>0.7</b>	-	-	<b>610</b>	<b>59.4</b>	-	106	-	-	-
8705 DI	0.0083	-	-	-	<b>875</b>	<b>48.4</b>	148	<b>265</b>	<b>2.35</b>	-	-

8705 DD	<b>0.0118</b>	<b>4.4</b>	-	0.677	<b>900</b>	<b>351</b>	201	168	<b>0.831</b>	-	-
0501 SH	<b>0.0171</b>	-	-	-	400	-	-	-	-	-	-
0501 DD	-	-	-	-	-	-	-	-	-	-	11.8
X01 DW	<b>0.016</b>	-	-	-	<b>755</b>	<b>58.1</b>	94.6	195	<b>0.56</b>	-	-

- Expand the environmental monitoring network to ascertain the vertical and horizontal extent of groundwater contamination on and off site.
- Employ corrective measures to restrict groundwater contamination to the facility site itself.
- Request that the DEC require Financial Assurance Funding to expand the monitoring network and for remediation of the site. These costs are not currently provided for in the FAF.
