## **Flood Mitigation Needs Assessment**

**Six Mile Creek, Salmon Creek, Fall Creek, & Cayuga Inlet  
Tompkins County, New York**

**September 2005**

**MMI #2343-01**

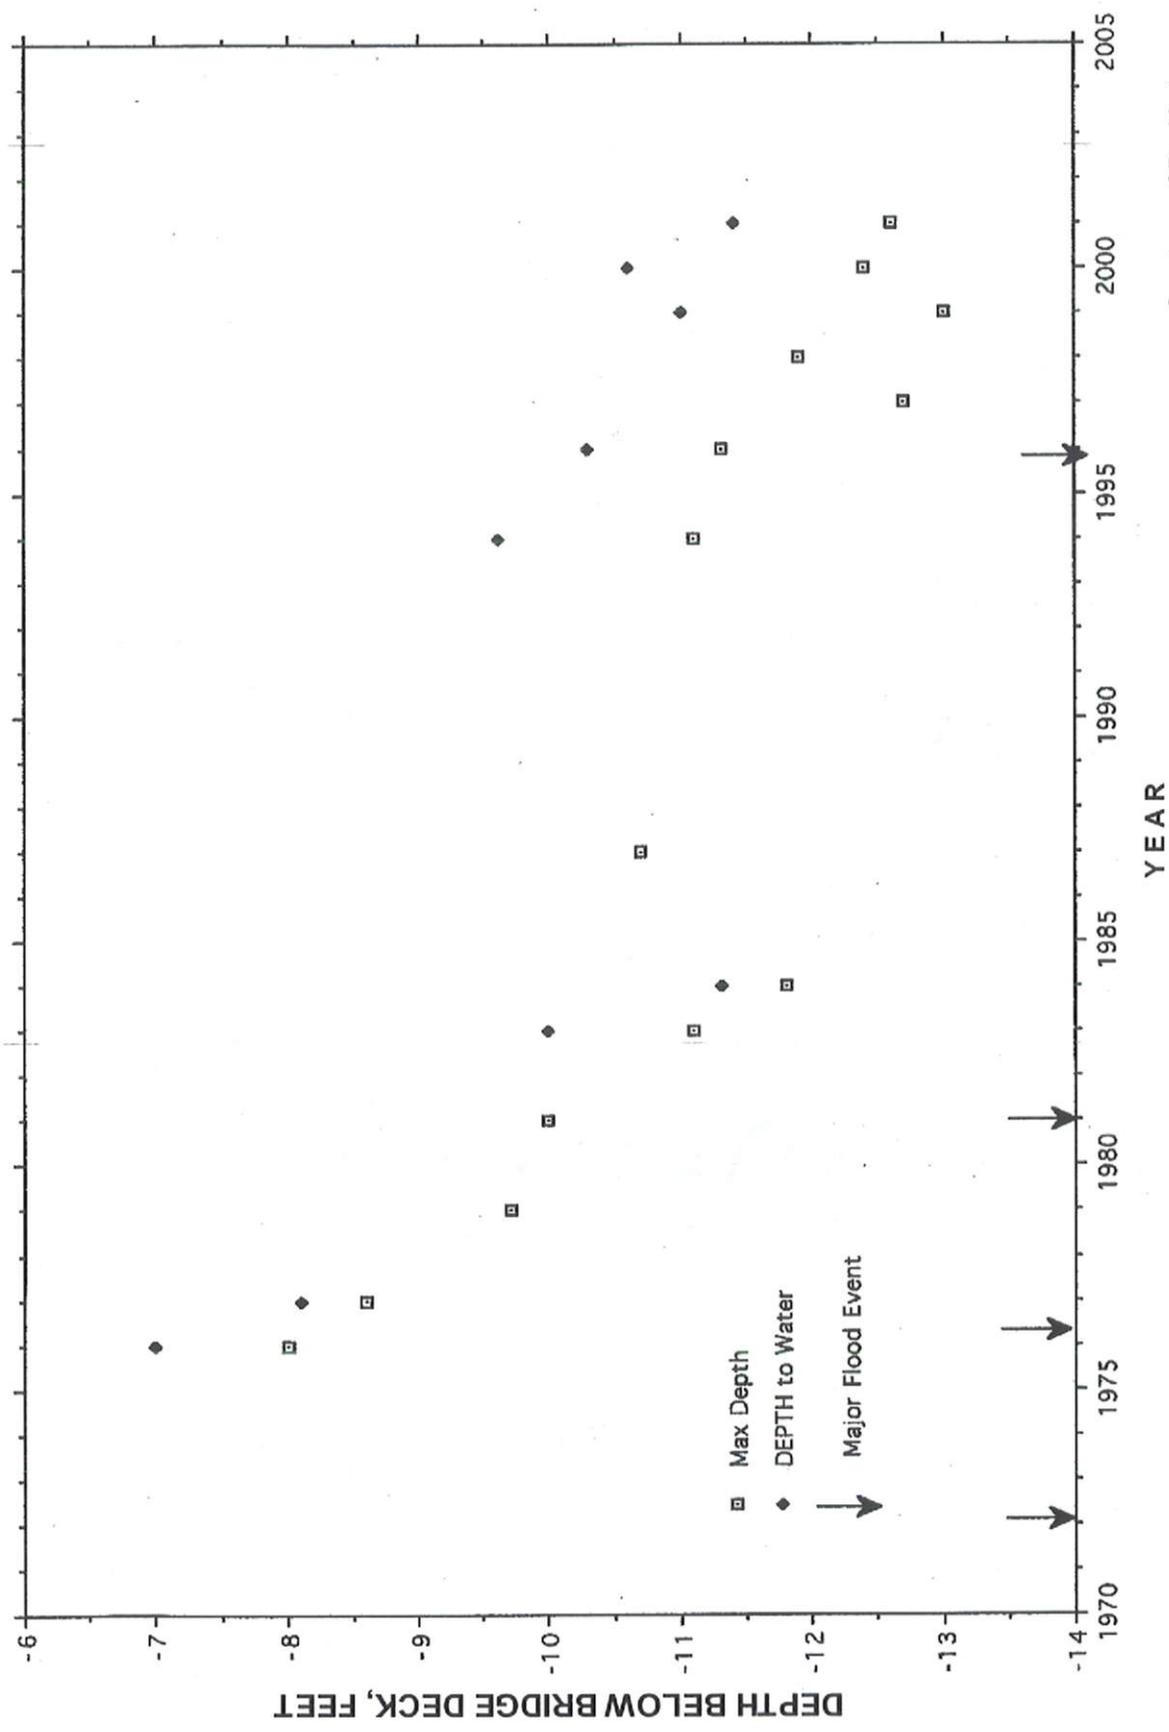
**FIGURE 5-1**

**SIX MILE CREEK AT GERMAN CROSS ROAD  
DEPTH OF CHANNEL BELOW BRIDGE DECK**

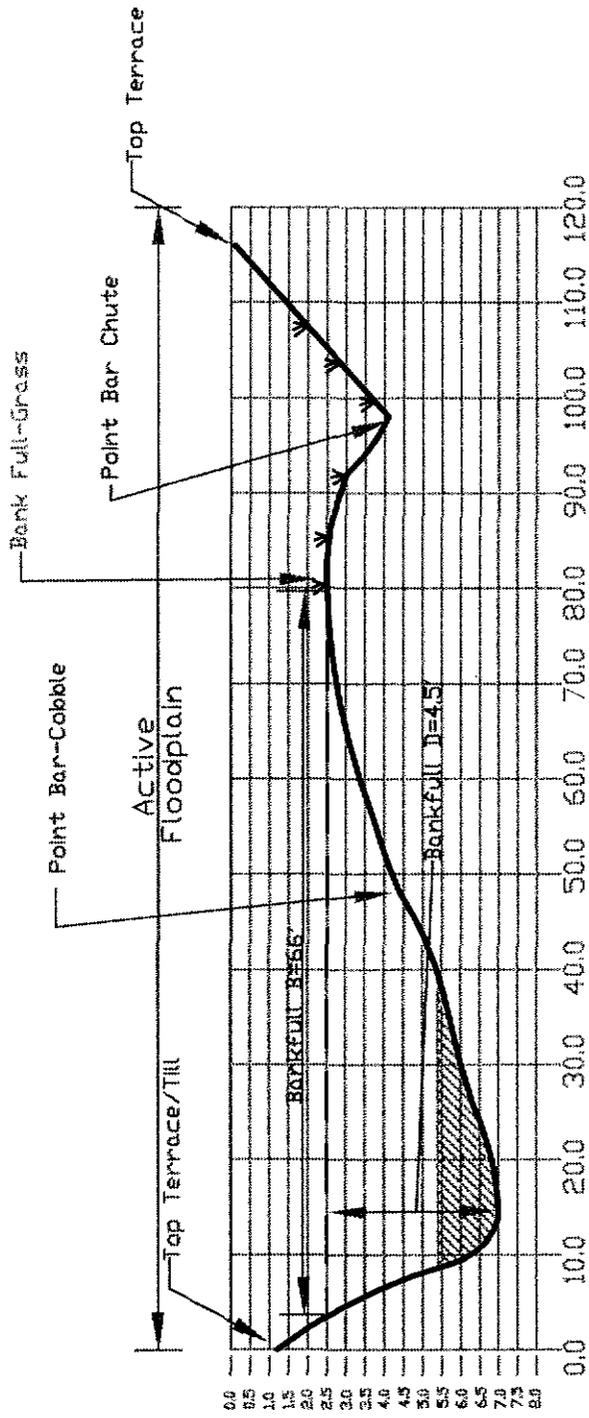
SHEET:  
**Figure 5-3**

**Bend Cross Section  
Karlo Property**

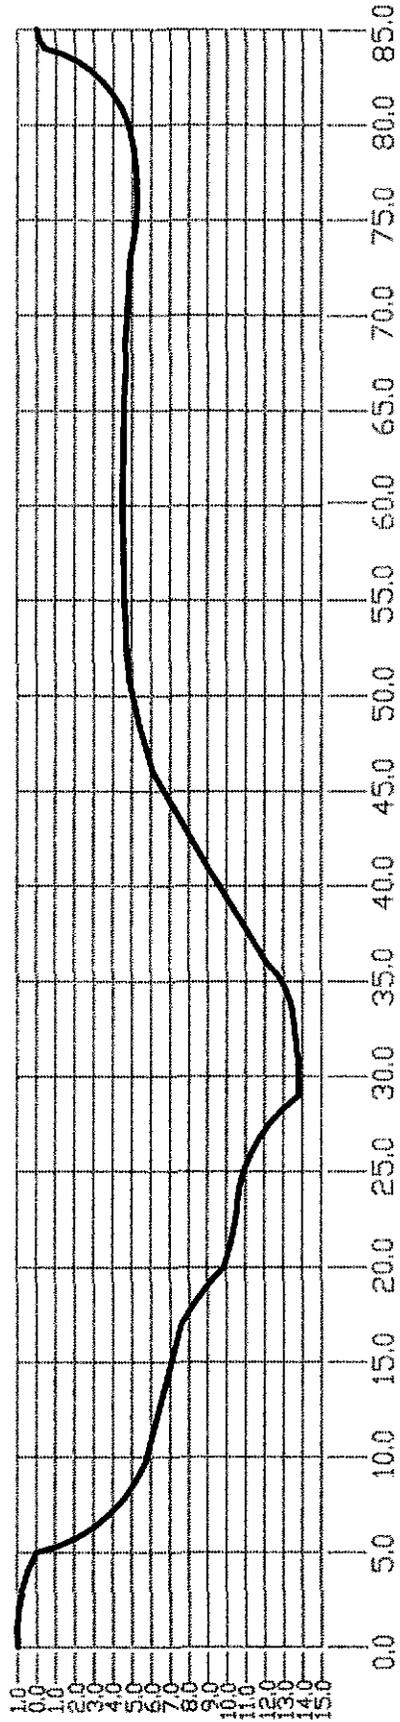
**Figure 5-4**

**Gully Cross Sections  
Karlq Property**

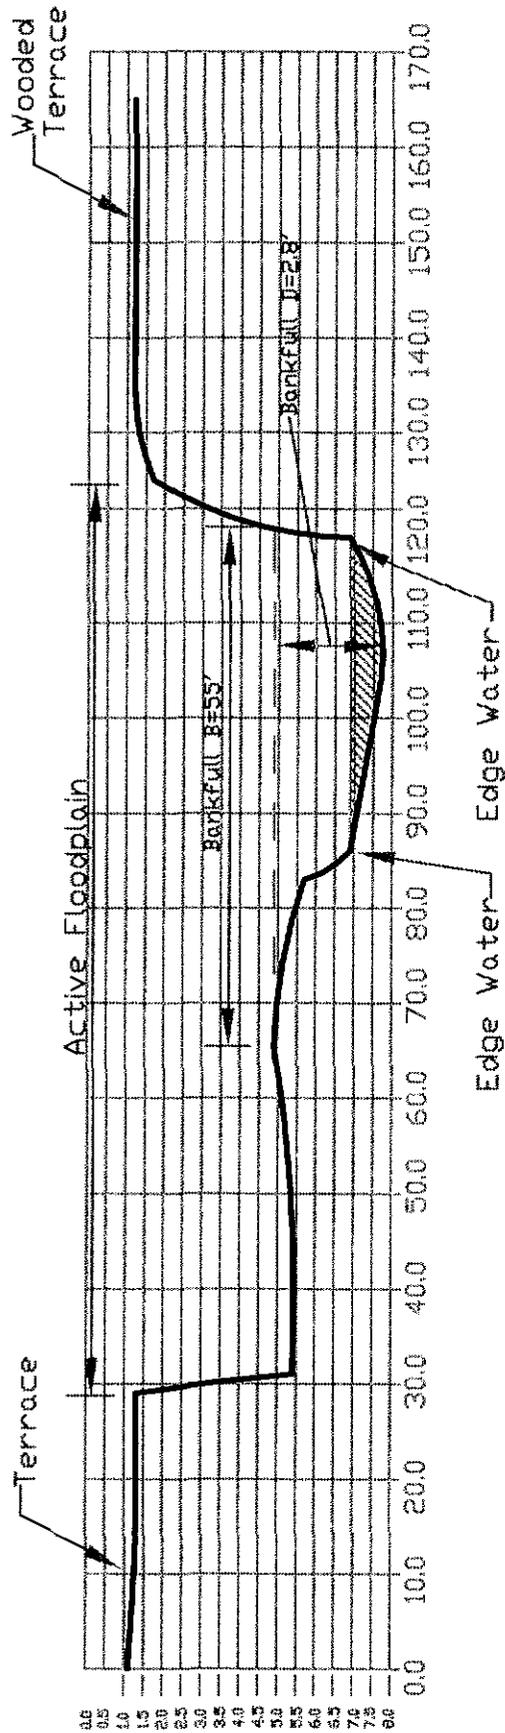
**Figure 5-5**

**River Cross Section  
165 ft D/S Banks Road**
