Southern Cayuga Lake Watershed

South Cayuga Lake Inlet Complex

Dredge Material Analysis

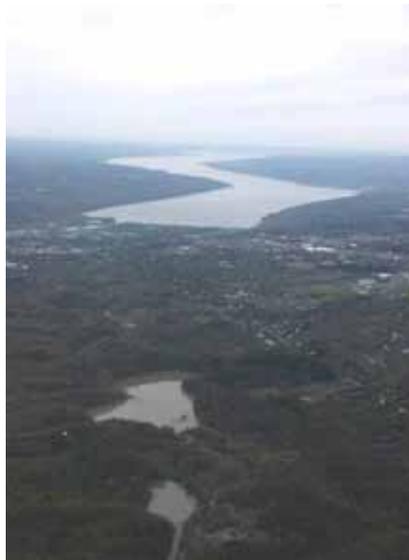
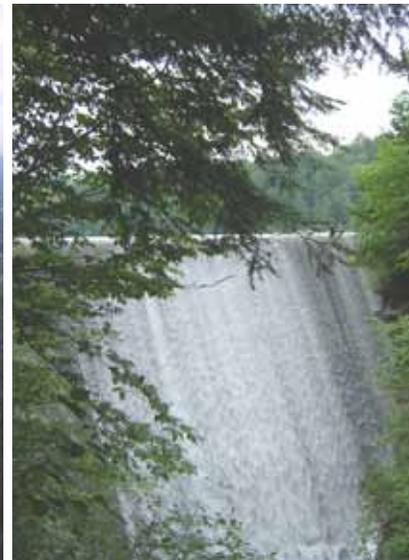
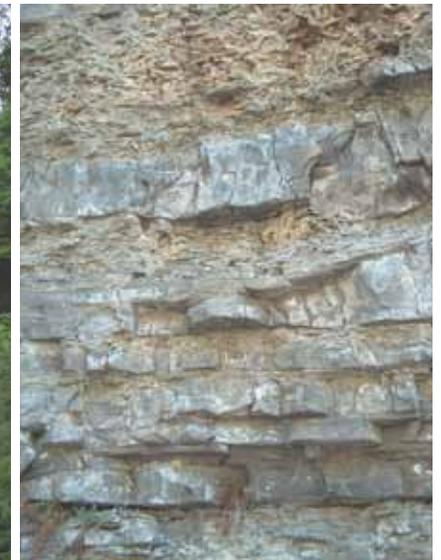
Figure 2.1 a

Watersheds operate at several scales (Figure 2.1.a-c), from large bodies of water and their surrounding environments (1), the waterways that flow through them (2), and the geologic matrix that composes the edges and bottoms of the hydrologic channels (3). A watershed is the upslope area that drains to a specific point, typically the outlet of a stream, river, or lake or the point where a lower order stream meets a higher order stream (Hollingshead, Anderson, and Haith, 2008.). The South Cayuga Lake Inlet Complex is fed by four (4) subwatersheds: Cayuga Inlet, Buttermilk

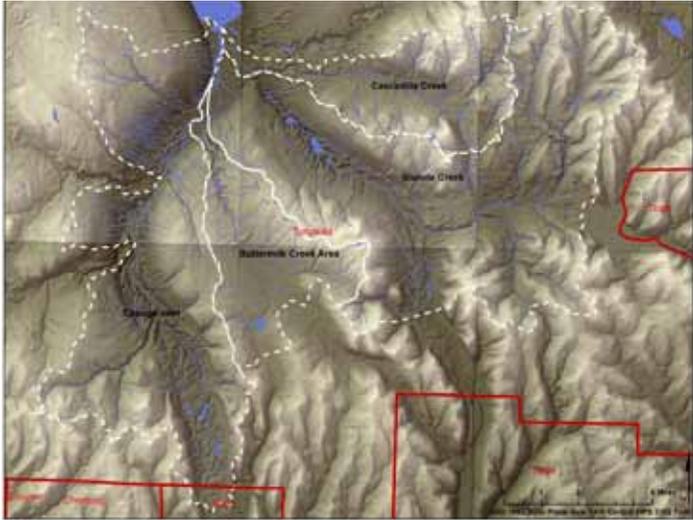
Figure 2.2 - The Four Watersheds that Feed South Cayuga Lake Inlet

Creek, Six Mile Creek, and Cascadilla Creek (Figure 2.2 – The four subwatersheds that feed the South Cayuga Lake Inlet Complex (hillshade vertical exaggeration 5x)). Cayuga Inlet is the second-largest in area, receives flows from Treman State Park and outlets through the Flood Control Channel. Buttermilk Creek is the smallest in area, flows through Buttermilk Falls State Park, and outlets into the Flood Control Channel. Six Mile Creek is the largest in area, provides the city's drinking water supply, and is channelized through its lower reaches through South Ithaca. Cascadilla Creek is the second smallest in area, runs through Collegetown, Downtown, and outlets into the inlet at the Farmers Market.

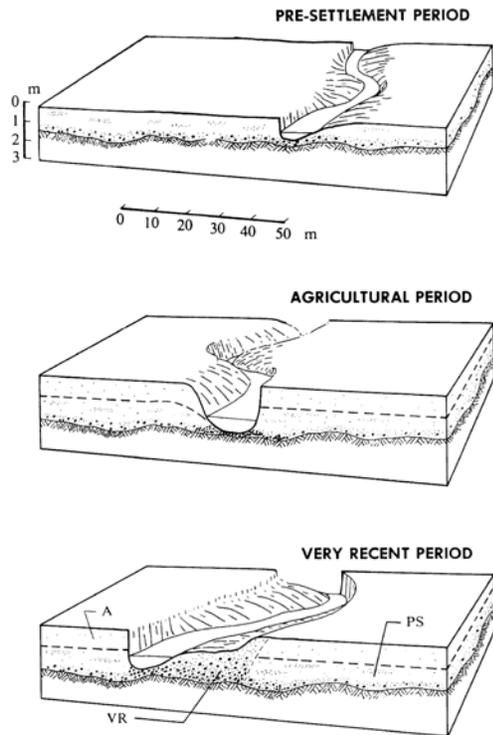
Fig. 7. Flood plain development model. Schematic representation of three-stage development of Maryland Piedmont flood plains. Pre-settlement period (PS): undisturbed stream in natural regime. Agricultural period (A): excessive upland erosion and flood plain sedimentation. Very Recent period (VR): reduced sediment load, reworking of flood plain sediment and redeposition of coarsest sediment as new, lower flood plain level.

Figure 2.3 - Diagram of legacy sediment development

(Figure 2.3 – Diagram of legacy sediment development (Maryland piedmont floodplain development model. Jacobson, B.D. and Coleman, D.R. 1986. Figure 7: 635)). They alter and continue to impair the hydrologic, biologic, aquatic, riparian, and water quality functions of pre-settlement and modern environments (Hartranft, n.d.).

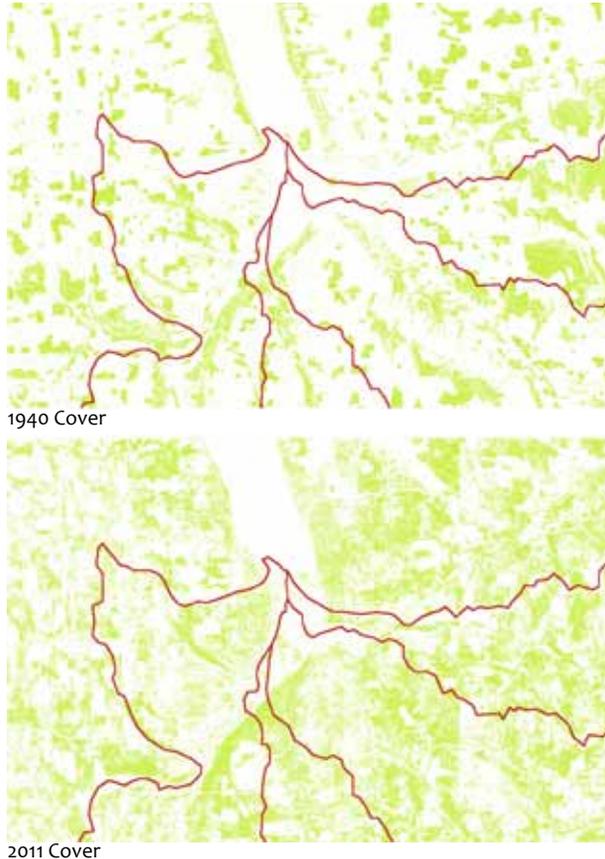
Figure 2.4 - Canopy cover of South Cayuga Lake area

forest cover dropped to 19% by 1900 (Smith, Marks, and Gardescu, 1993). However, this percentage increased to 28% in 1938 and 50% by 1980 (Figure 2.4 – Canopy cover of the South Cayuga Lake area). This fact indicates that the majority of forests in Tompkins County today are post-agricultural, and of these reforested areas

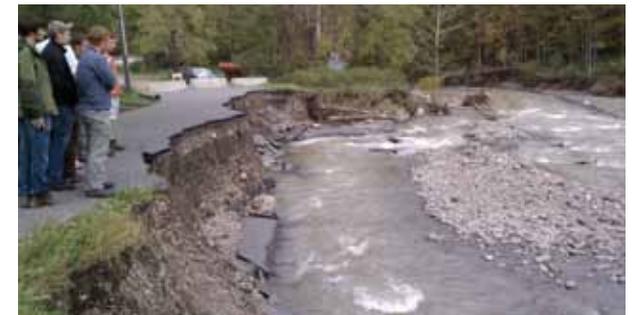
Figure 2.5 a - Roadbank erosion

Two other major contributors are roadbanks and streambanks (Figure 2.5.a-b – Streambank and roadbank erosion following Tropical Storm Lee, Banks Rd., Six Mile Creek, Ithaca NY (30 September 2011 – Photo: M. Gonser)). Roadside ditches are sources of sedimentation and erosion. Generally, the closer they are to the lake the more erosion is occurring mainly due to steep gradients from the upland portions of the watershed down to the lake (G/FLRPC and EcoLogic, 2001a, p.14). With the exception of the Buttermilk and Cascadilla

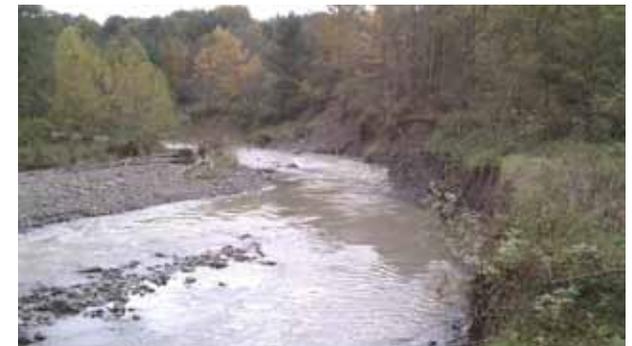
Figure 2.5 b - Streambank erosion

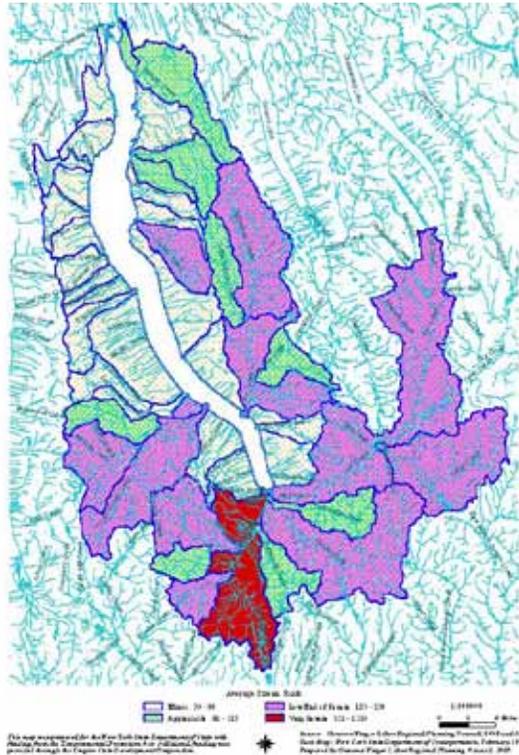
Figure 2.6 - Erosion classification by subwatershed

Creek watersheds, the southern subwatersheds have numerous road ditches classified as “very severe”. Six Mile Creek roadbanks are areas of concern, with numerous sites documented as moderately eroded or severely eroded. Cayuga Inlet appears to have serious roadbank erosion. G/FLRPC and Ecologic (2001a) found a number of road ditches documented as having moderate or severe erosion problems, and a few very severe sites.

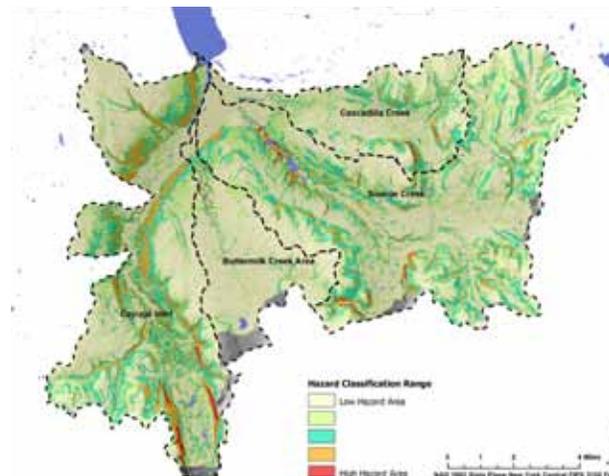
Figure 2.7 - Landslide susceptibility for the four (4) South Cayuga Lake subwatersheds (hillshade exaggeration 5x)

The team conducted a landslide susceptibility analysis adapted from a USGS/ NYSGS preliminary landslide analysis algorithm (NYS Division of Homeland Security and Emergency Services, 2007). The two inputs into the model are slope and soil conditions, from which six (6) weighted factors are derived and used to determine a hazard range. The factors are derived from two (2) data sources: digital elevation models (DEMs) – (1) slope;

USDA SSURGO Digital Soil Survey – (2) American Association of State Highway and Transportation Officials (AASHTO) soil classification, (3) liquid limit, (4) hydrologic group, (5) physical soil properties (as % silt and clay), and (6) hazard of erosion (see Appendix X for an abridged methodology). The resultant output (Figure 2.7 – Landslide susceptibility for the four (4) South Cayuga Lake subwatersheds (hillshade exaggeration 5x)) illustrates that the area's highest hazard zones are along gorge channels and stream banks. As previously noted, these fragile systems undergo a natural erosion process that is unlikely to be influenced through human intervention.

However, this model is merely a depicted of the susceptibility of land to mass wasting and is not a determination of occurrence. Though the landslide susceptibility analysis is useful in identifying areas of concern, field checks are necessary for validation. Current canopy cover (estimated at 55-60%), which suggests slope stability, qualitatively appears to correspond with the areas of higher landslide susceptibility indicating that land cover and use is an important additional factor to consider, and is a condition that is perhaps improving (Figure 2.8 – Current canopy cover within the four (4) South Cayuga Lake subwatersheds with hydrography).

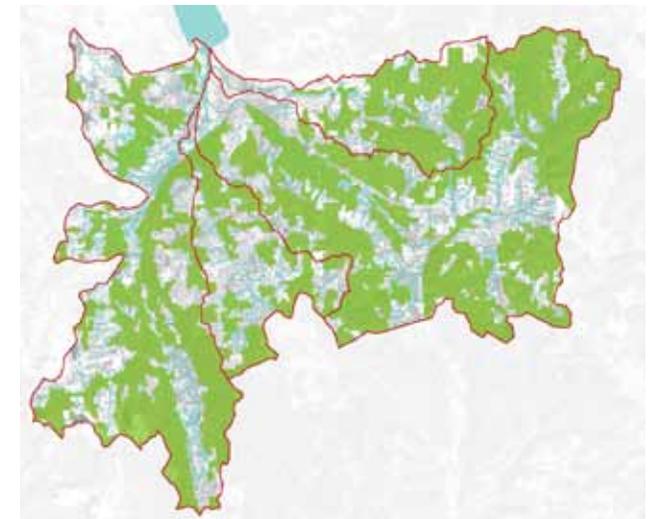
Figure 2.8 - Current canopy cover within the four (4) South Cayuga Lake subwatersheds with hydrography

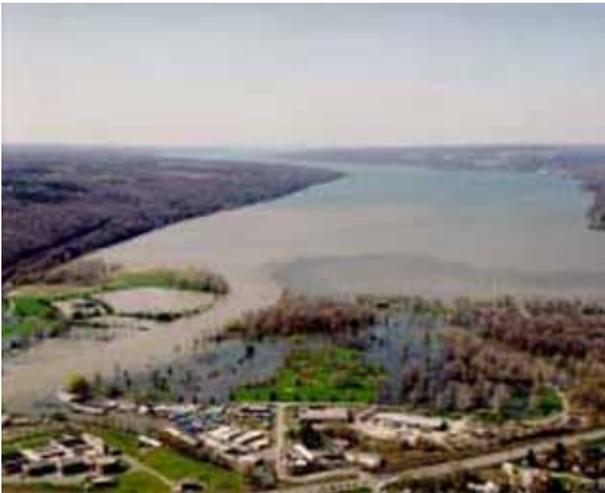
Figure 2.9 - Sediment plume in South Cayuga Lake, 1993 (G/FLRPC and Ecologic, 2001a, Figure 4.2.8)

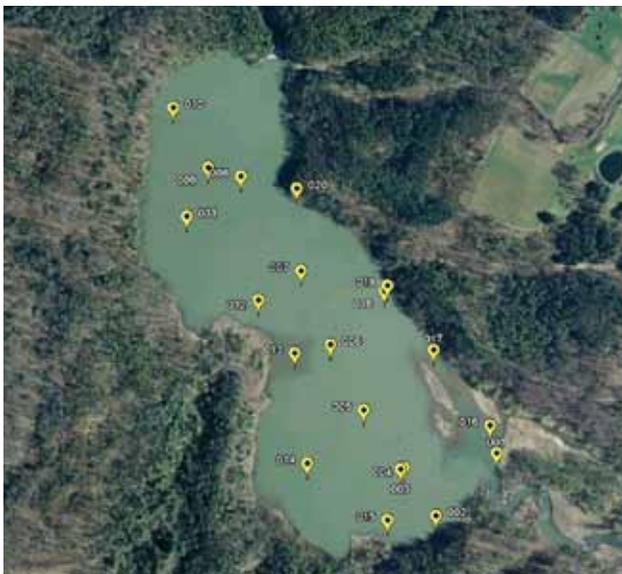
Figure 3.1 - Location of sample sites in Six Mile Creek Reservoir

The original plan was to collect samples from the Cayuga Inlet, but the Inlet was closed once *Hydrilla verticillata* was discovered. We made the decision to use the Six Mile Creek Reservoir as a sample site because dredging is already planned to increase the depth of the reservoir, and it is very similar as it is simply upstream. It is also used by the City of Ithaca as a reservoir for drinking water, so it would provide a useful data set. A total of 16 samples were gathered. 10 samples were tested; 3 from the left transect, 4 from the center, and 3 from the right [Fig 3.1].

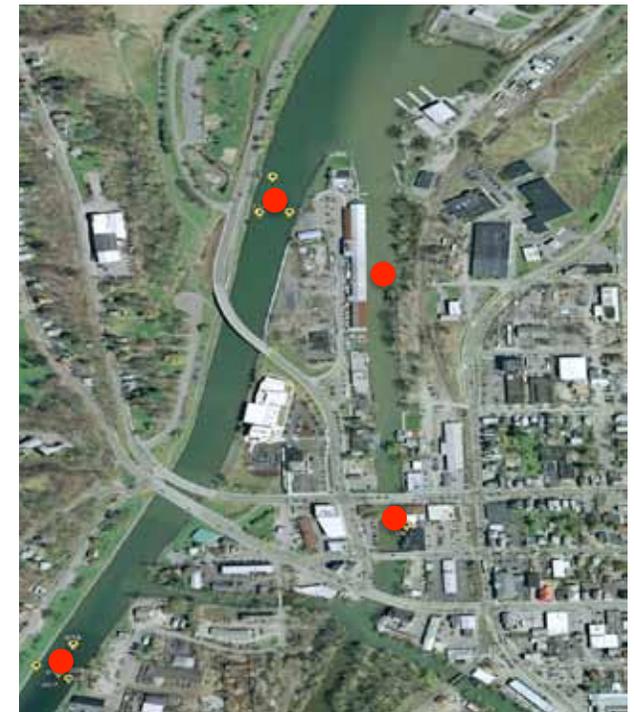
Figure 3.2 - Location of sample sites in Cayuga Inlet

Once the inlet was reopened, this sample site was selected because it is the location of the dredging project. These samples were intended to provide a better understanding of what the dredge material consists of and what it could be used for. Three samples were tested throughout the Inlet and Channel, as denoted by the red tags in the photo below [Fig 3.2].

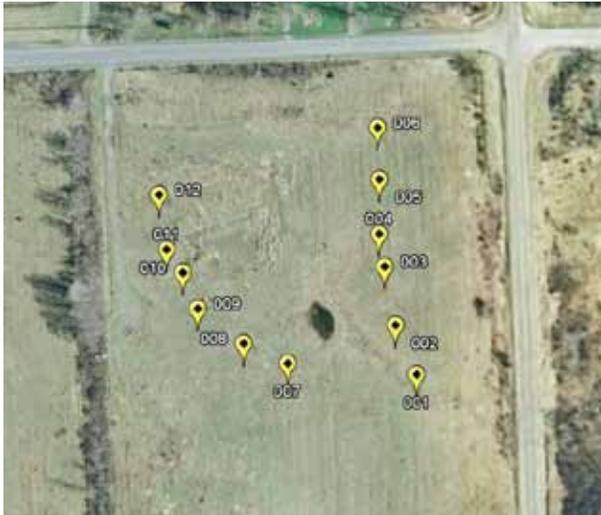
Figure 3.3 - Dredge and Non-dredge sample sites

Six samples were taken from the dredge material and six samples were taken from the field directly adjacent [Fig 3.3].

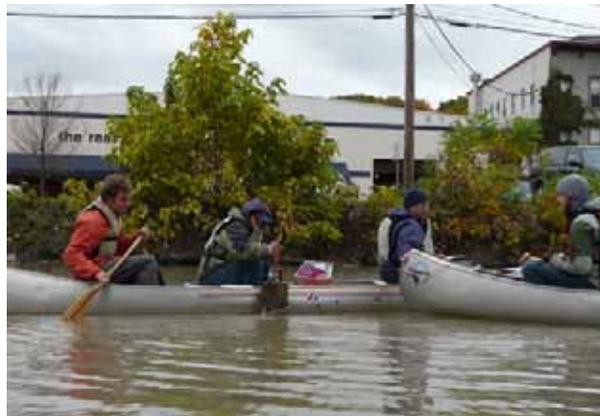
The Materials and Methods section for soil analysis has been adapted from the Cornell Soil Health Assessment Training Manual, since the tests were carried out in the Cornell Soil Health Lab. The samples from the Inlet and the Reservoir were taken using an Eckman dredge dropped from a canoe onto the substrate [Fig 3.4]. The samples at

Figure 3.4 - Students harvesting dredge material from inlet

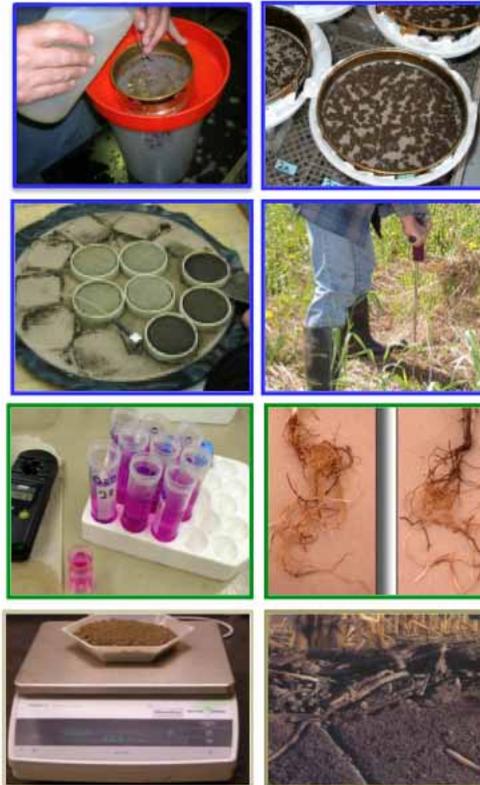
Figure 3.6 - Critical tests performed on the dredge material

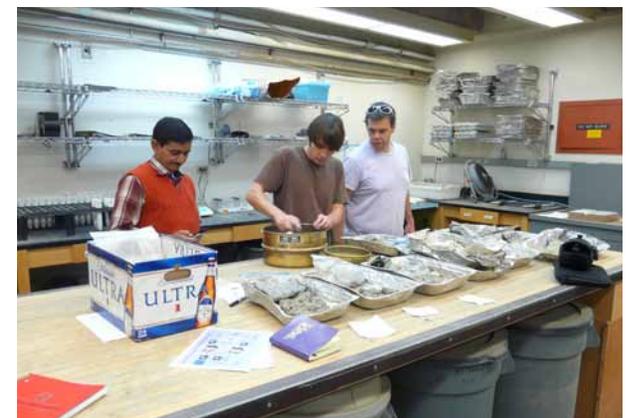
- A portion of the soil sample is oven-dried at 60 C and sieved past 2mm.
- About 14g (+/- 0.1g) of sieved soil is added to a 50ml centrifuge tube containing 42ml of 3% soap (sodium hexametaphosphate) solution.
- Shake vigorously on reciprocating shaker for 2 hours to fully disperse soil into suspension.
- Entire contents of centrifuge tube are washed onto a 0.053mm soil sieve assembly. Sieve assembly consists of 0.053mm sieve on top of a plastic funnel above a 600ml beaker.

Figure 3.7 - Students performing Soil Texture test

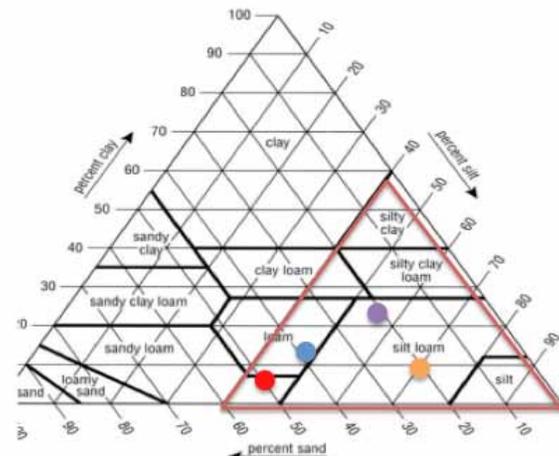
Table 3.1 - Soil Texture Triangle with Inlet, Dryden, and Reservoir soil range in red.

Another preconceived notion about the dredge material was that it would be predominantly clay and fine particle material. However, our testing found that the Cayuga Inlet is a sandy loam, which contains very little clay (only 6.82%) [Table 3.1].

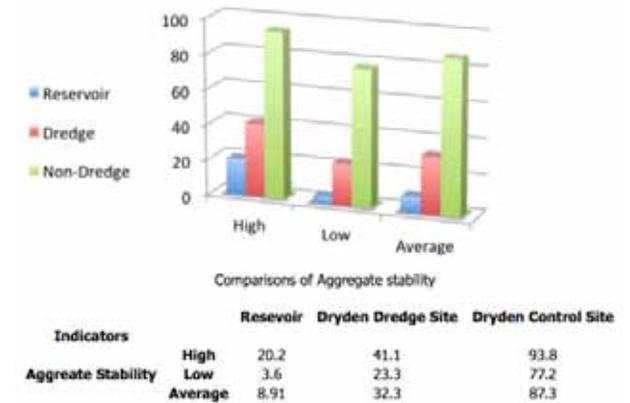
Table 3.2 - Graph of Aggregate Stability results between the reservoir and Dryden samples.

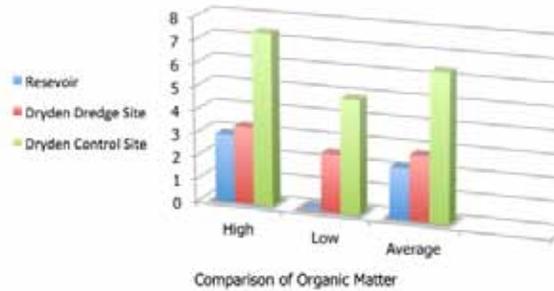
Indicators		Reservoir	Dryden Dredge Site	Dryden Control Site
Organic Matter	High	2.9	3.3	7.4
	Low	0.07	2.5	4.9
	Average	2.2	2.8	6.4

Table 3.3 - Graph of Organic Matter results between the reservoir and Dryden samples.

Originally, it was thought that there would be no organic matter in the dredge material, however we found that there was 2.2% organic matter in the Reservoir site samples. This is not a very high amount, but around a 5% OM content is recommended for agricultural uses, and it is much higher than the expected content of 0%. [Table 3.3] (Refer to appendix B for charted results)

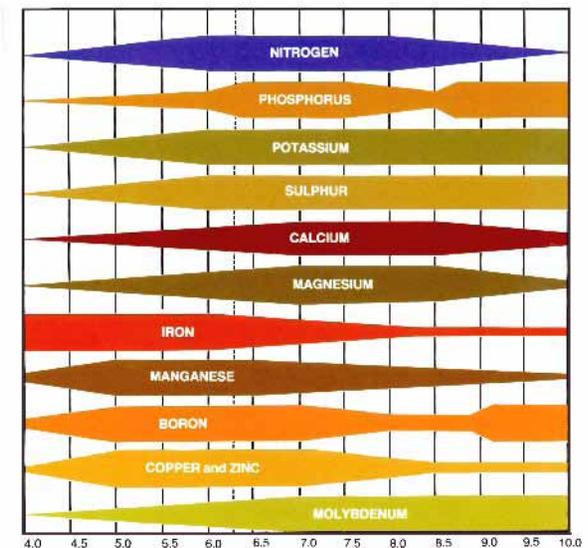
Figure 3.8 - pH Nutrient Chart

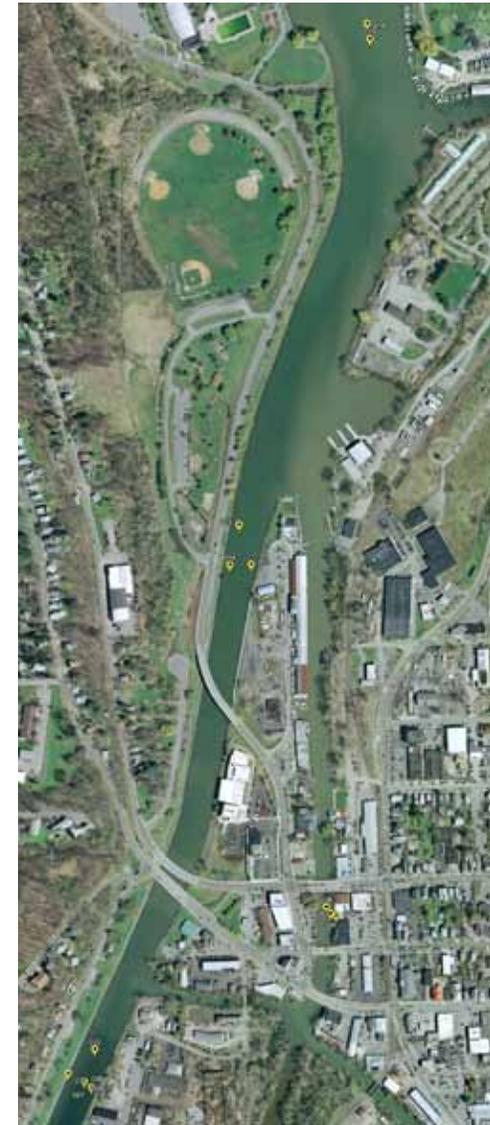
Figure 3.10 - Location of samples on Cayuga Inlet by ECOLOGIC for metals testing

According to the Ecologic LLC report, several hotspots were found for Lead, Copper, PAHs, and PCBs, qualifying the dredge material from Cayuga Inlet as Class B [Fig 3.9/3.10]. However, the majority of the samples tested at Class A levels, and when

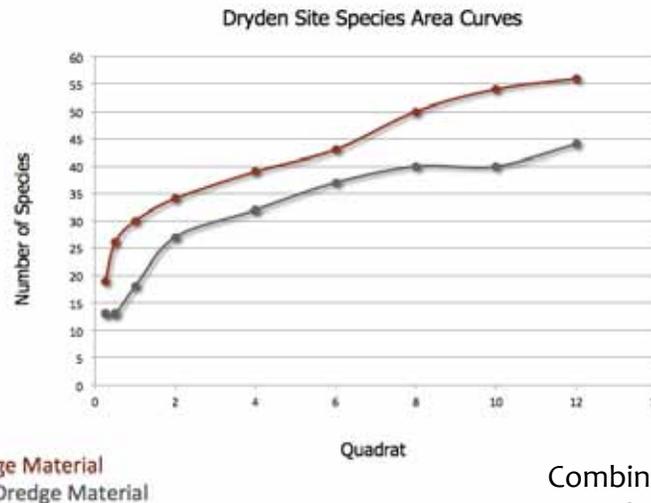
Figure 4.1 - Dryden Site Species Area Curve

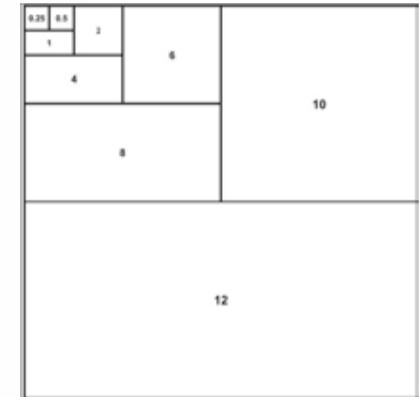
Figure 4.2 - Nested Quadrat

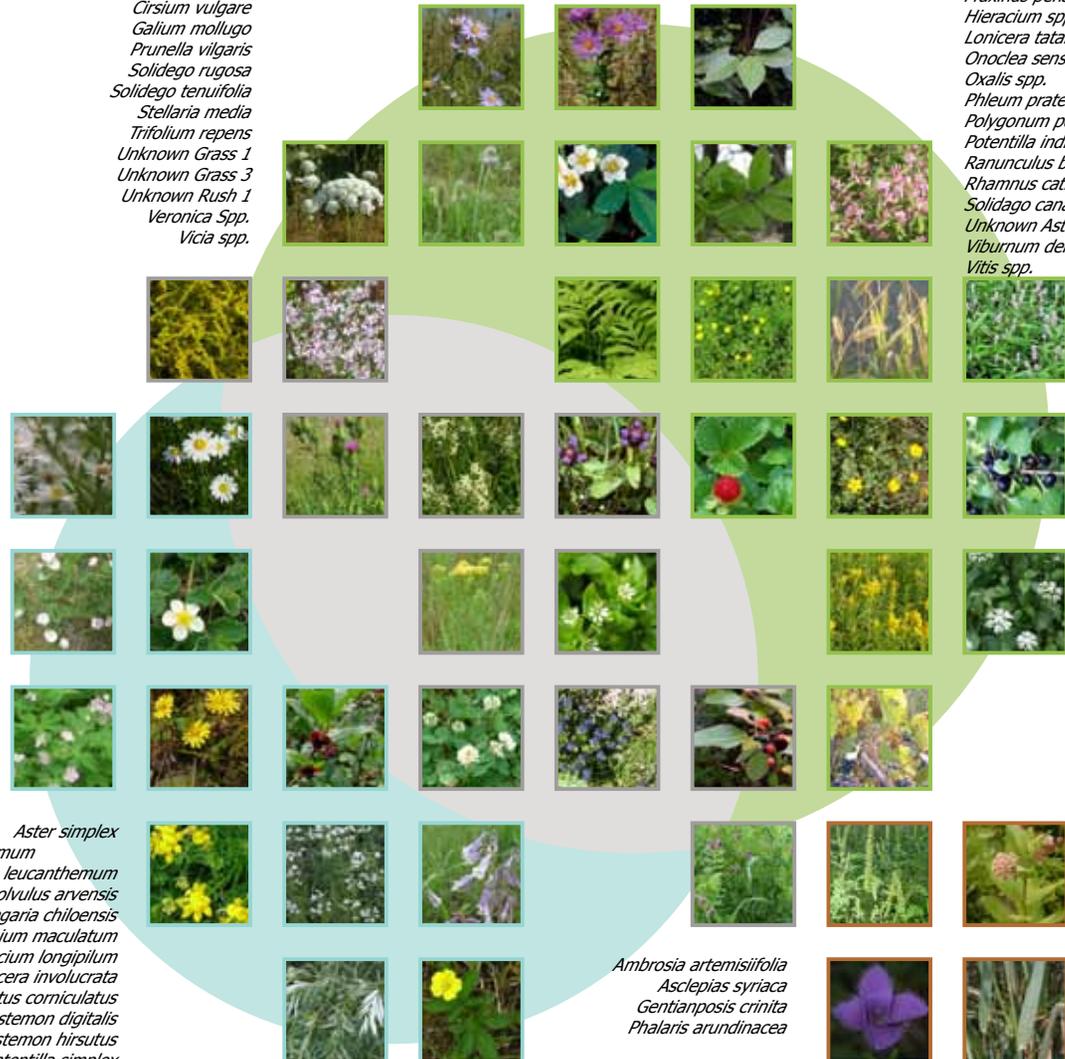
Figure 4.3 - Dryden Plant Communities

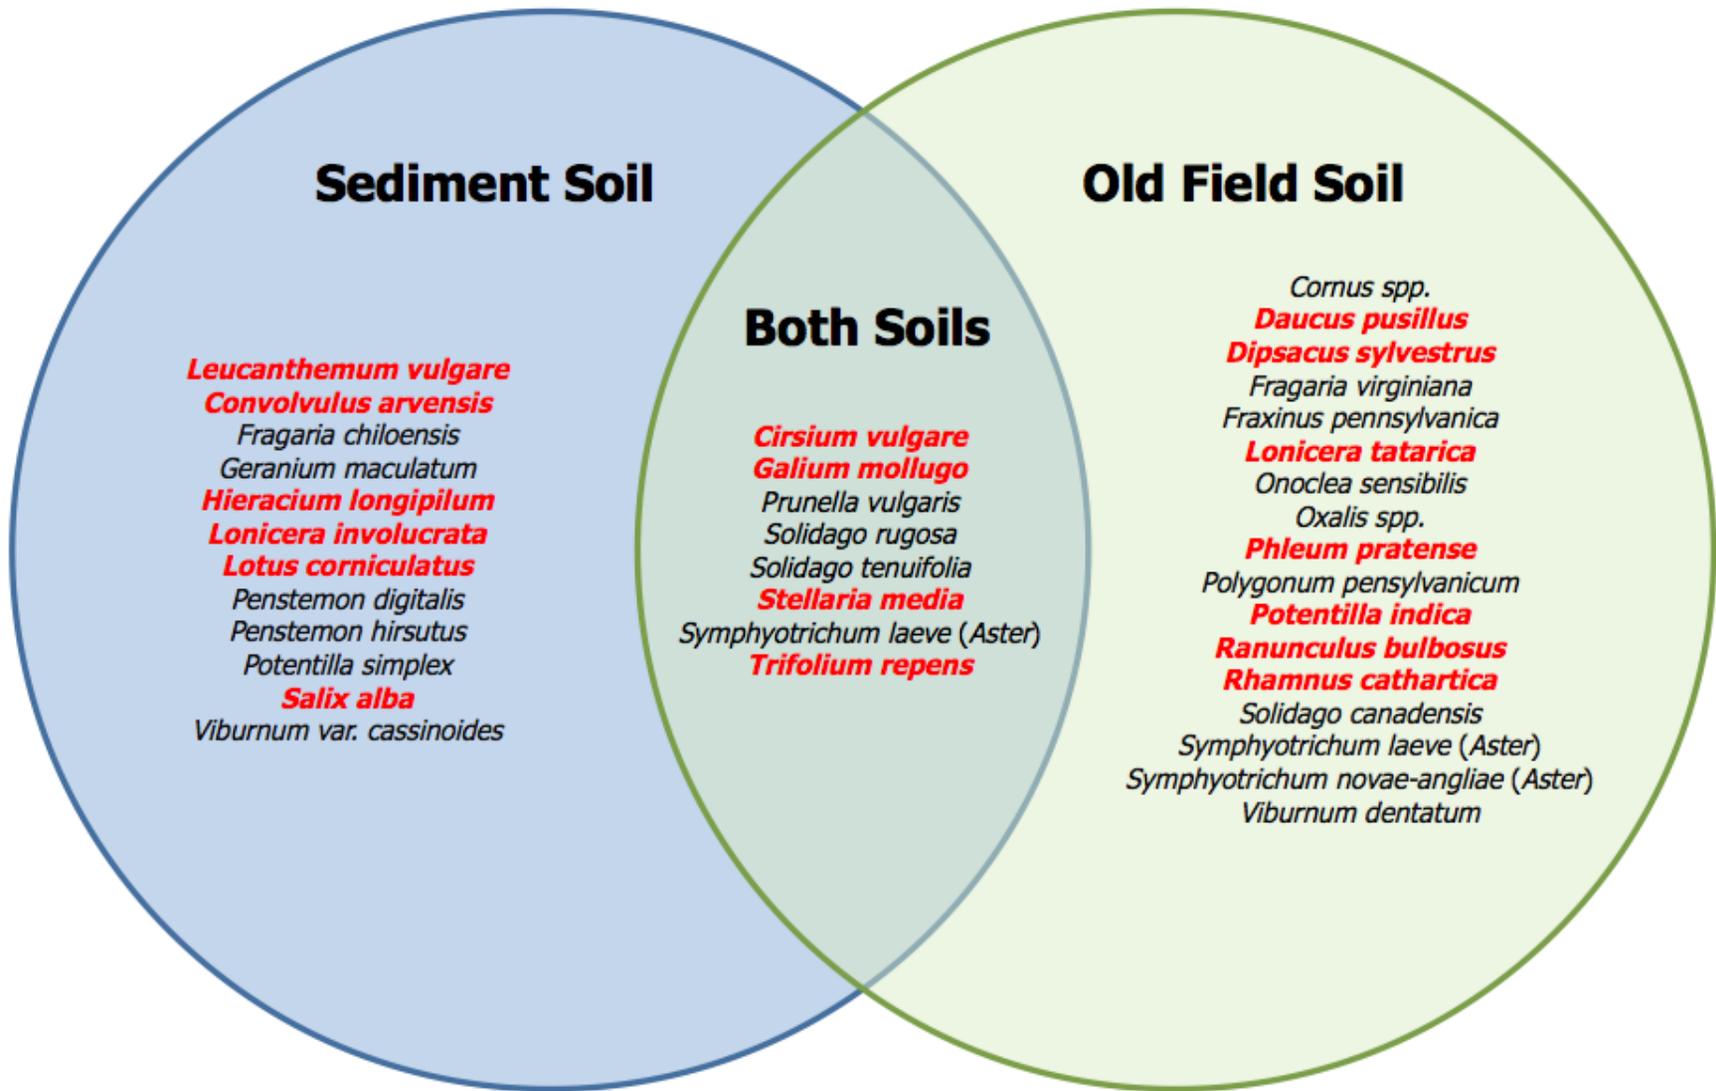
Figure 4.4 - Dryden Plant Communities
