Septic System Replacement Grants

Douglas Barnes
Tompkins County Whole Health

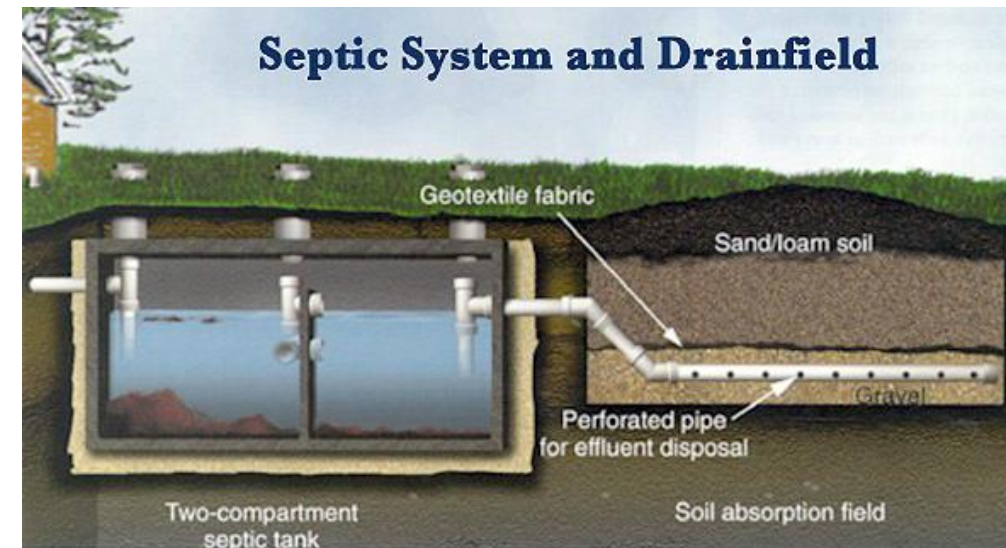
Image Source: Produced by Agricultural Communications, The Texas A&M University System, EPA

- Approximately 25% of the homes in America use an OWTS system to process gray and black water produced in the home.
- Typical layout of an OWTS
- Septic tank
 - solids settle to the bottom
 - Oils and greases float to the top
 - Bacteria can start the breakdown of some of the organic material
 - Water and dissolved materials, now called effluent, leave the tank
- The effluent then goes to a distribution box and is separated into several lateral pipes that lead to an absorption bed (commonly called a leach field)
 - From there the effluent percolates through the soil for further treatment

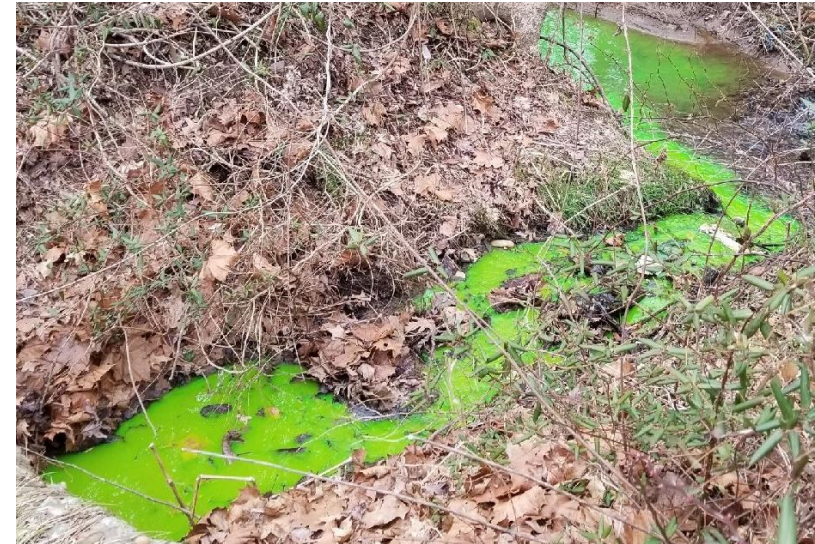
Dye from a dye test surfacing in a ditch

- Homeowners are encouraged to properly use and care for their septic systems to prolong life expectancy, but failures are bound to occur at some point either through misuse or age
- The EPA estimates over 50% of systems are 30 years old or older and that 10-20% of systems are in “failure”, which can range from leaky septic tanks, broken distribution boxes, plugged absorption field pipes, or overloaded soils.
- These failures can allow effluent to leach into the soil and reach groundwater sources, or even reach the surface and run into surface waters directly before it has time to be processed.
