Dry Sites: An Introduction

Appendix A - Landslide Susceptibility Analysis Methods

Fall 2011 Restoration Ecology Class: Hort 440

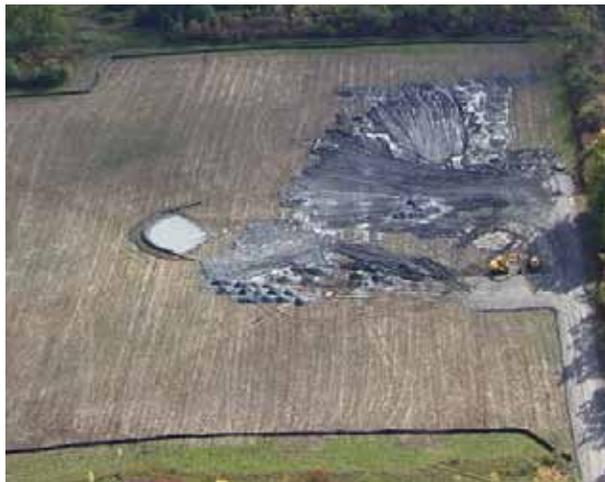
Figure 6.5 a - Sediment spread across field. 10 1999. Courtesy of Patrick McNally, Associate Director - EHS Compliance.

As has been discussed earlier in this report (in the Dredge Material tests), after the installation of Cornell's Lake Source Cooling project in Cayuga Lake 12 years ago, approximately 3,000 cubic yards of subaqueous soil slurry was spread over the western half of the old agricultural field in nearby Dryden, NY. After the site was left to a

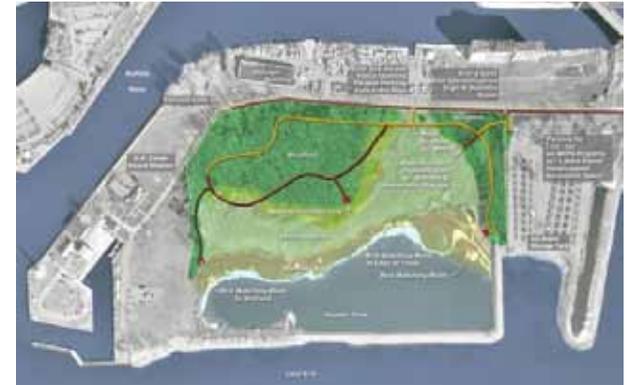
Figure 6.6a - Times Beach Nature Preserve plan

Despite the area being concentrated with many contaminated soils, since 1976 nature has reclaimed Times Beach. Presently, four distinct habitat zones have been identified within the site: a silt flat, marshland, woodland, and upland. The Niagara River and Buffalo shoreline area are part of a flyway for migratory birds and the established zones have become a haven for more than 240 species of birds such as great blue heron, great egret, wild turkey, common goldeneye, lesser yellowlegs, downy woodpecker, Carolina wren, belted kingfisher, and red-tail hawk. Due to the vast array of species, three bird-watching locations have been constructed on-site.

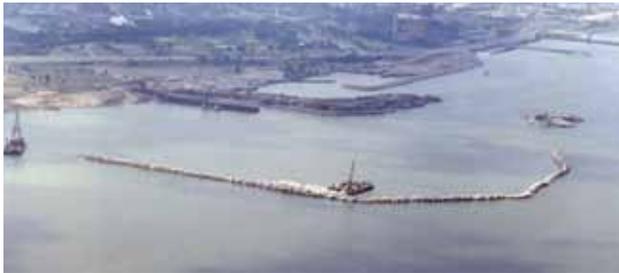
Figure 6.8 b - Dike 14 perimeter construction (1975)

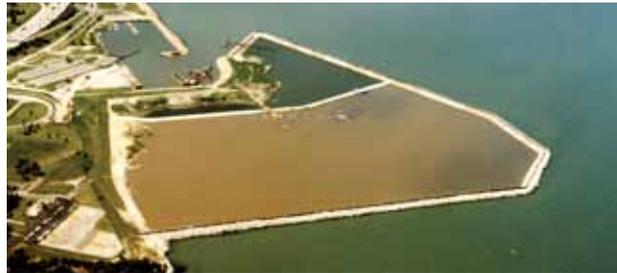
Figure 6.8 d - Dike 14 with mud flats (1984)

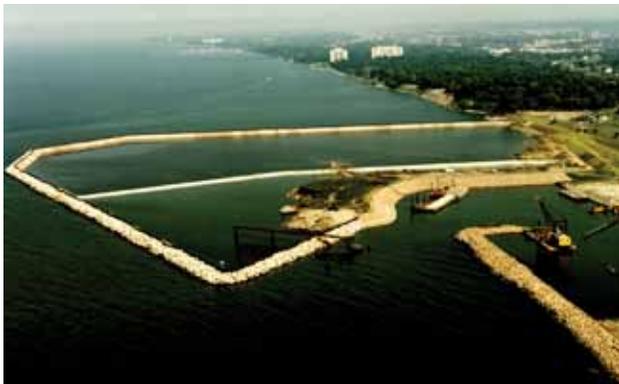
Figure 6.8 c - Dike 14 perimeter completed (1983)

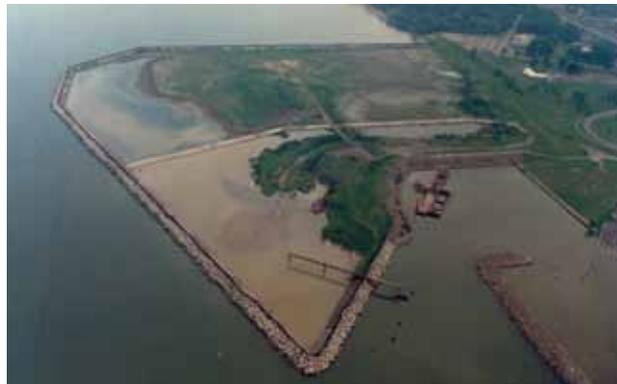
Figure 6.8 e - Dike 14 vegetation growth (1986)

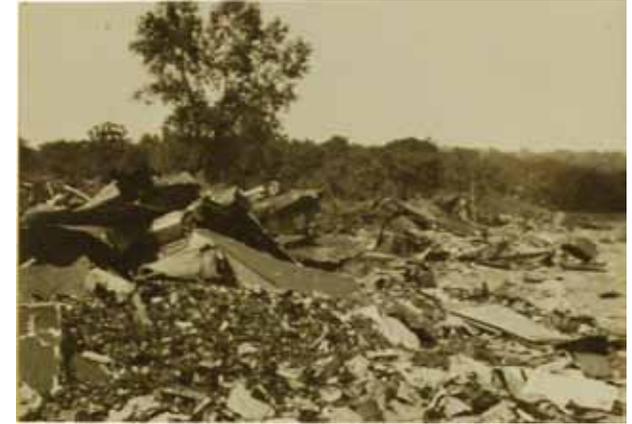
Figure 6.8 b Dump site in Stewart Park, 1921.
Photo: William Wiedorn

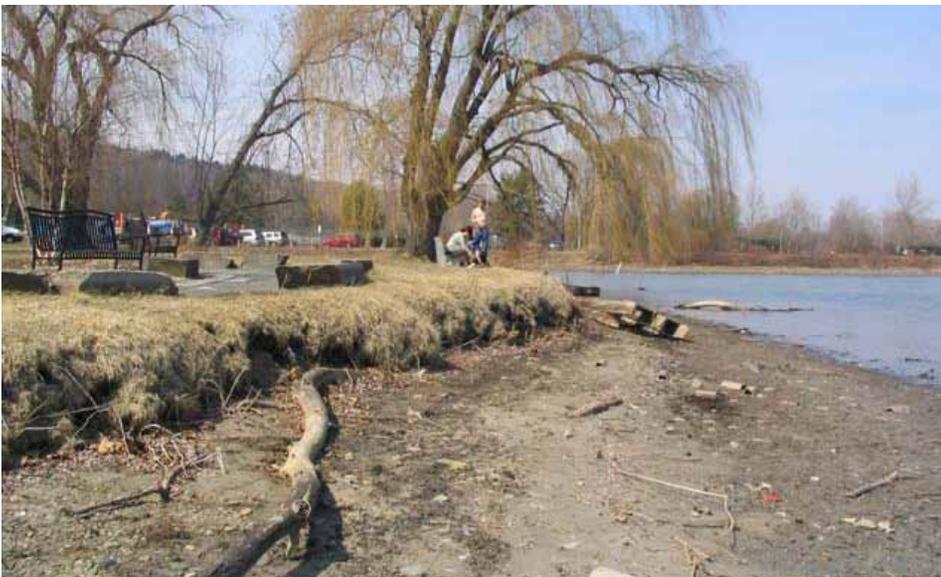
Figure 6.10 a - Cass Park: bank loss and erosion. Courtesy of the City of Ithaca.

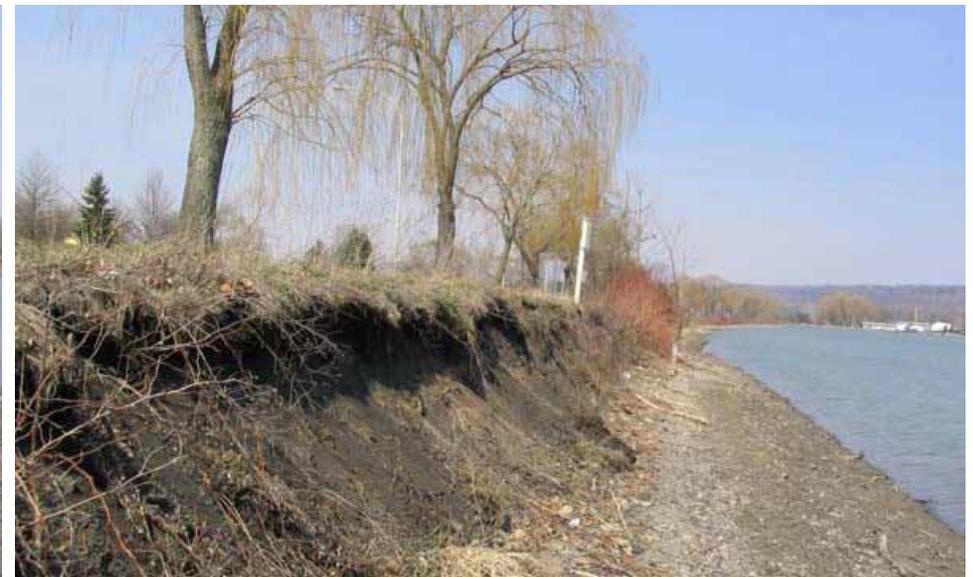
Figure 6.10 b - Cass Park: bank loss and erosion. Courtesy of the City of Ithaca.

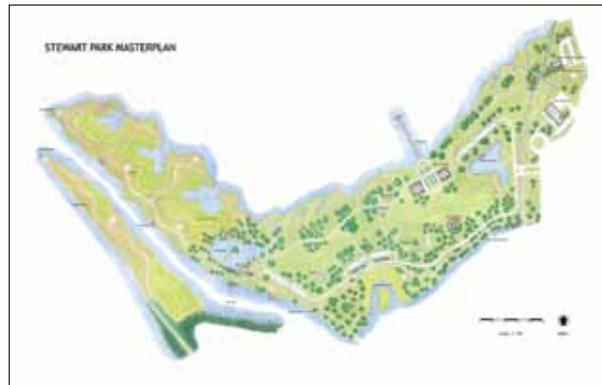
Figure 6.10 d - Stewart Park Conceptual Plan. Designed by Fred Cowett.

watching, and fish access. Sediment from Six-mile Creek, Cascadilla Creek and Fall Creek would be pushed further to the north in Lake Cayuga, away from the Stewart Park shoreline, which could allow for safer swimming conditions. However, it is perceived by NYDEC that this would negatively impact fish habitat. Recreating wetlands reintroduces ecosystem function that has been lost with the draining of wetlands and creates new ecosystem services and potentially contains dredge material that contains Hydrilla to one location, with the use of a in water silt curtain.

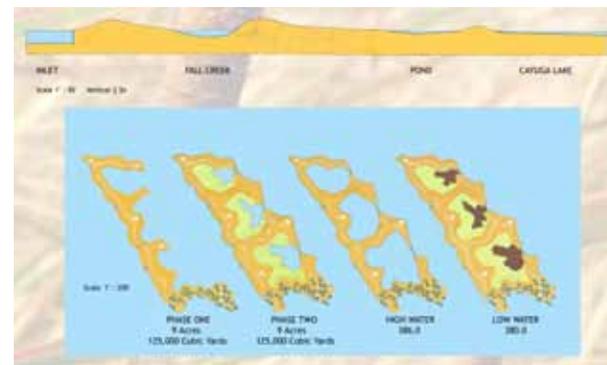
Figure 6.10 e - Stewart Park Wetland Phasing. Drawn by Fred Cowett.

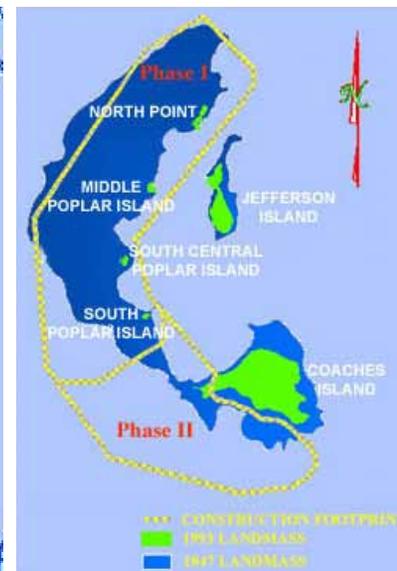
Figure 6.11 b - Phasing.

The island borders were first reconstructed with armored rock edges and then filled with slurry of dredge material. From there, the island was divided into cells, based on what could be a workable dredge load over a manageable period of time. The first deposited substrate consisted of sand, and is now filled with material from the dredge

approach channels leading to the Baltimore Harbor. Dredge material is not used from the Harbor in order to minimize heavy metals or toxic conditions. The material arrives at Poplar Island from November to March and it pumped through 24” pipes at a concentration of 10% sediment to 90% water to its destined cell. Once there, the water is left to drain and dry out. Oxygen, pH, salinity, and turbidity are monitored every hour to ensure proper functioning of the constructed environment. Once the desired conditions are reached, planting occurs. At the end of the construction all cells will be connected.

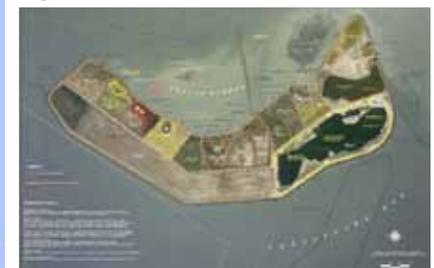
Figure 6.11 d - 2009 Master Plan. (all images from USACE)

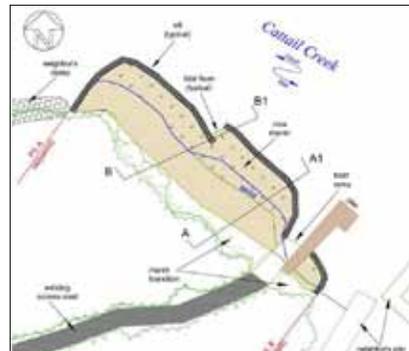
Figure 7.12 a - Typical plan.

algae blooms, eutrophication, and dissolved oxygen levels. Prior to construction, the site is first analyzed and state and local permits are obtained. Next the sill is constructed by placing filter cloth and stone at the desired location. The existing bank is then graded and sand is placed as a growing medium. Typically, marsh grasses are installed; *Spartina alterniflora* below the Mean High Water Table and *Spartina patens* above the Mean High Water Table. Exclusion fences are then installed to protect the new plants from geese.

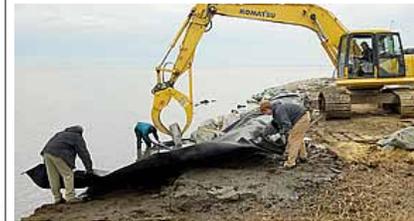
Figure 7.12 c - Sill construction.

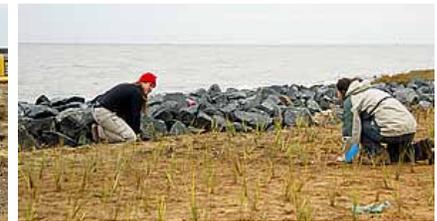
Figure 7.12 e - Marsh grasses installed.

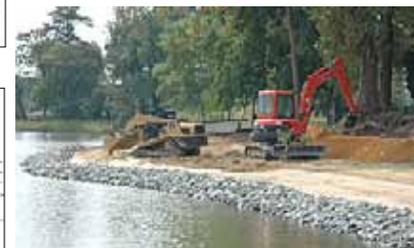
Figure 7.12 d - Existing bank is graded and sand is placed.

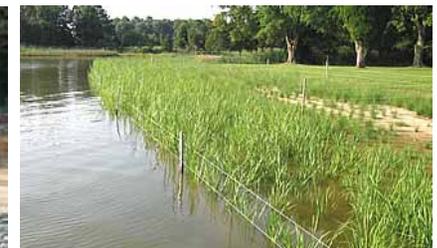
Figure 7.12 f - Exclusion fences installed to protect the new plants from geese.

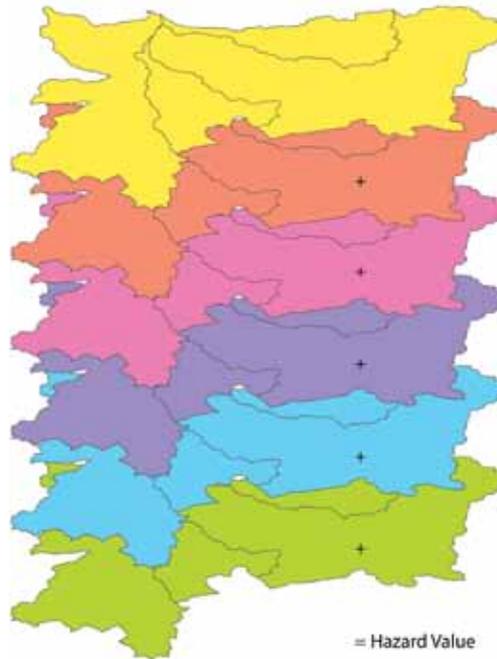
LANDSLIDE HAZARD ANALYSIS MATRIX						
Factor	Soil Classification (AASHTO)	Slope	Liquid Limit	Hydrologic Group	Physical Soil Properties	Hazards of Erosion
Rating	1 - 16	10 - 50	2 - 8	1 - 4	1 - 4	1 - 12
Factor rating or range and numerical rating in parenthesis	1 (2) 2 (4) 3 (6) 4 (8) 5 (10) 6 (12) 7 (14) 8 (16)	% slope 0-2 (10) 3-7 (20) 8-15 (30) 16-25 (40) >25 (50)	0-65 as: 00-15 (2) 16-30 (4) 31-45 (6) 46+ (8)	A through D A, sand and gravel (1) B, sandy-coarse (2) C, mod.f.texture (3) D, clay/silt texture (4)	% silt and clay as: 0-25 (1) 26-50 (2) 51-75 (3) 76-100 (4)	Word/# modifier: slight, 0.0 (1) moderate, 0.33 (4) severe, 0.65 (8) very severe > 0.65 (12)

Figure A.1 - Abridged methodology of landslide susceptibility analysis (adapted from a USGS/NYSGS preliminary landslide analysis algorithm (NYS Division of Homeland Security and Emergency Services, 2007)).

6 Weighted Factors

- 2) American Association of State Highway and Transportation Officials (AASHTO) Soil Classification
- 3) Liquid Limit
- 4) Hydrologic Group
- 5) Physical Soil Properties (as % silt + clay)
- 6) Hazard of Erosion
