Tompkins County Walkability Assessment Methodology and Case Studies

September 24, 2007

Case Study Areas:

- Northeast Ithaca
- The Village of Trumansburg

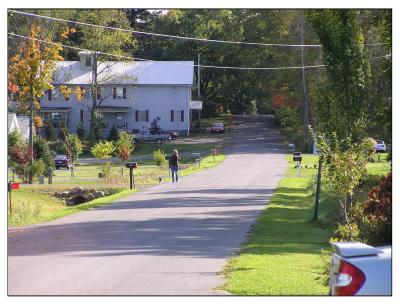
Residential Street in the Village of Trumansburg, Without Sidewalks or Shoulder

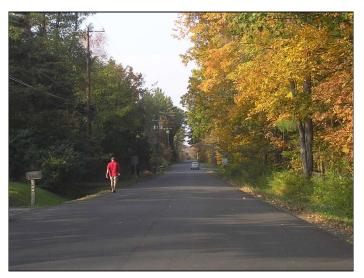
Deep Swales Along Residential Street

narrow, semi-rural roads. These roads typically have roadside ditches or swales and no curbs and gutters.

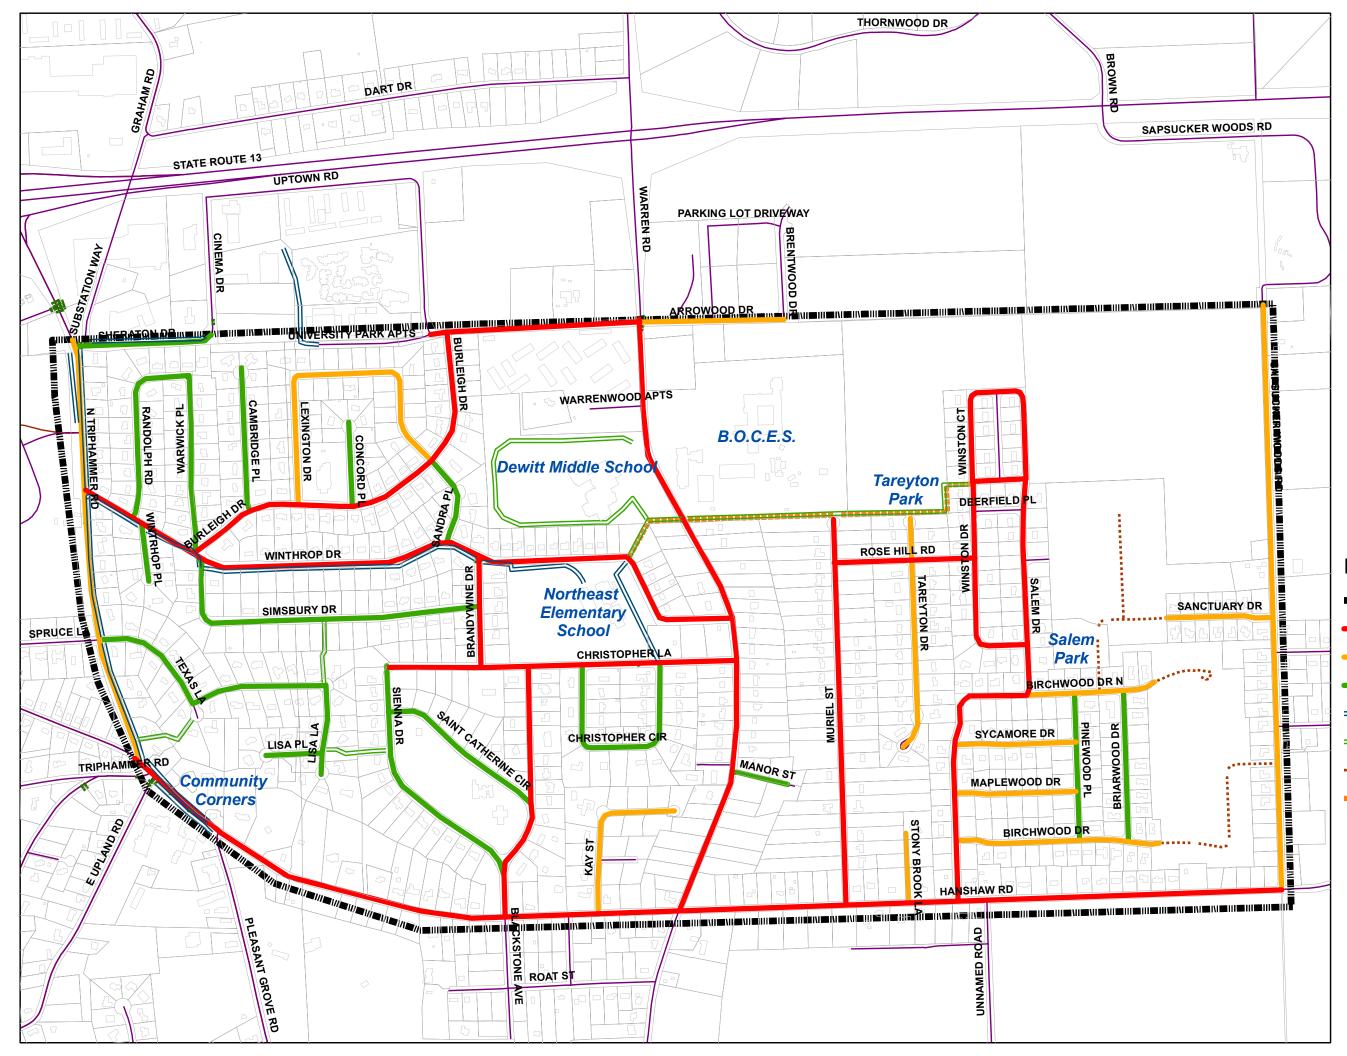
NE Ithaca Priority Ranking of Walkway Improvements

Maps, titled "Priority Ranking of Walkway Improvements," which display the results of the "Revised Survey Results Ranking Matrix," may be found at the end of each case study in Section 3.0. The walkways in need of improvement are classified using a numerical rating, with 0-49 being classified as low, 50-69 being classified as medium, and 70+ being classified as high priority. Future walkability studies that use the revised survey tool will more easily be able to incorporate survey results into a database fully populated from the field survey data sheets.

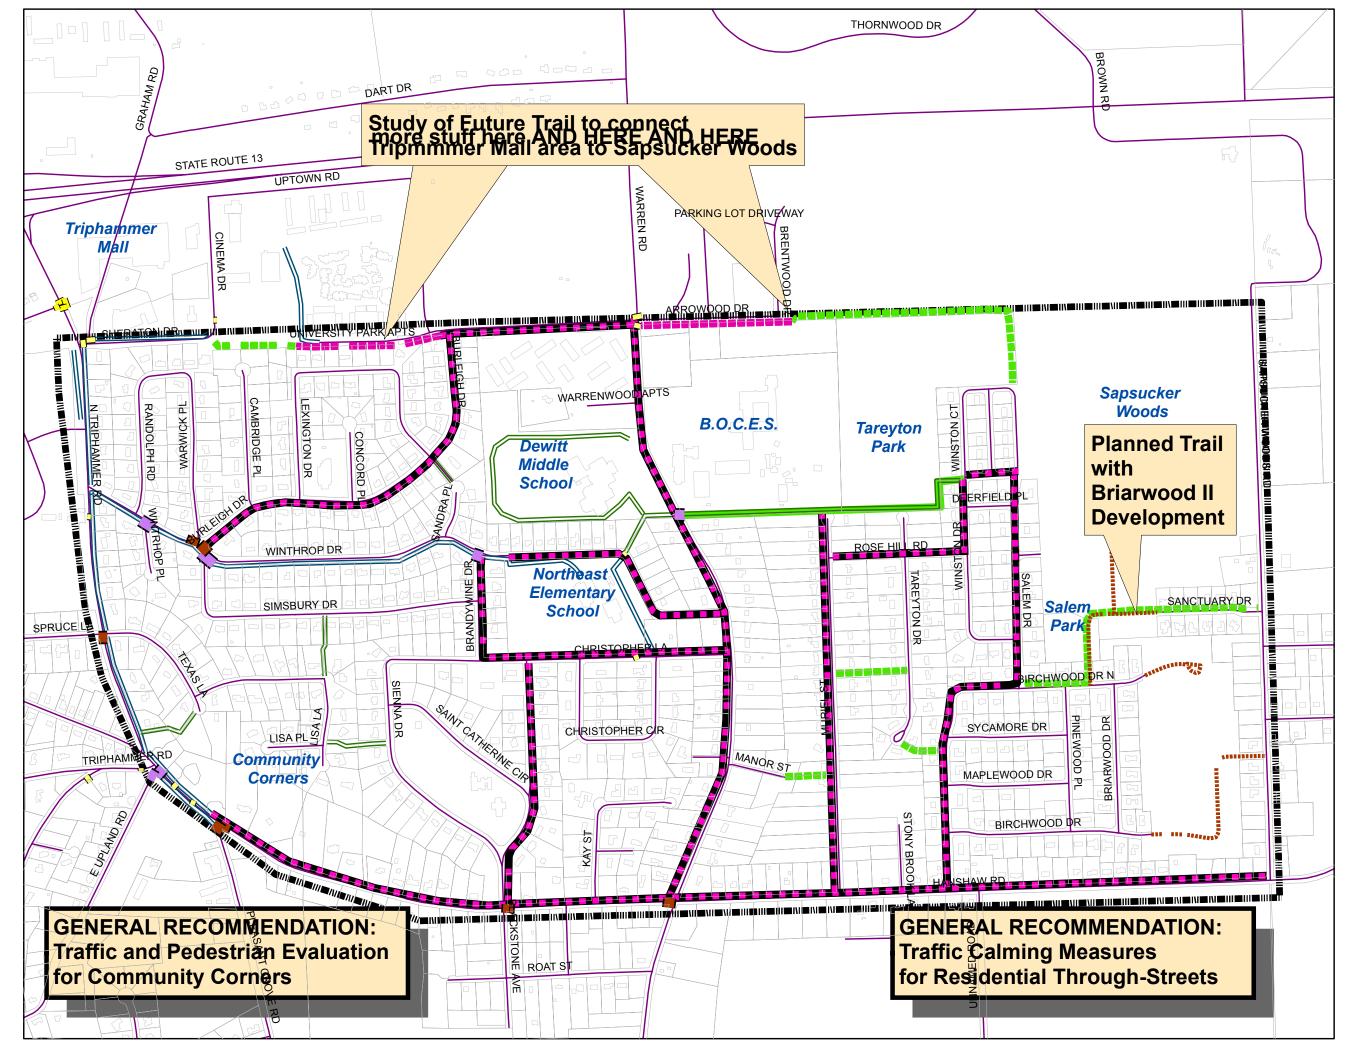
Northeast Ithaca Walkability -Recommended Projects

conducting the studies, to develop the "Walkability – Recommended Projects" maps, which may also be found at the end of each case study in Section 3.0.

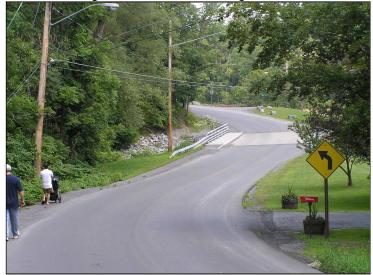
Members of the steering committee and the project team also spent one afternoon walking many of the streets and slate sidewalks to observe the field conditions of the neighborhoods within the study area. This provided additional insight to the concerns information and discussed in the first meeting.

Walking Along King Street

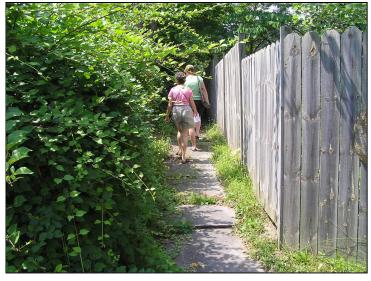
Brush Overgrowth between Street and Sidewalk

hedges at their property lines, breaking the continuity completely. While some residents are comfortable walking on the smooth road pavement, many would prefer not having to walk on Village streets with children in strollers or on scooters.

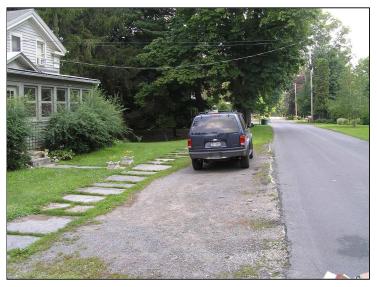
Non-Standard Parking Arrangement

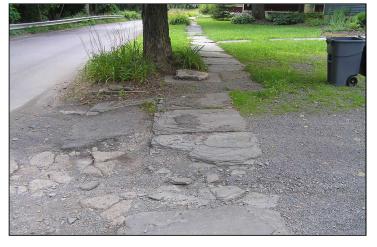
Example of Sidewalk in Deteriorated Condition

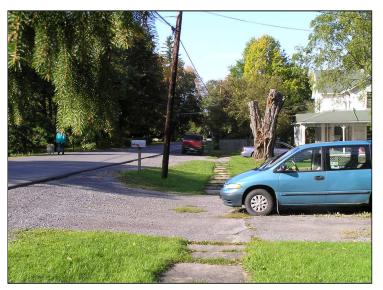
Tree lawns with street trees enhance the visual quality of these historic streets, while serving many functions, including separating the sidewalks from vehicles, providing shade, and

Tree Lawn Area that Needs Improvement

supplying street trees with pervious and uncompacted soil in which to grow and thrive.

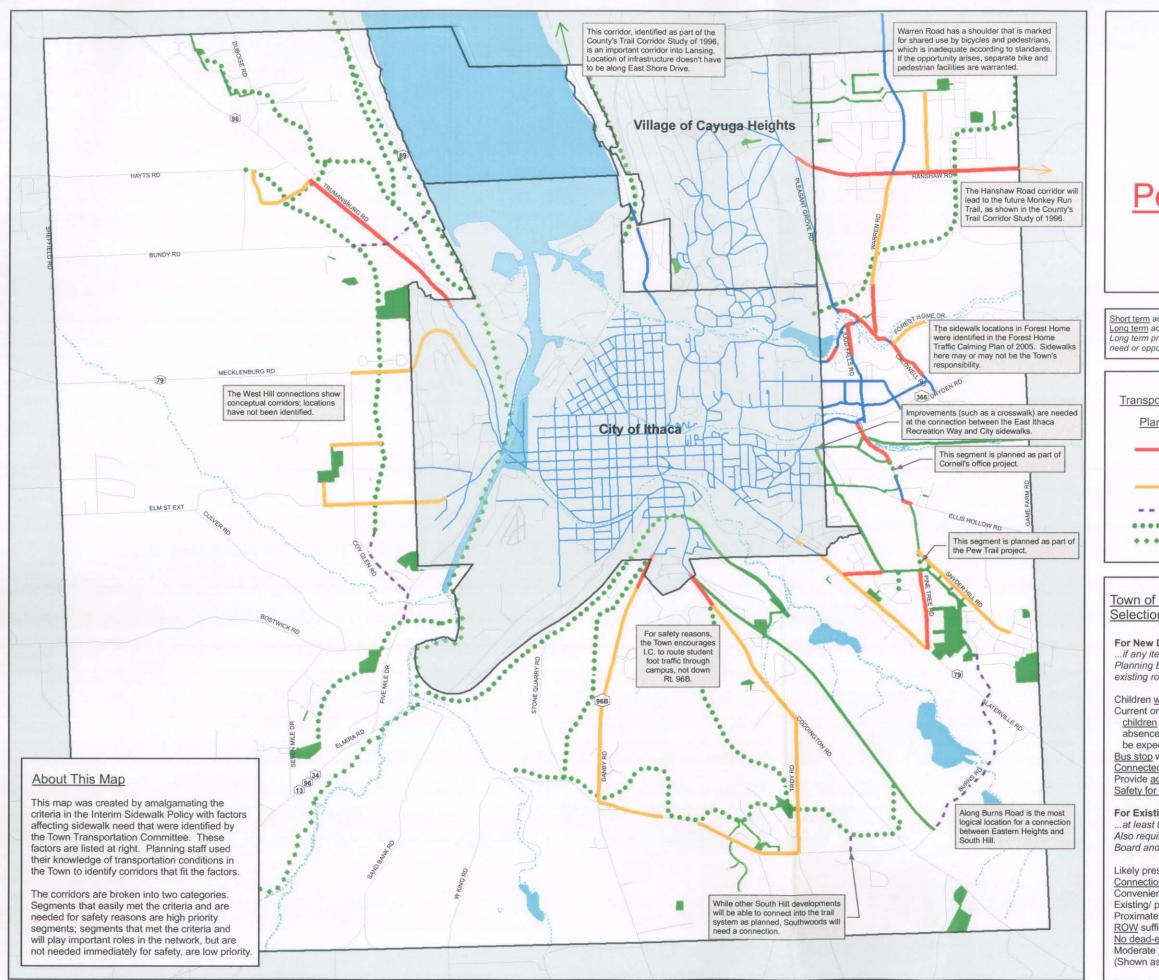
WORKING MAP: Prioritized Pedestrian Corridor Needs Town of Ithaca Tompkins County, New York Short term accomplishes goals in approximately ten years. Town of Ithaca ong term accomplishes goals over twenty years. 215 N. Tioga St. ong term projects become priorities based on changes in Ithaca, NY 14850 need or opportunity (funding, with another project, etc). Legend Transportation Infrastructure Existing Conditions Planned Infrastructure Trails & Recreation Ways Essential corridors Existing Bike and Ped. identified with restrictive interpretation of criteria; immediate need Roads **Recommended corridors** Creeks identified with broader interpretation of criteria; long-term need Existing Town Parks = = Approximate corridors; no time frame Lakes •••• Planned Corridors (Recreation Plan) Hack Diamond Trail Factors Favoring Pedestrian Town of Ithaca Interim Sidewalk Policy Infrastructure Selection Conditions Higher density/ intensity of land use (Medium and high density residential, For New Development> neighborhood/ office park commercial) ... if any item applies. Located along the route of a bus Planning Board may also require sidewalks on Within 1/2 mile of an elementary school existing roads to connect into existing sidewalks. Within 1/2 mile of other pedestrian generators Children walk to school; 85th percentile speed > 25 mph Current or likely future presence of numerous High volume/ classification children in an environment where, in the (arterials, collectors, > 4,000 vpd) absence of a sidewalk, many children can Outside funding is available; be expected to be present on the road shoulder; hence, cost to Town is low Bus stop within convenient walking distance; Links into existing or planned Connected to other sidewalks; pedestrian network Provide access to trail system or public park; Sufficiency of existing infrastructure Safety for pedestrians. Factors Against Pedestrian For Existing Development Infrastructure ...at least three must apply. Also requires recommendation of the Planning Detrimental to environmental resources Board and approval from the Town Board including natural, historic, scenic, agricultural, etc. Likely presence of children Negative neighborhood concensus Connection to existing or planned system Convenient walking distance of ped. generator Existing/ planned shoulders inadequate N Data Sources: Tompkins County Information Technology Services, GIS Proximate access to public transit Division; Town of Ithaca Public Works Department; Town of Ithaca Town Code; Town of Ithaca Transpo ROW sufficient, or easement reasonably obtained NAD 1983, State Plane Central. No dead-ends w/o forseeable connection Moderate peak hour traffic December 20, 2005 Contact: ntedesco@town.ithaca.nv.us (Shown as part of Ped. Circulation Plan)

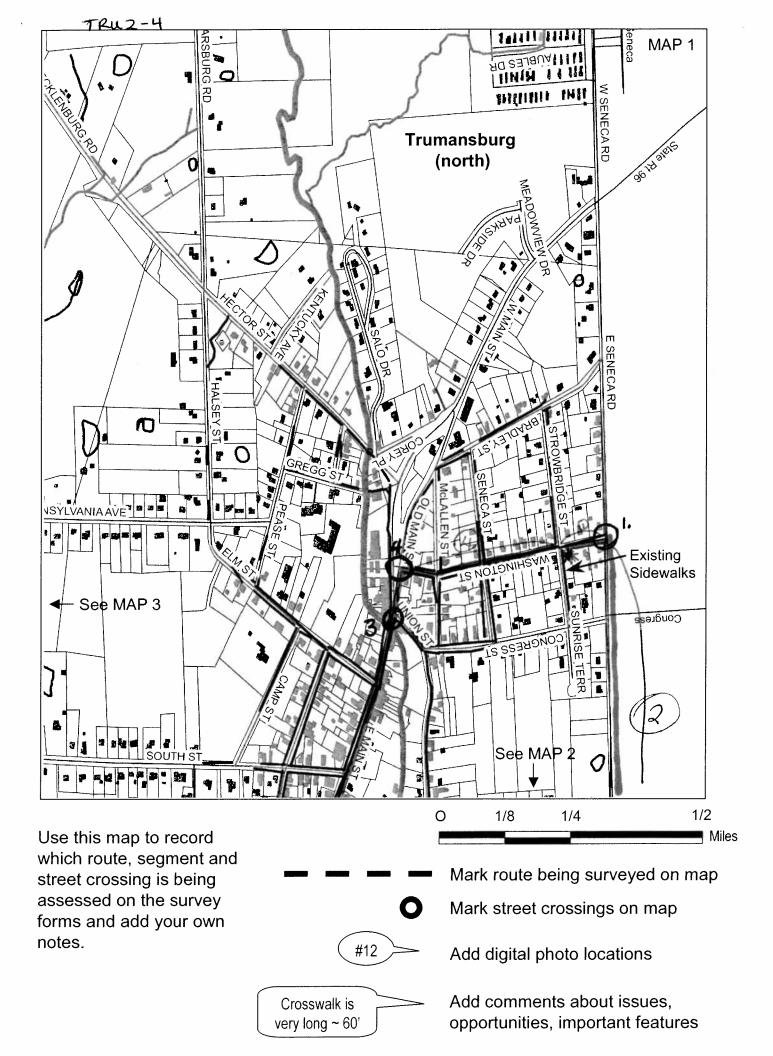
1) Slate sideopalk on W side of street, in dispepair, cracked & heaved. NO sidewalk S side TRU 2-5 (2) NO sidewalk, berm or other provision for walking. This is a lovely, semi-rural walk, but safety is an issue. Cars are not consistent in obeying the 30 MPH speed limit - it's a nice straightway! (4) Sidewalk along entire W side: heaved & cracked slate from Old Main to McLallen, concrete rest of the way in variable condition. Good from McLallen to Seneca, heaved & cracked from Seneca St to Seneca Rd. Edges overgrown w/torf in Sidewalk in some spots E side of st but not continuous.
