# Cayuga Coal Ash Disposal Facility

Mitigation & Remediation Options

John Dennis and Brian Eden

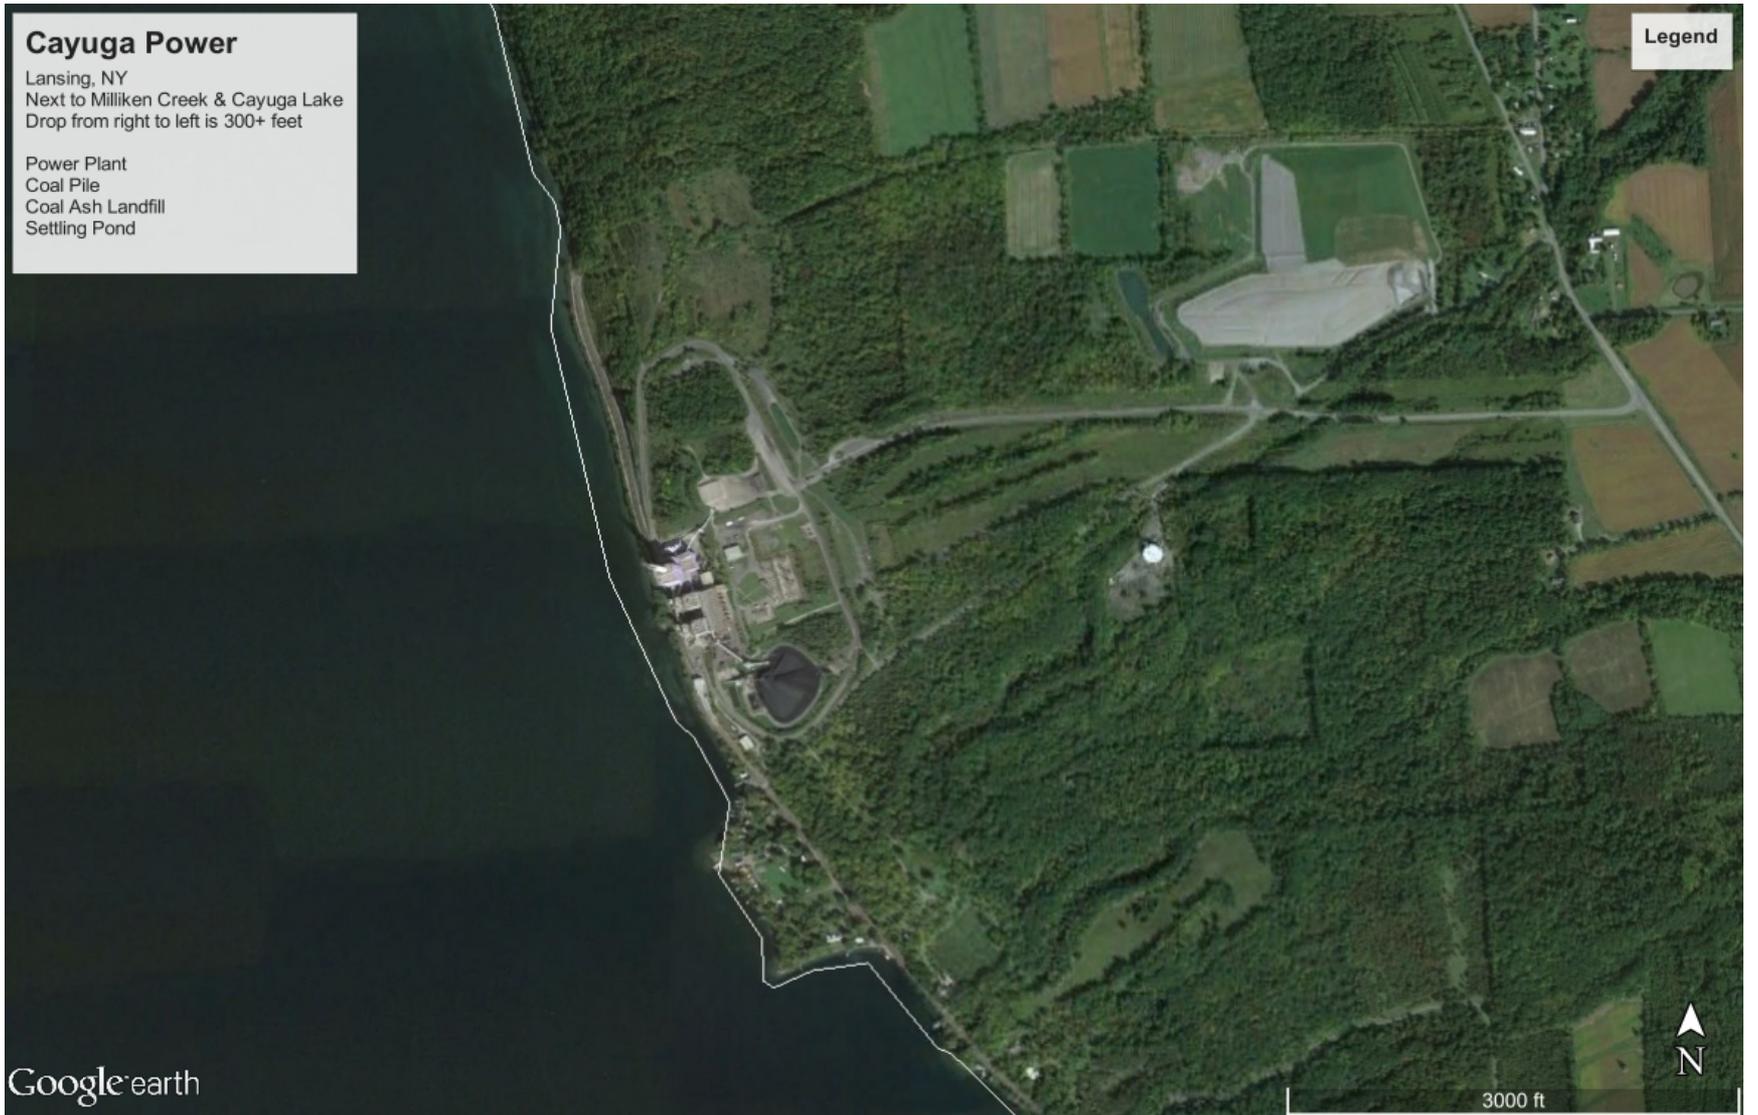
Lansing, NY  
Next to Milliken Creek & Cayuga Lake  
Drop from right to left is 300+ feet

Power Plant  
Coal Pile  
Coal Ash Landfill  
Settling Pond

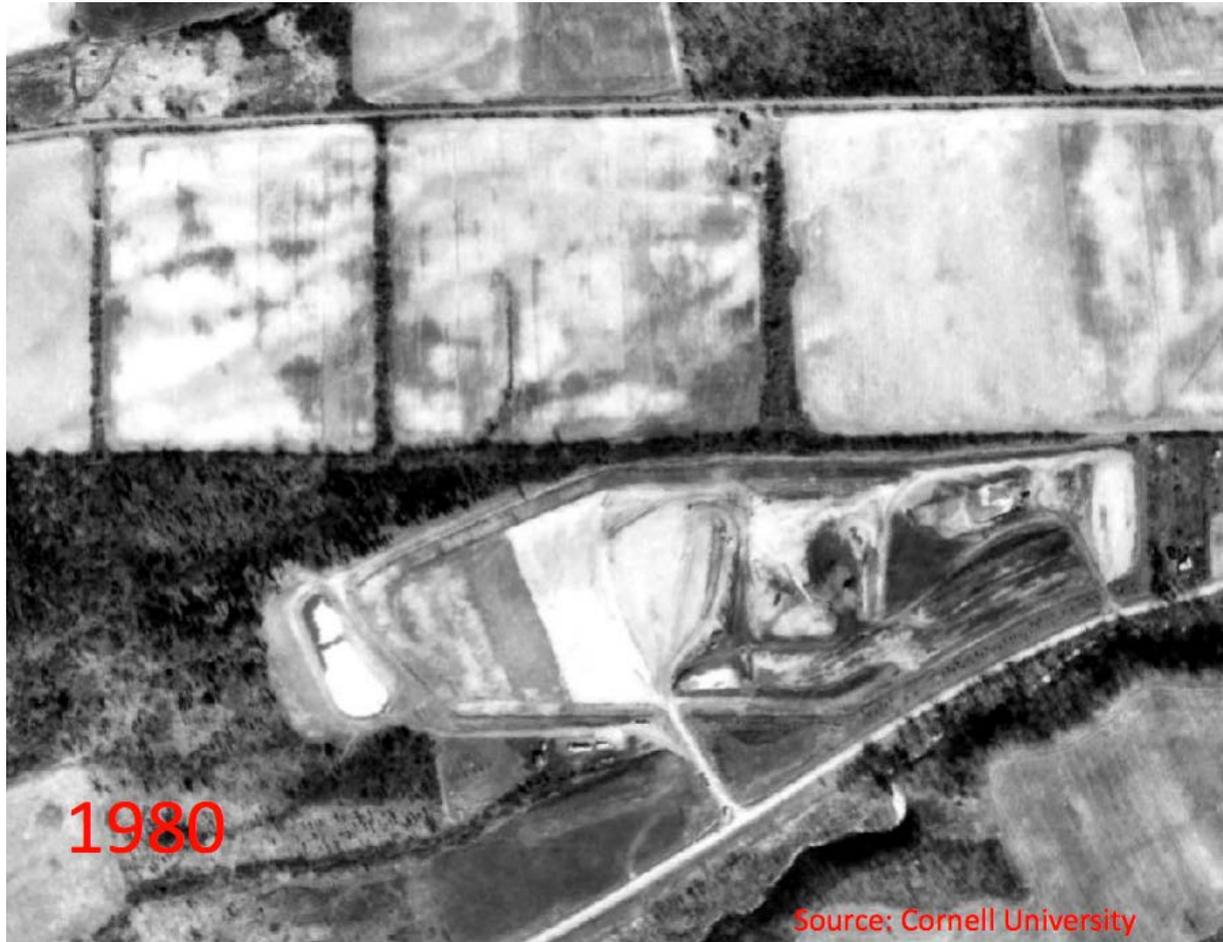
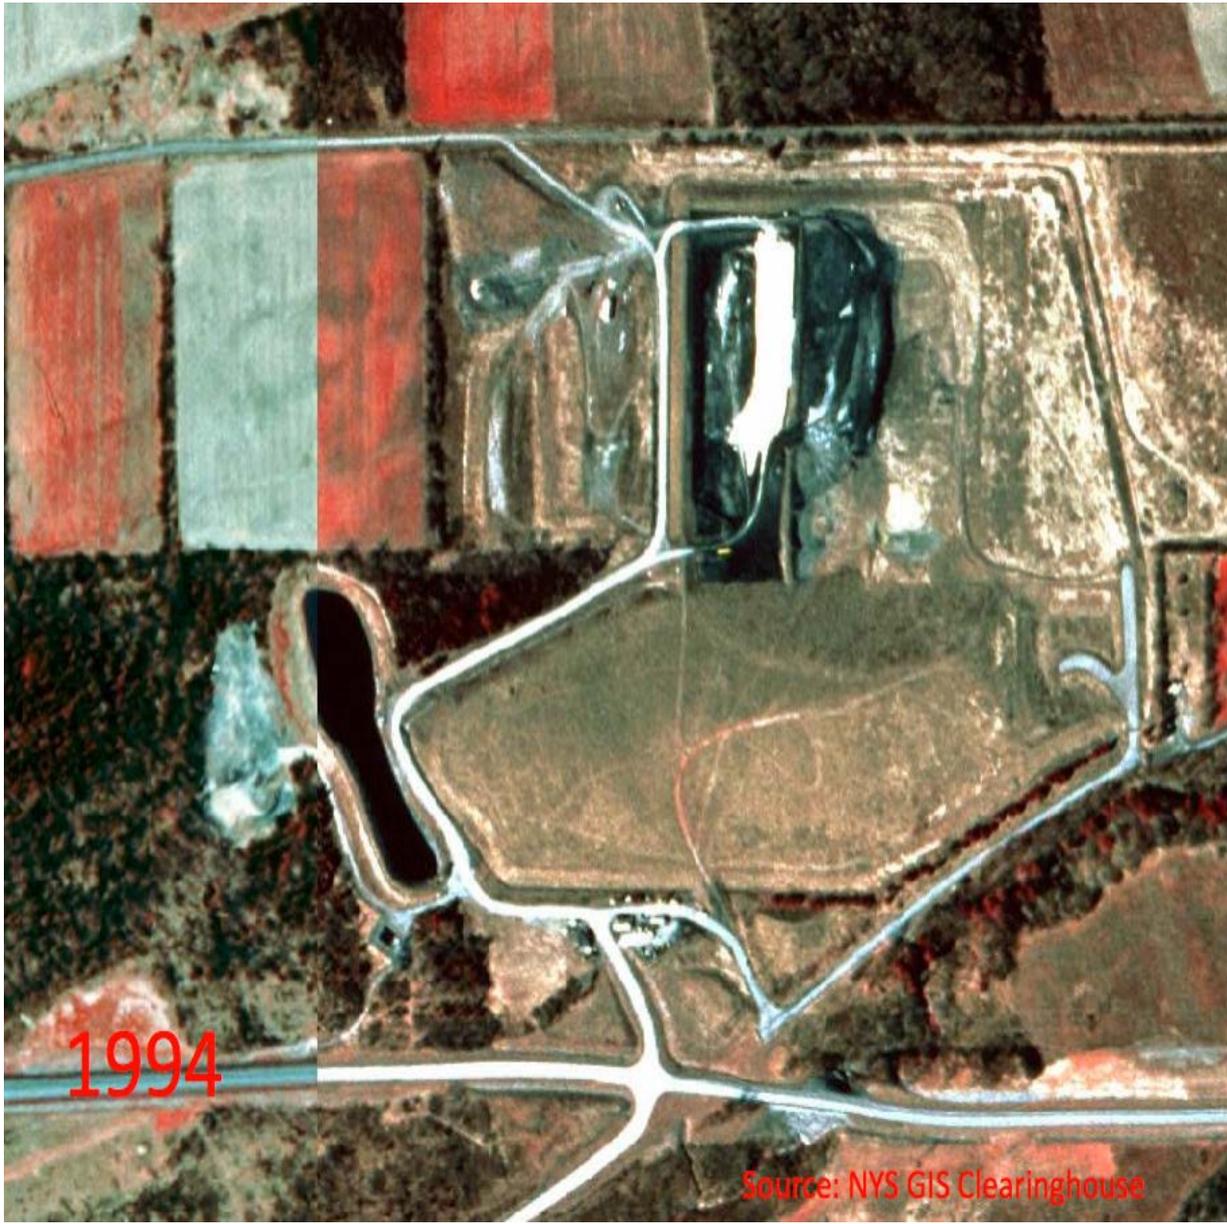
1994

# Phase 1: started 1977

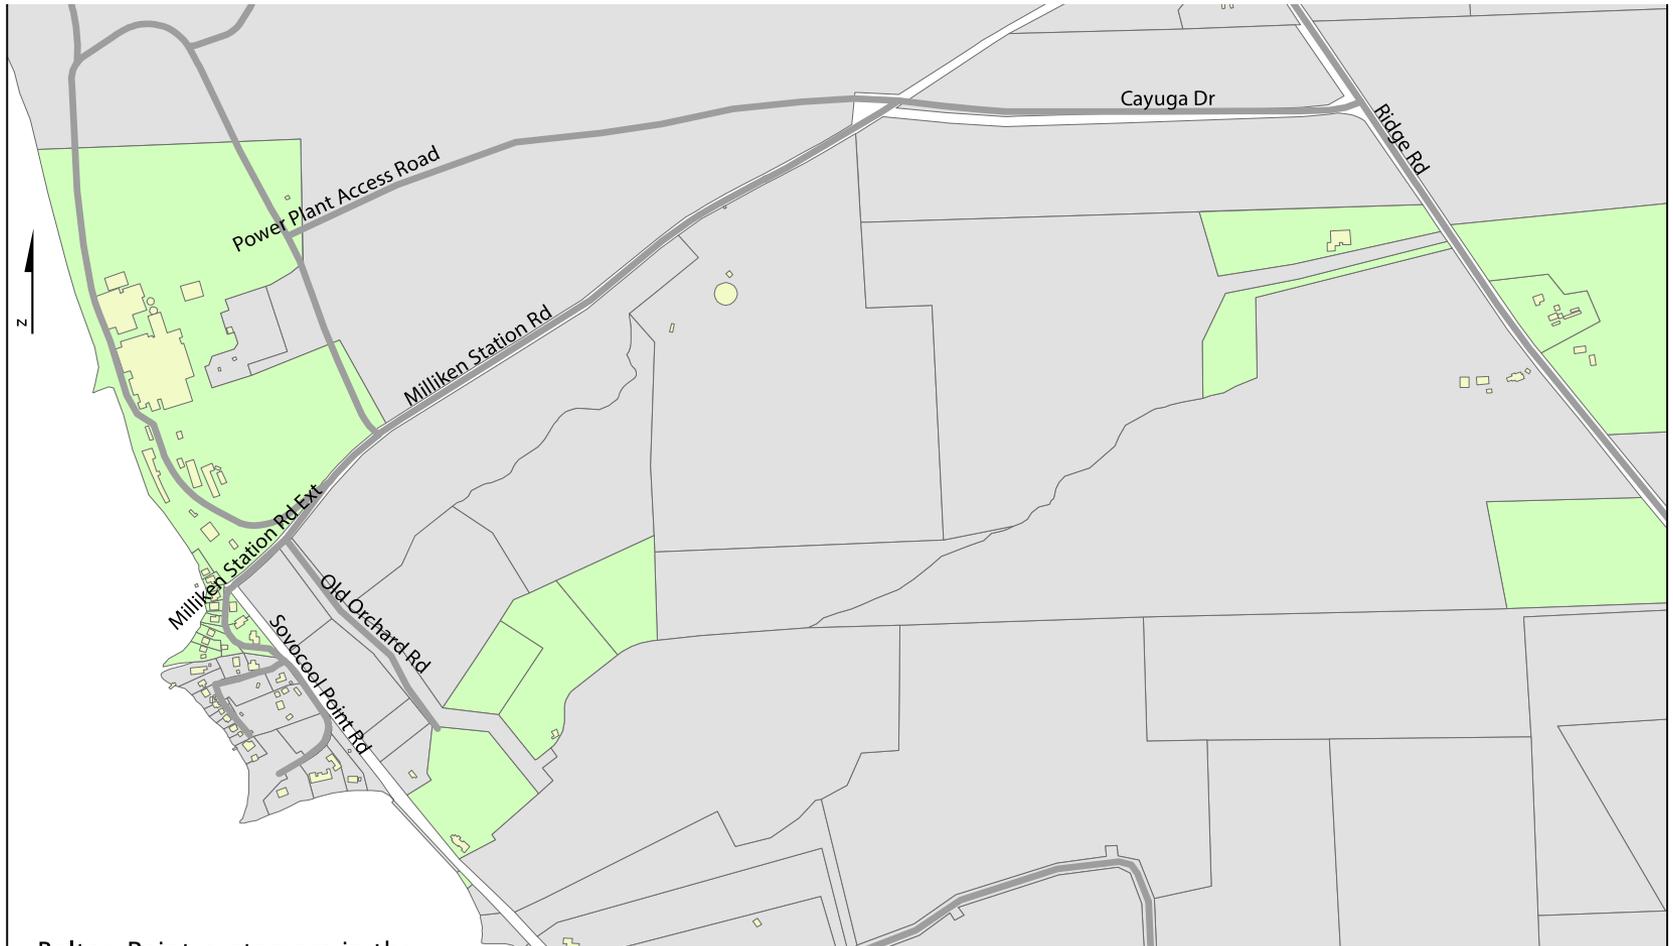
Bolton Point water >2000

# Bolton Point Water >2000

Brian noted that the EPA Facility Report on Cayuga can be accessed on the EPA web site. It indicates that “no wastewater treatment technology is currently in place at the facility”. A potable drinking water source was added to the plant in the 1990s and some residents on the north side of Milliken Creek at Lake Ridge Point were added to the Bolton Point system in 2001.
