NYSDOT Maintenance Facility Relocation & Redevelopment Feasibility Study

February 2016
Updated August 2016

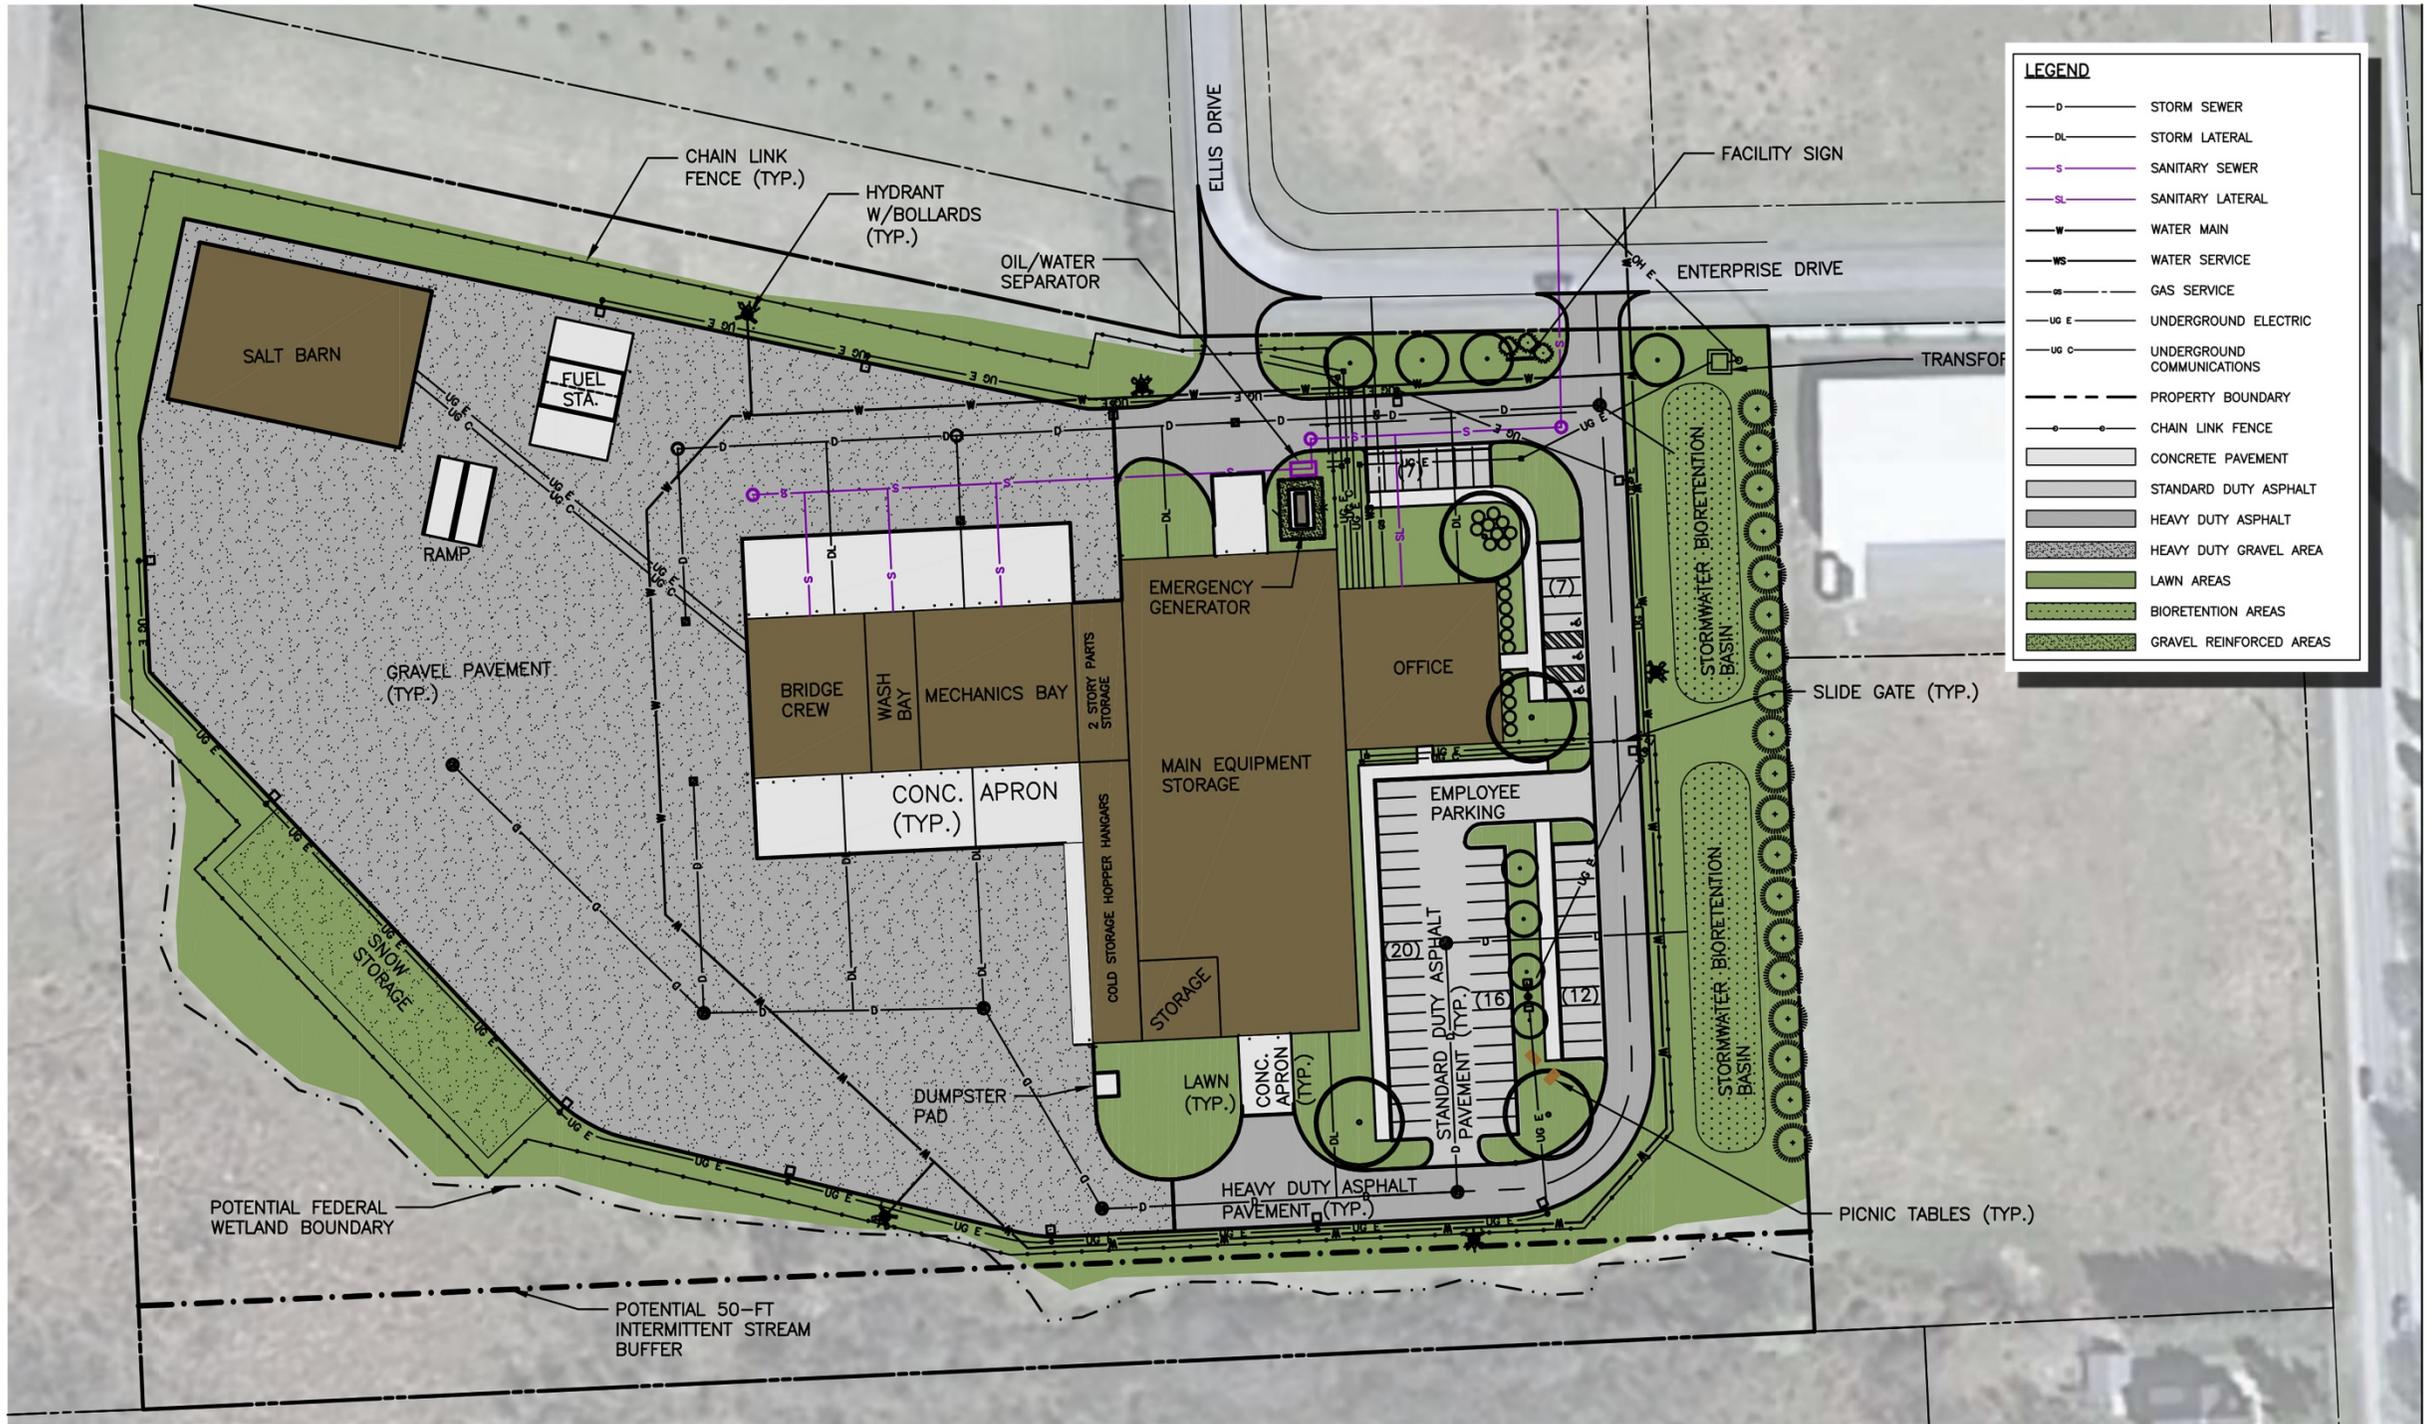
Figure 1: Dryden Site Plan

The Dryden site (10.8 acres) is essentially 30% larger than the Ithaca site (7.6 acres). Over the years, the NYSDOT has added Quonset hut style structures and converted a sign shop garage to house their vehicles. This has required staff time to make improvements for vehicle storage that could have been devoted to other maintenance efforts.

Based on the NYSDOT’s stated program requirements, the consultant team prepared a schematic site plan illustrating all buildings and accessory structures. The total estimated budget is \$14M for the consolidated facility in Dryden or \$11M for a replacement facility on Warren Road in the Town of Lansing, (not including infrastructure improvements to the site).

NYSDOT purchased a 10.8 acre site in the Village of Dryden for consolidation of both the Ithaca and Cortland maintenance facilities. Tompkins County has identified and evaluated an alternative site (Town of Lansing) should NYS DOT prefer to replace the existing facility in the Ithaca area. All efforts should be made in a joint effort between the three parties to request full funding of the project from NYSDOT officials in Albany or through Economic Development Grants through the Southern Tier Regional Economic Development Council’s Combined Funding Application and/or Upstate Revitalization Initiative process.

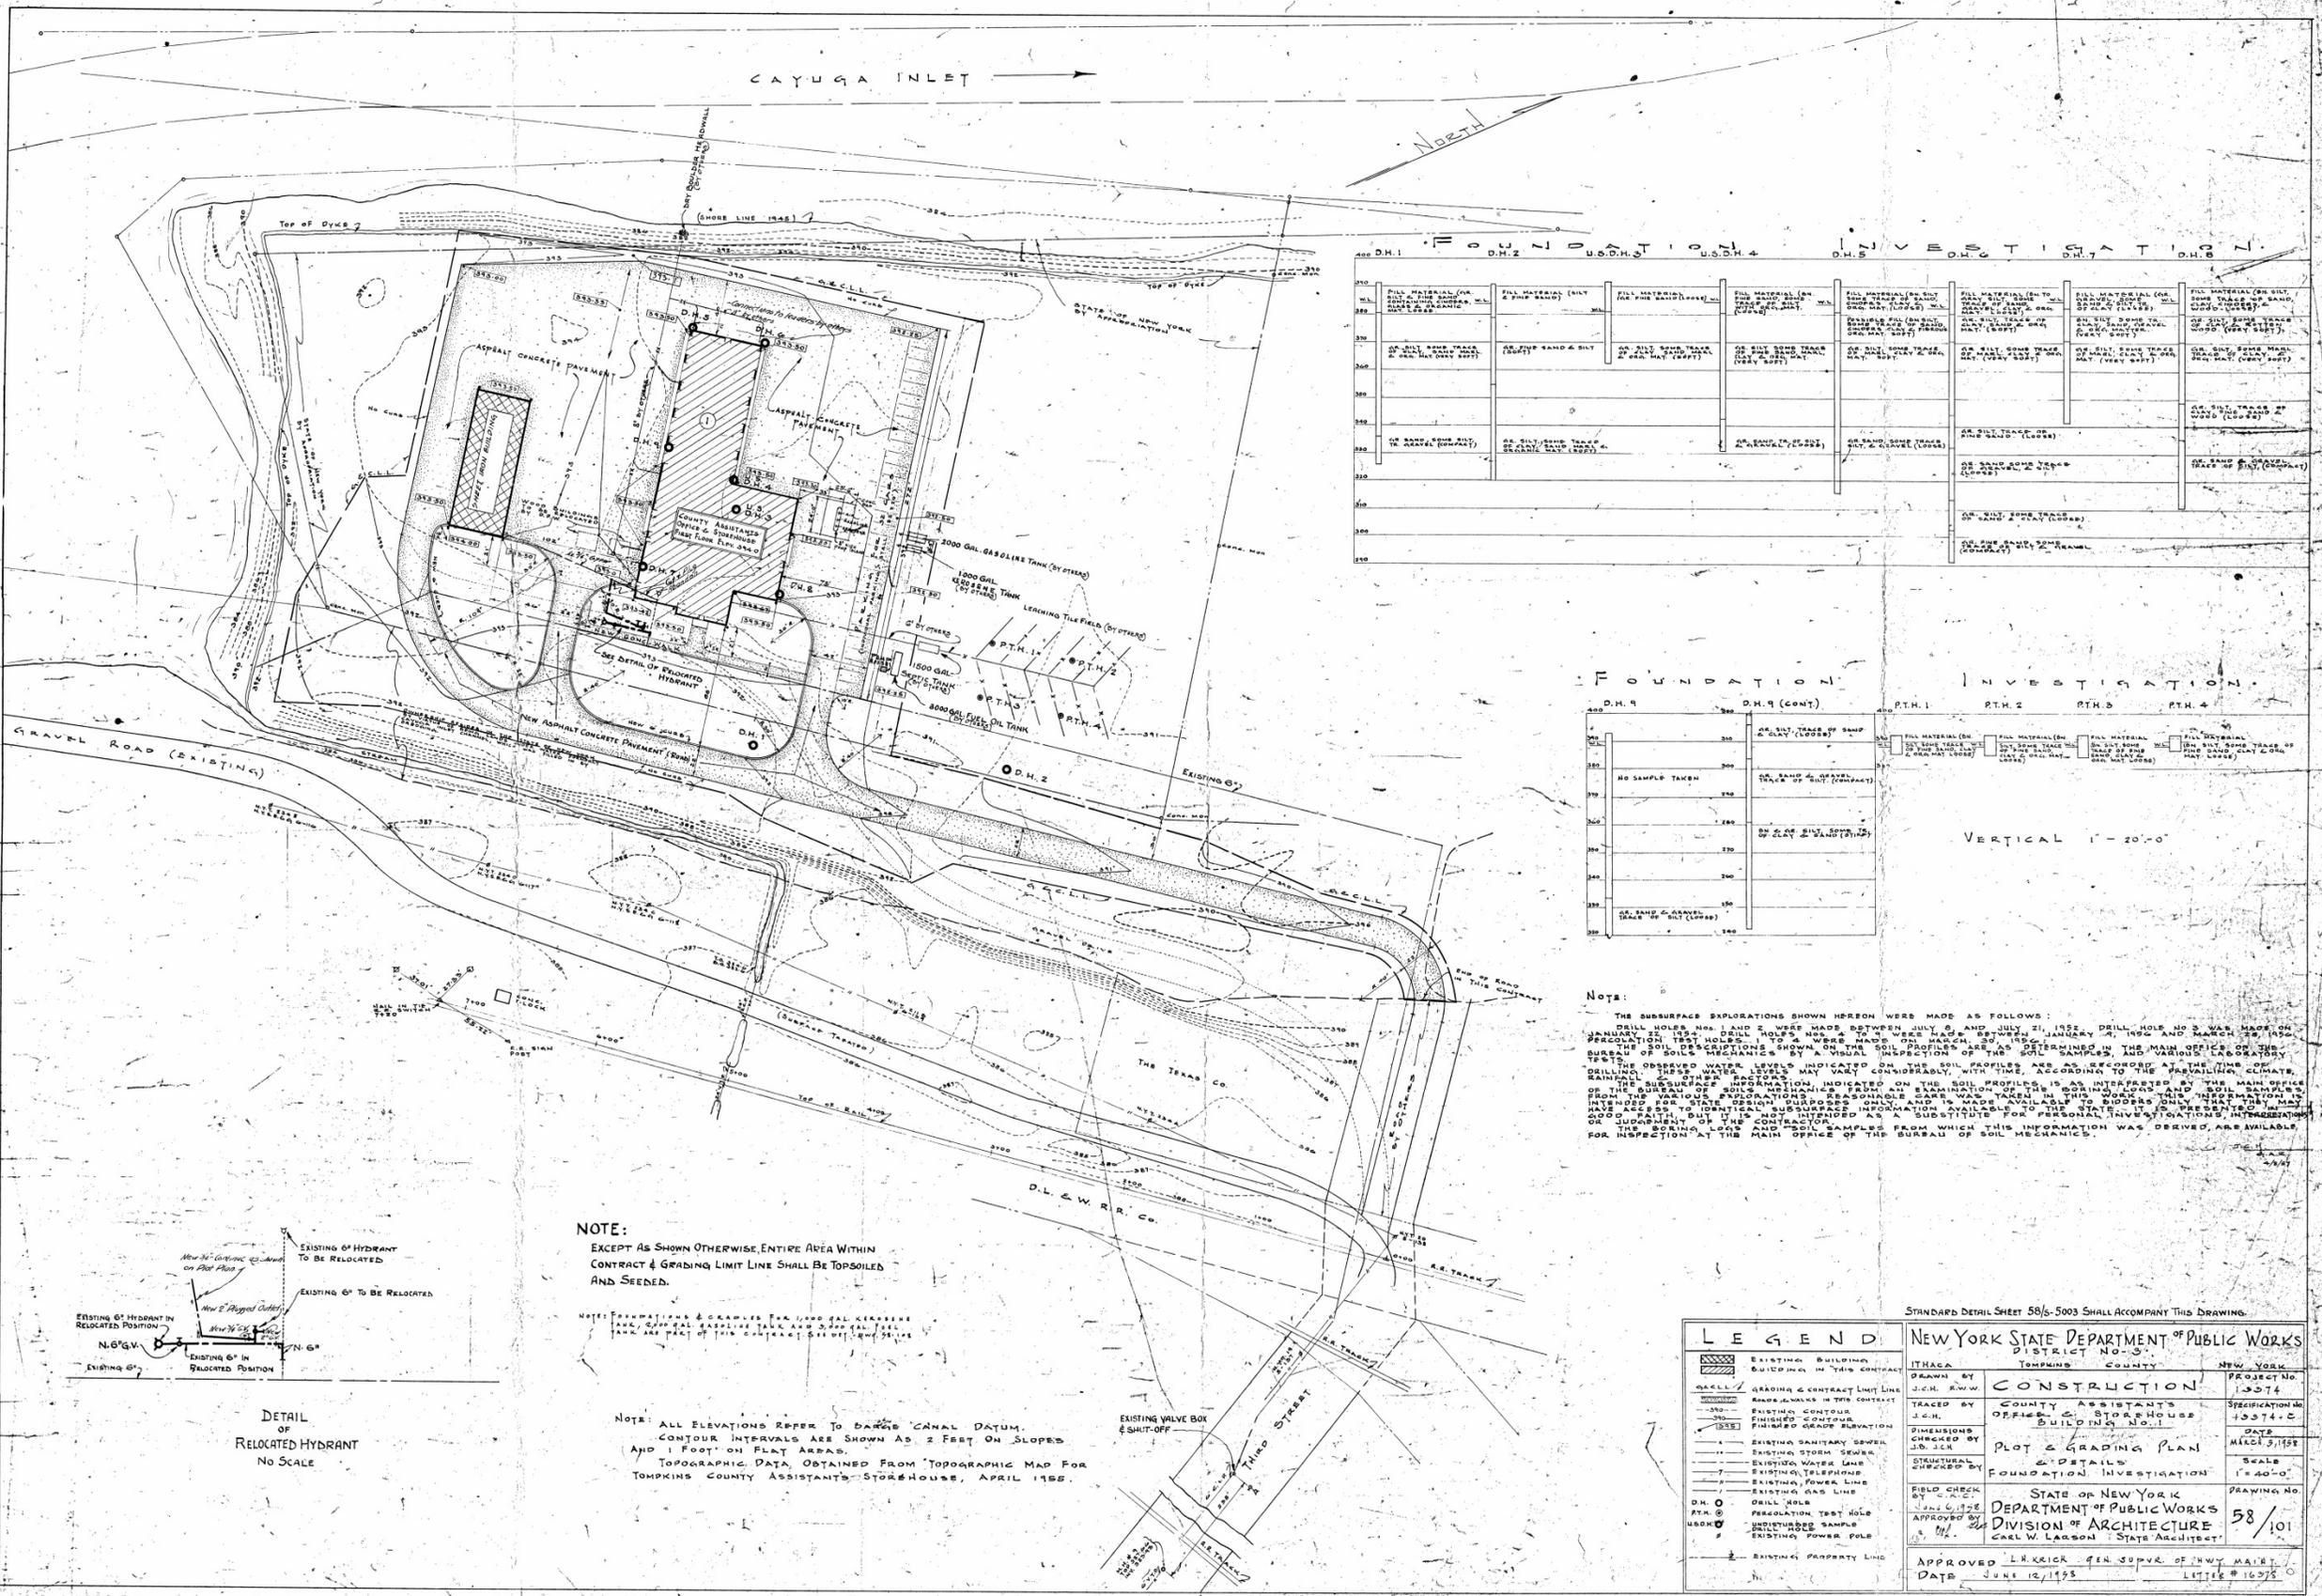
Figure 2: 1958 NYSDOT Plot & Grading Plan

- The site was vacant until 1958 (refer to **Figure 2, 1958 NYSDOT Plot & Grading Plan**) when the NYSDOT constructed the facility which exists today,
- There are historic activities on and/or near the site known as 'recognized environmental conditions' (REC's),

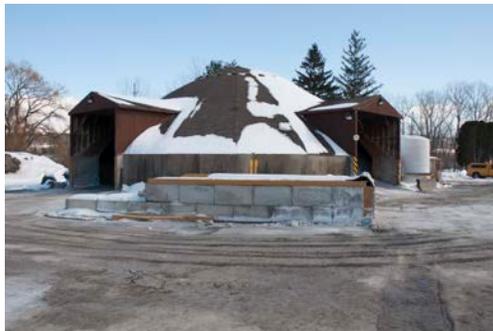
Existing Salt Barn at
Ithaca NYSDOT Maintenance Facility
(Fisher Associates)

- There is insufficient space within the primary maintenance structure to store all trucks. The former sign shop building has been adapted to garage space and two Quonset hut structures have been erected to house trucks.
- The Cayuga Inlet Waterfront Trail project occupies approximate ½ acre of property along the south and west perimeter of the site. Construction of the trail and security fence has reduced the area that was used by the NYS DOT for storage of equipment and bulk materials. It should be noted that the property adjacent to the trail used for storage was not owned by the NYS DOT.
- The existing salt barn causes operational inefficiencies due to size and access. The limited size requires more frequent truck deliveries from Cargill to replenish stock. Staff man hours required to load and manage the stockpile is excessive.

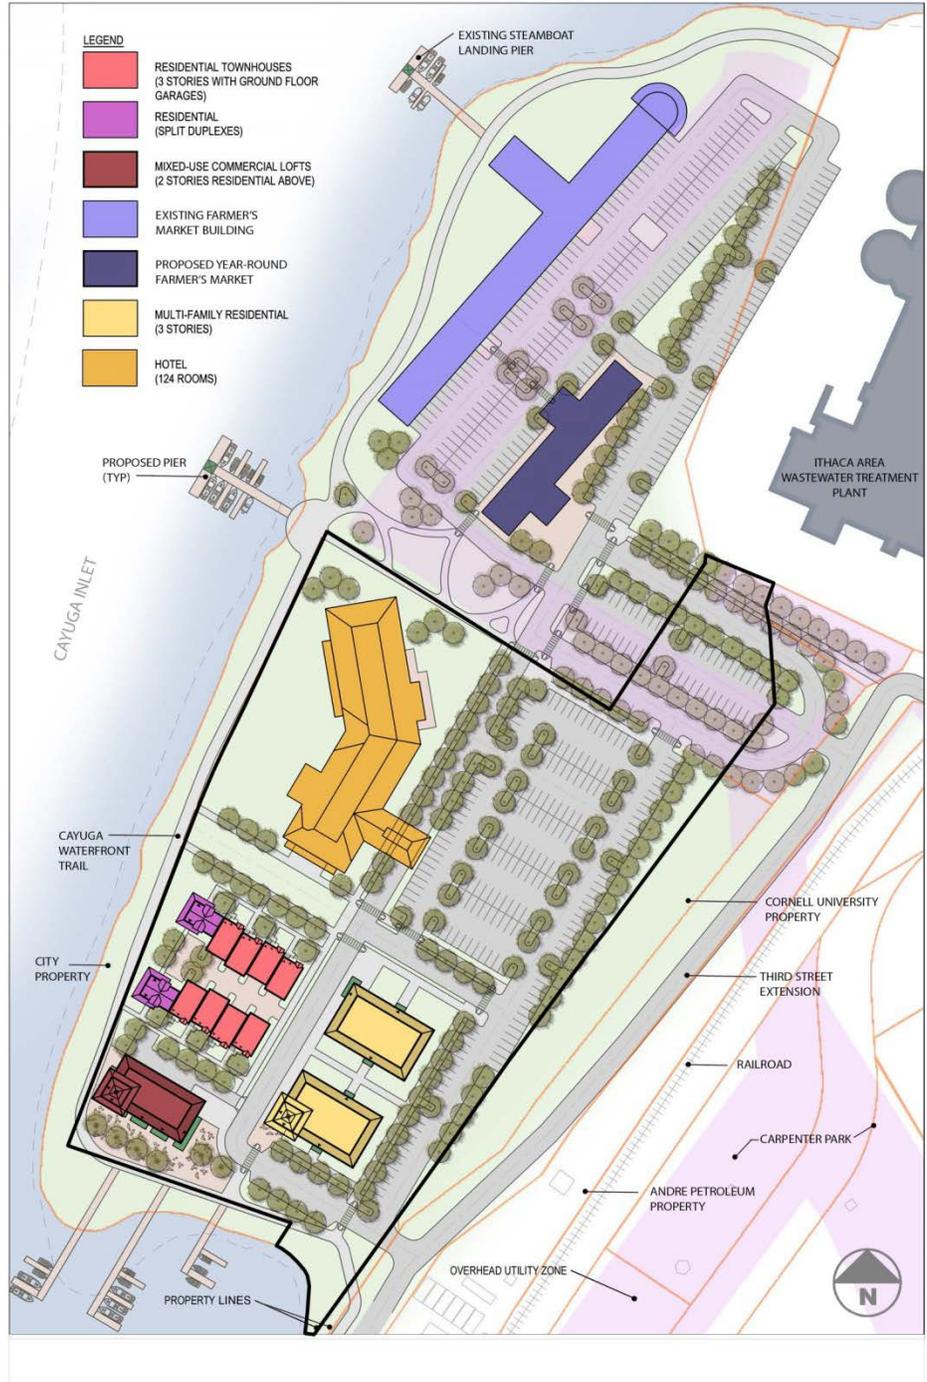
Figure 4:
Mixed-Use
Concept Design

Concept 2

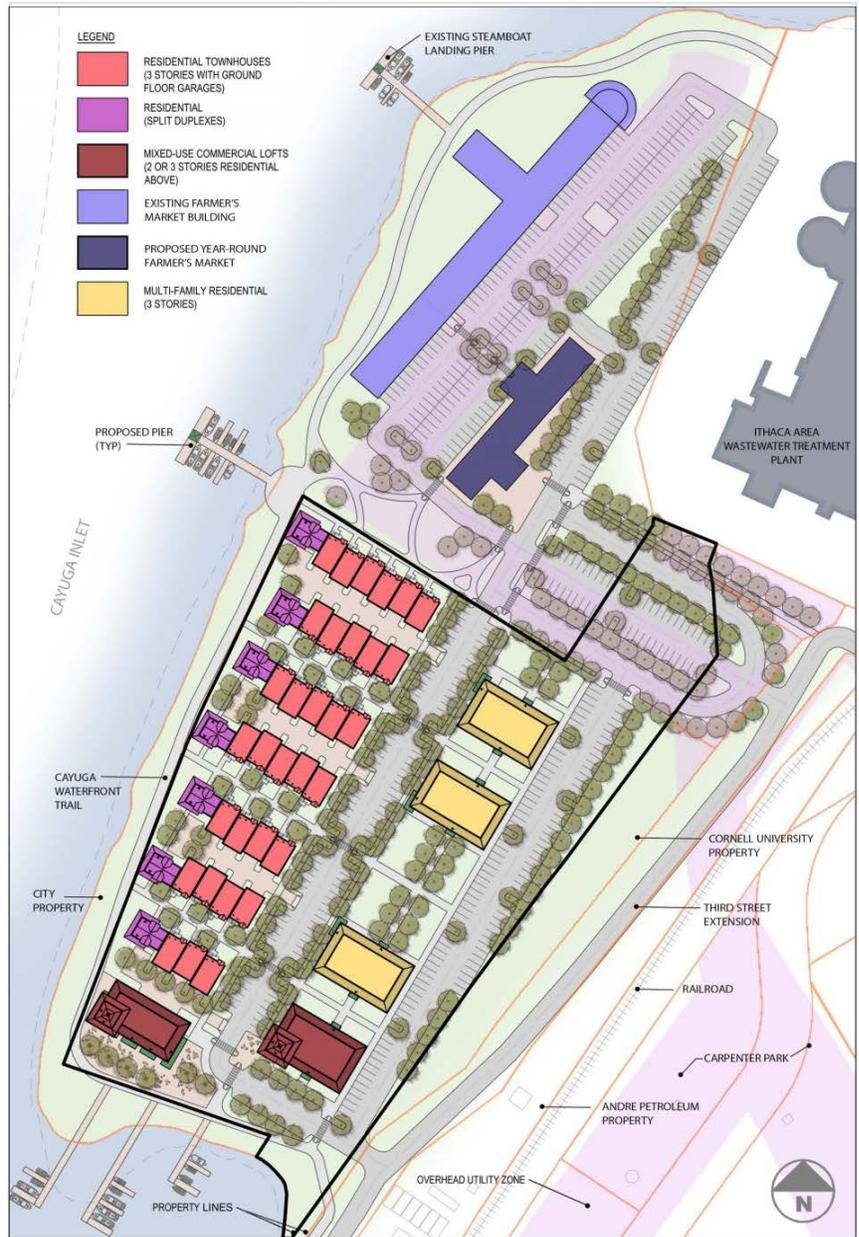
Figure 5:
Maximum
Density
Concept
Design

Concept 3

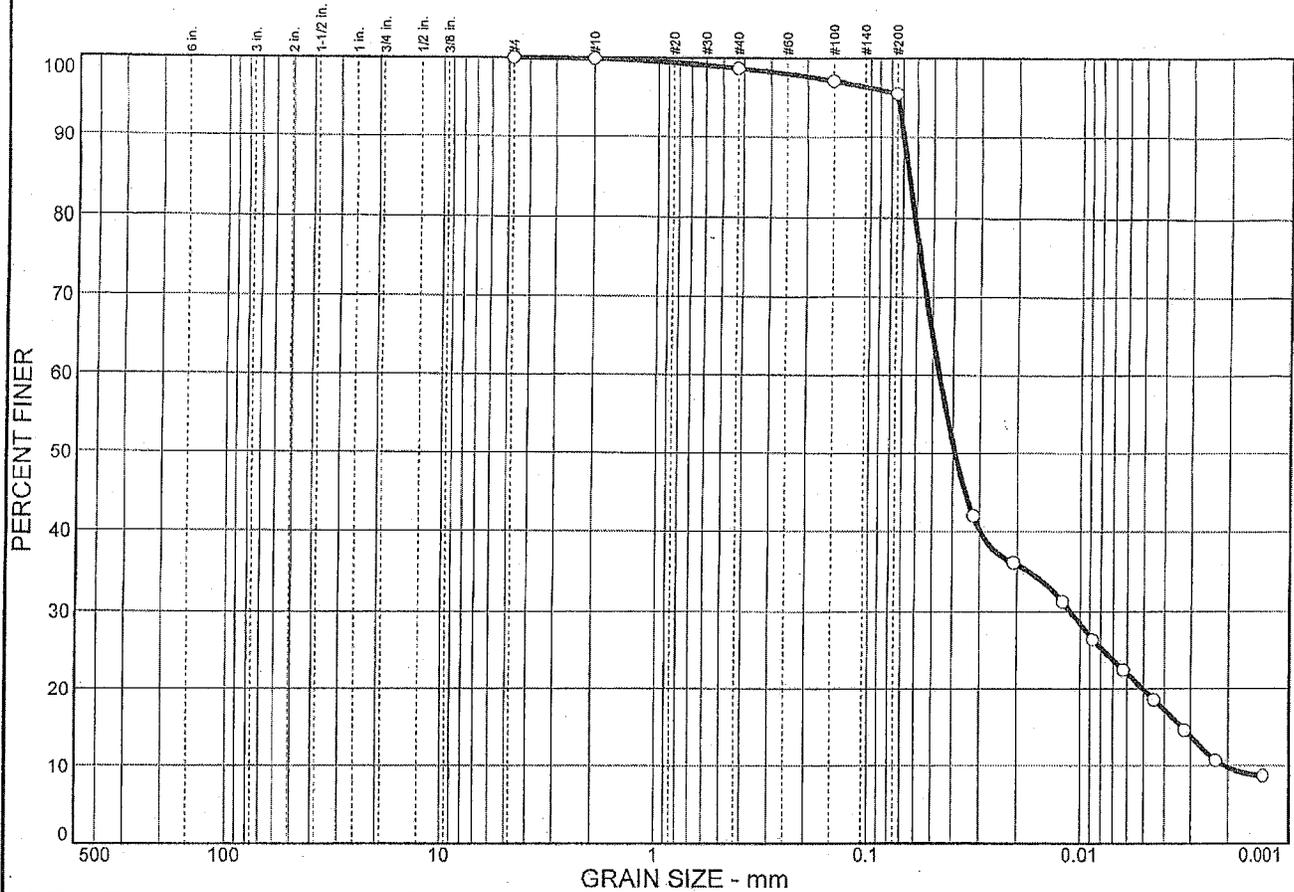
Particle Size Distribution Report

% COBBLES	% GRAVEL	% SAND	% SILT	% CLAY
0.0	0.0	4.5	75.7	19.8

SIEVE SIZE	PERCENT FINER	SPEC.* PERCENT	PASS? (X=NO)
#4	100.0		
#10	99.9		
#40	98.7		
#100	97.1		
#200	95.5

Fill soils were measured to a depth of six to eight feet and are characterized as very loose to compact silty sands, gravel or clay. The native lacustrine deposits underlying the fill are comprised of silts with clay, sand and/or organics with peat which extend to depths of 23 to 30 feet. Below this are soils with the characteristic of 'marl' with very soft consistency to depths of 45 to 50 feet. Underlying the marl are very loose sandy silts to 75 feet. Borings were explored to depths of 97 feet where soils are loose to firm in relative density with small amounts of gravel.

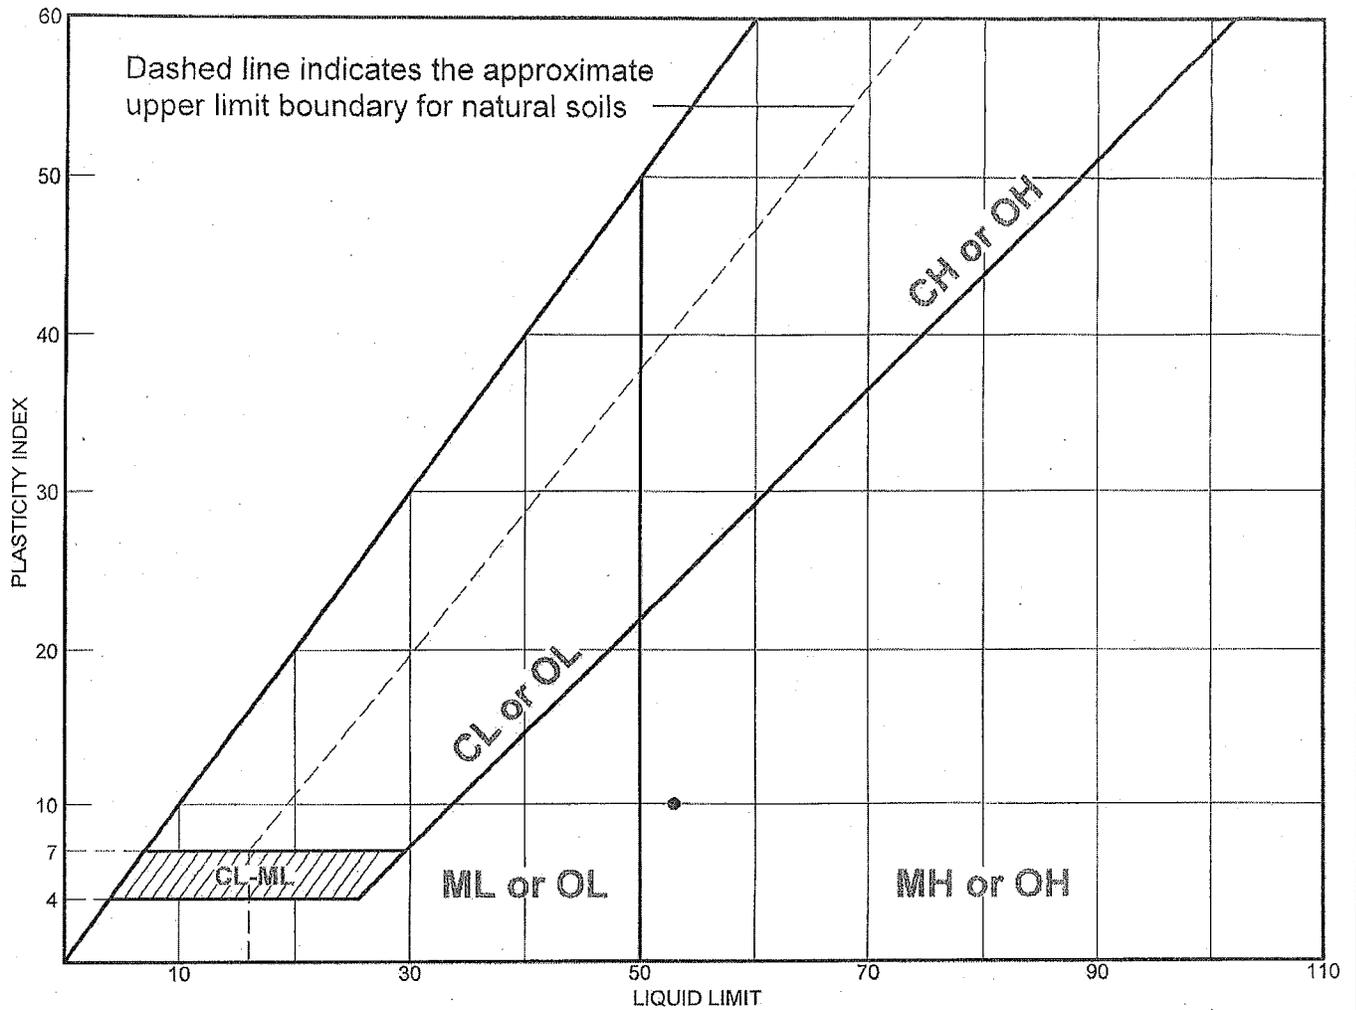
LIQUID AND PLASTIC LIMITS TEST REPORT

MATERIAL DESCRIPTION	LL	PL	PI	%<#40	%<#200	USCS
• Elastic silt	53	43	10	98.7	95.5	MH

Project No. BE-15-049 **Client:** Fisher Associates
Project: Relocation of NYSDOT Maintenance Facility
• Location: B-1,S-5

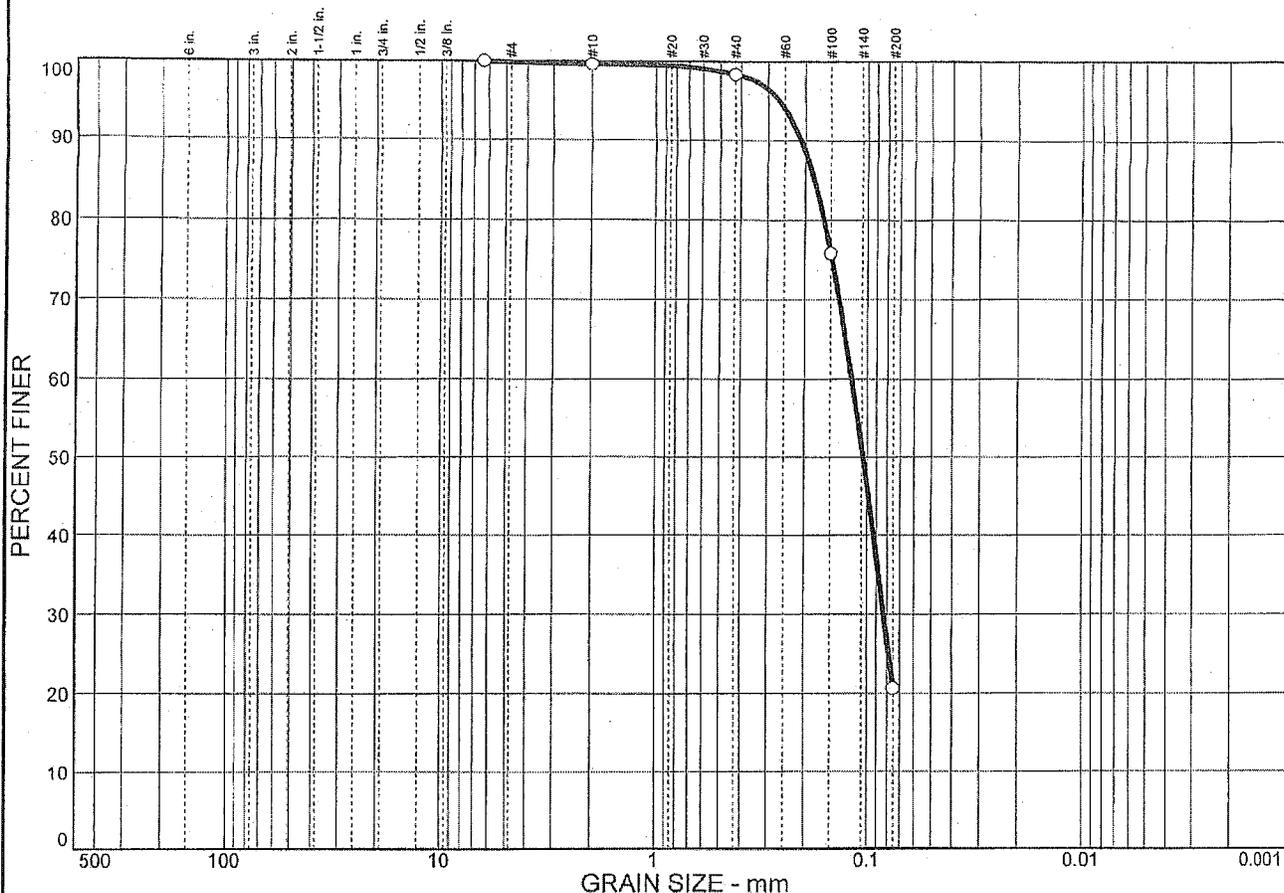
Particle Size Distribution Report

% COBBLES	% GRAVEL	% SAND	% SILT	% CLAY
0.0	0.1	79.3	20.6

SIEVE SIZE	PERCENT FINER	SPEC.* PERCENT	PASS? (X=NO)
0.25 in.	100.0		
#10	99.6		
#40	98.3		
#100	75.9		
#200	20.6

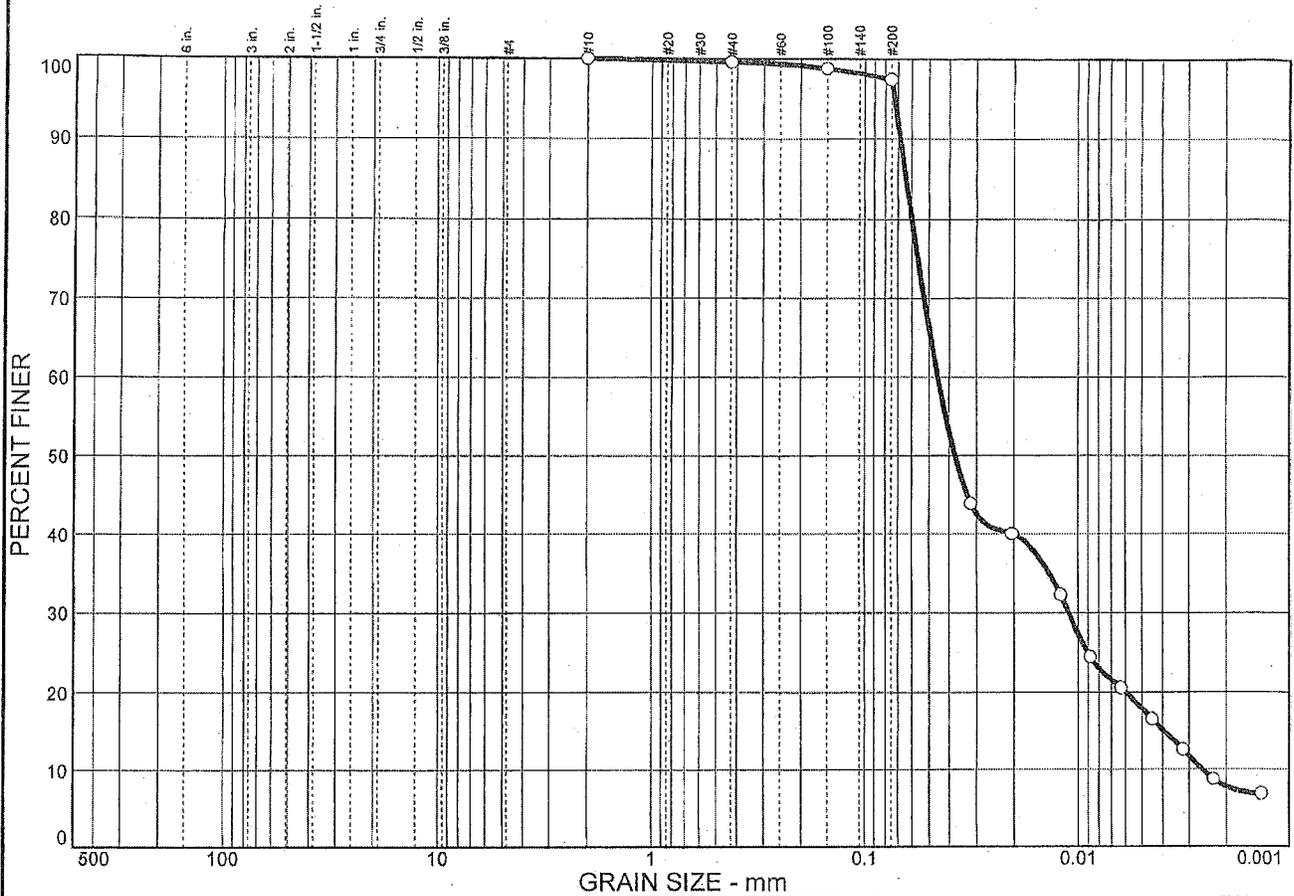
Particle Size Distribution Report

% COBBLES	% GRAVEL	% SAND	% SILT	% CLAY
0.0	0.0	2.6	79.6	17.8

SIEVE SIZE	PERCENT FINER	SPEC.* PERCENT	PASS? (X=NO)
#10	100.0		
#40	99.6		
#100	98.8		
#200	97.4

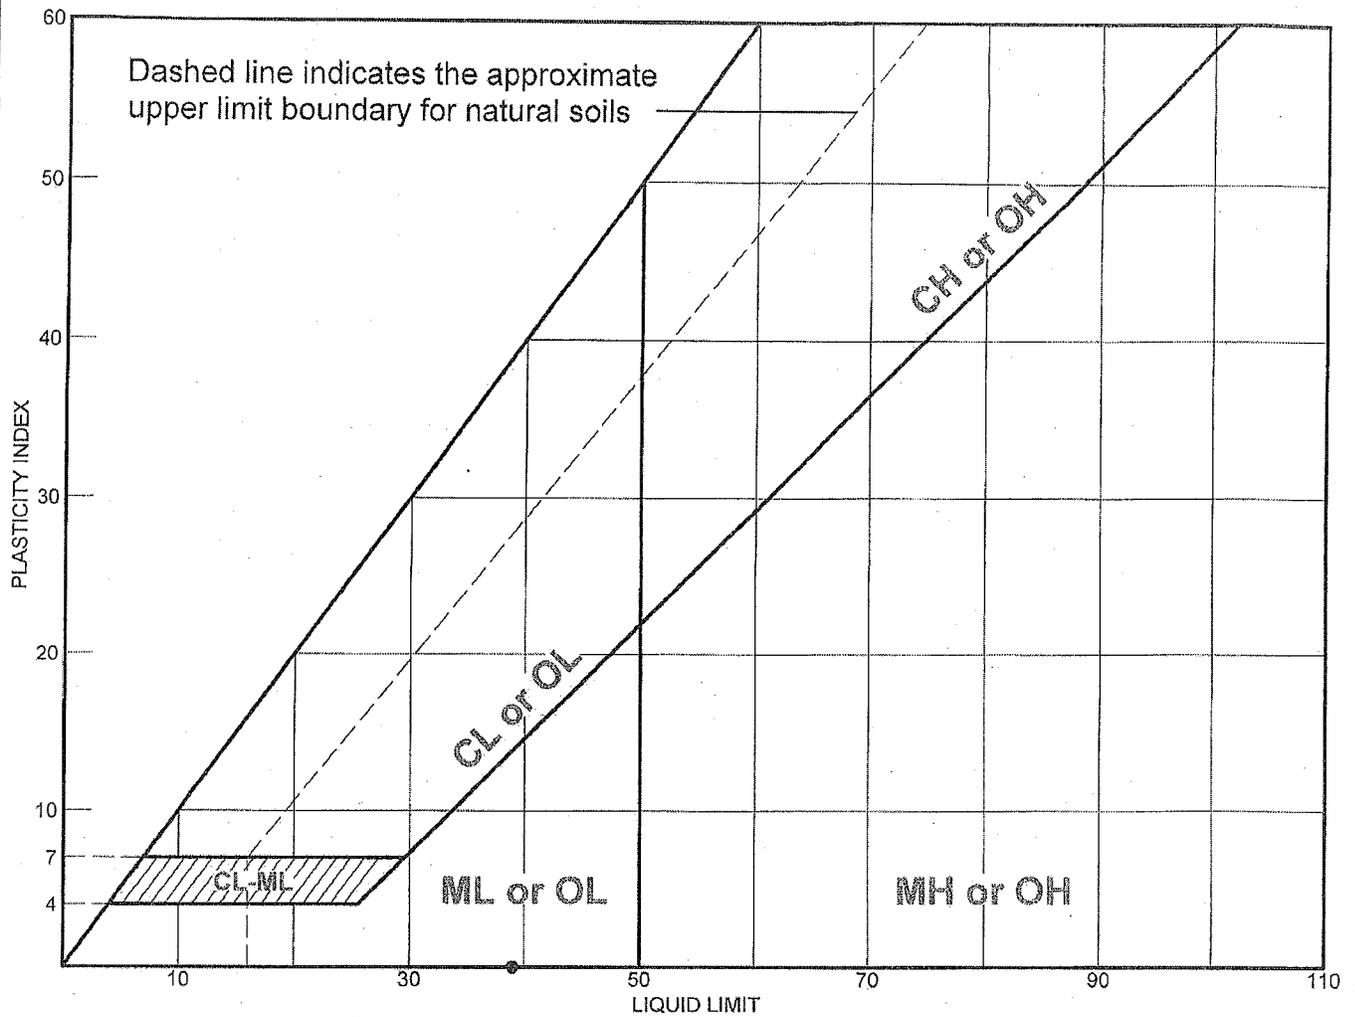
LIQUID AND PLASTIC LIMITS TEST REPORT

MATERIAL DESCRIPTION	LL	PL	PI	%<#40	%<#200	USCS
● Silt	39		NP	99.6	97.4	ML

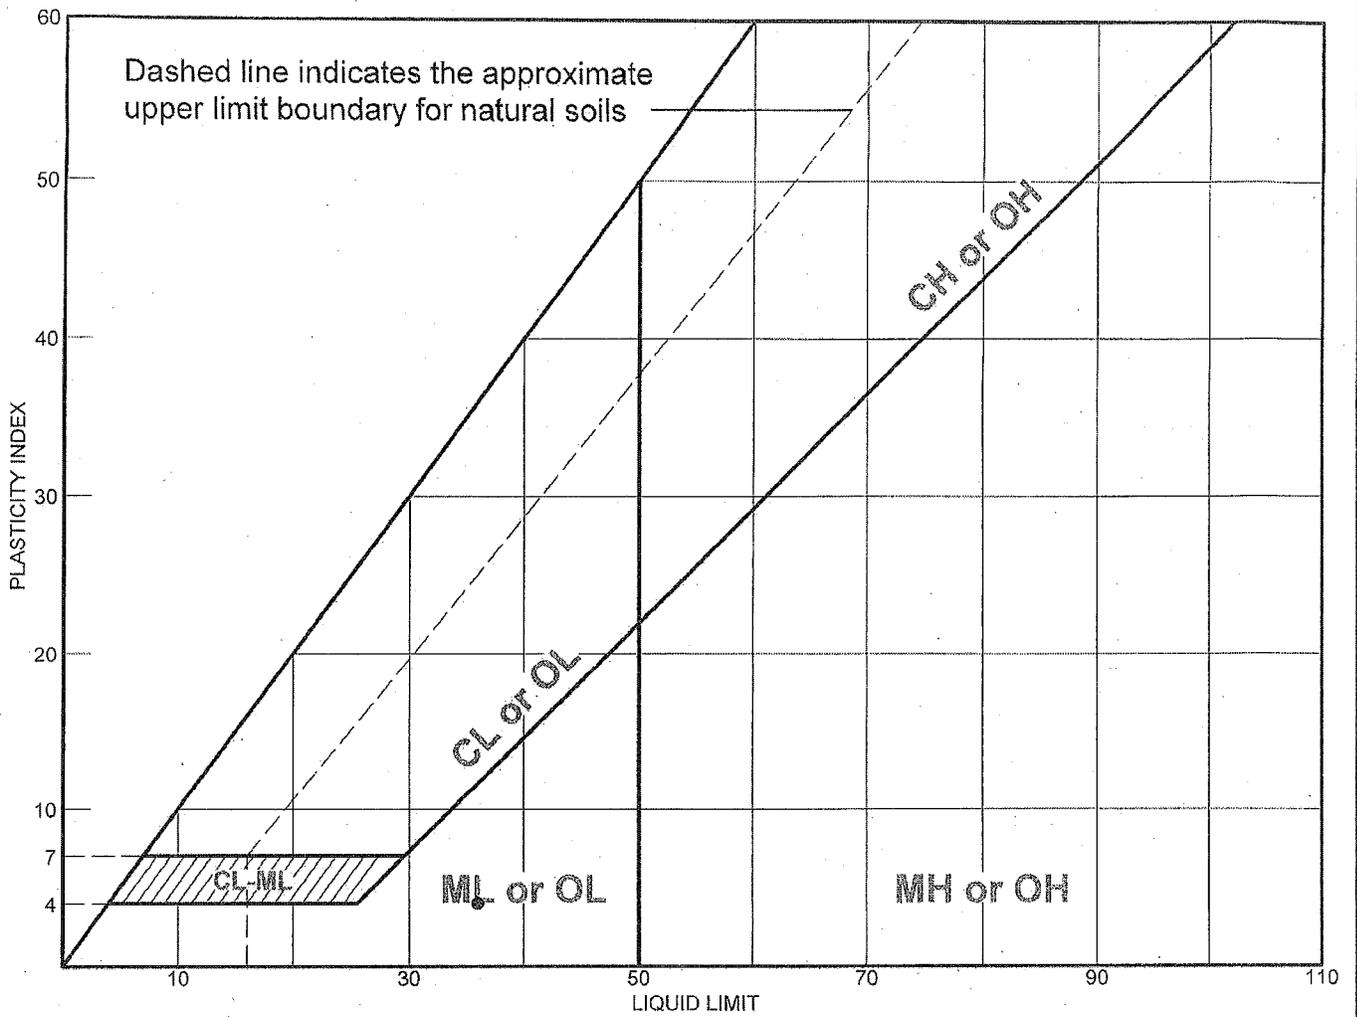
LIQUID AND PLASTIC LIMITS TEST REPORT

MATERIAL DESCRIPTION	LL	PL	PI	%<#40	%<#200	USCS
● Silt	36	32	4	99.5	96.9	ML

Project No. _____ Client: _____
 Project: _____
 ● Location: B-2,S-4

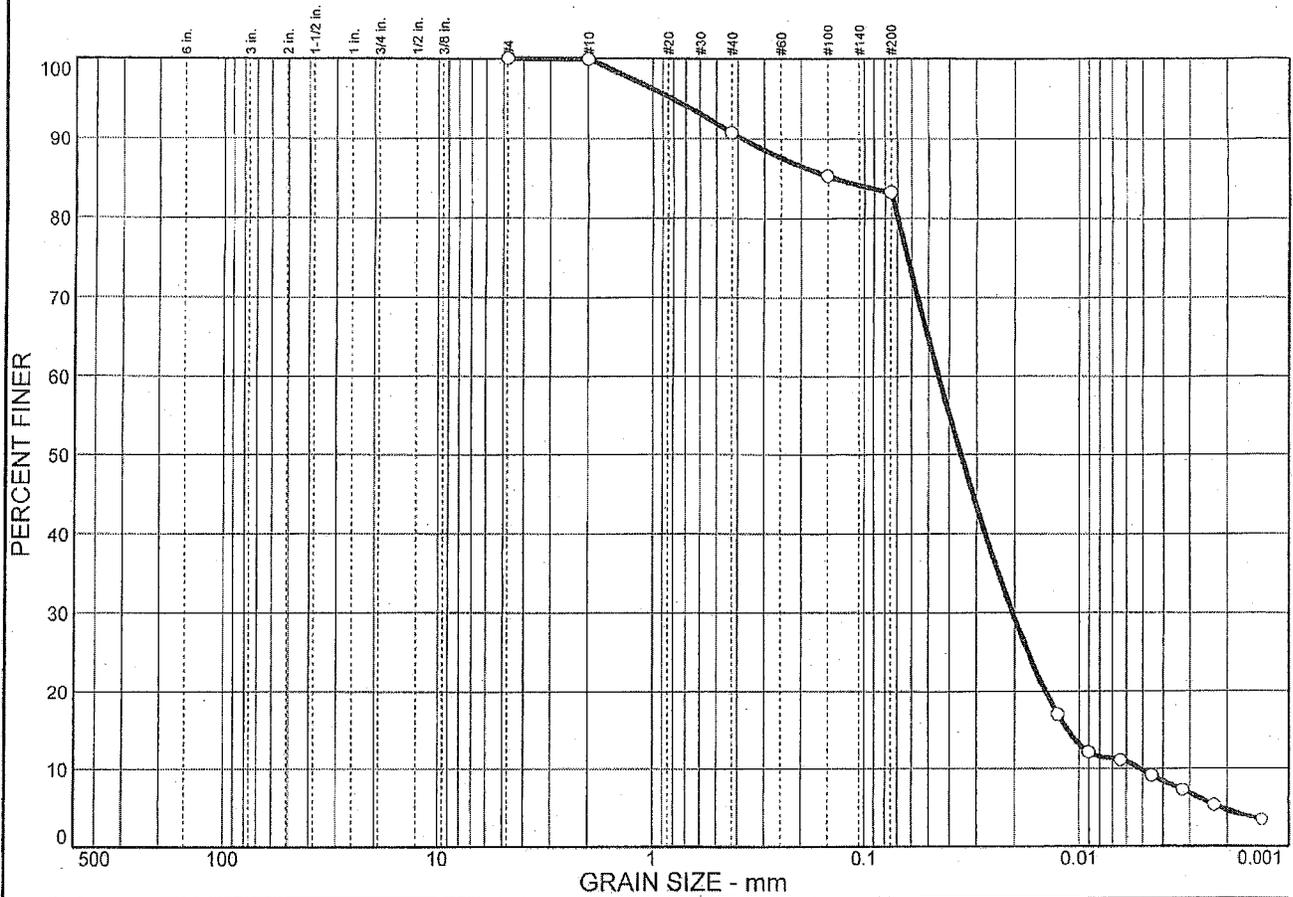
Particle Size Distribution Report

% COBBLES	% GRAVEL	% SAND	% SILT	% CLAY
0.0	0.0	16.7	73.6	9.7

SIEVE SIZE	PERCENT FINER	SPEC.* PERCENT	PASS? (X=NO)
#4	100.0		
#10	99.9		
#40	90.7		
#100	85.3		
#200	83.3

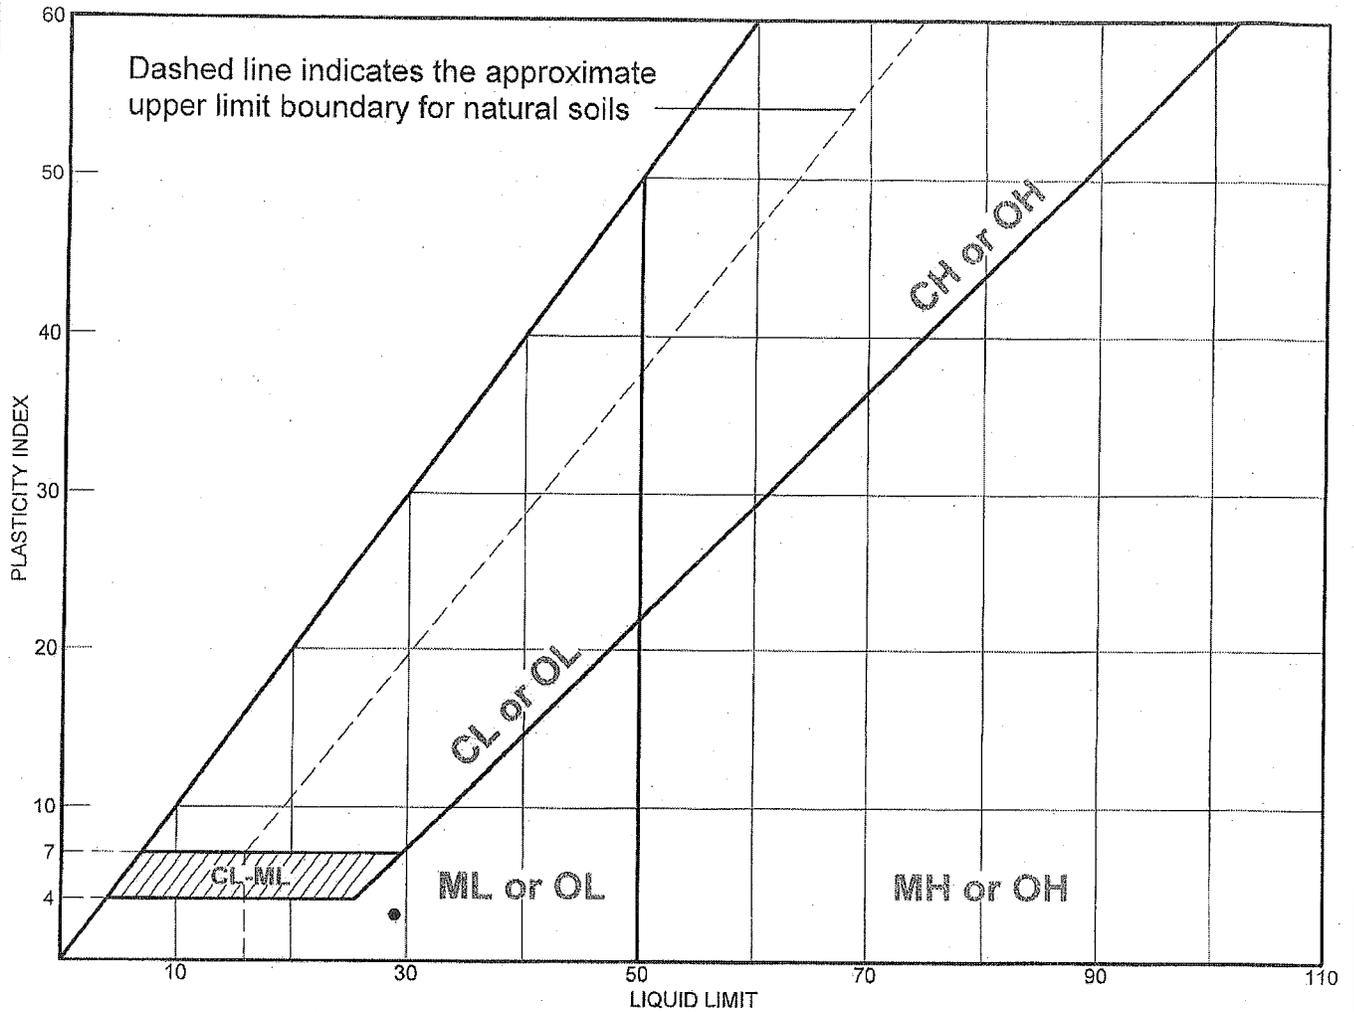
LIQUID AND PLASTIC LIMITS TEST REPORT

MATERIAL DESCRIPTION	LL	PL	PI	%<#40	%<#200	USCS
● Silt	29	26	3	96.3	95.1	ML

Project No. Client:
 Project:
 ● Location: B-3,S-7

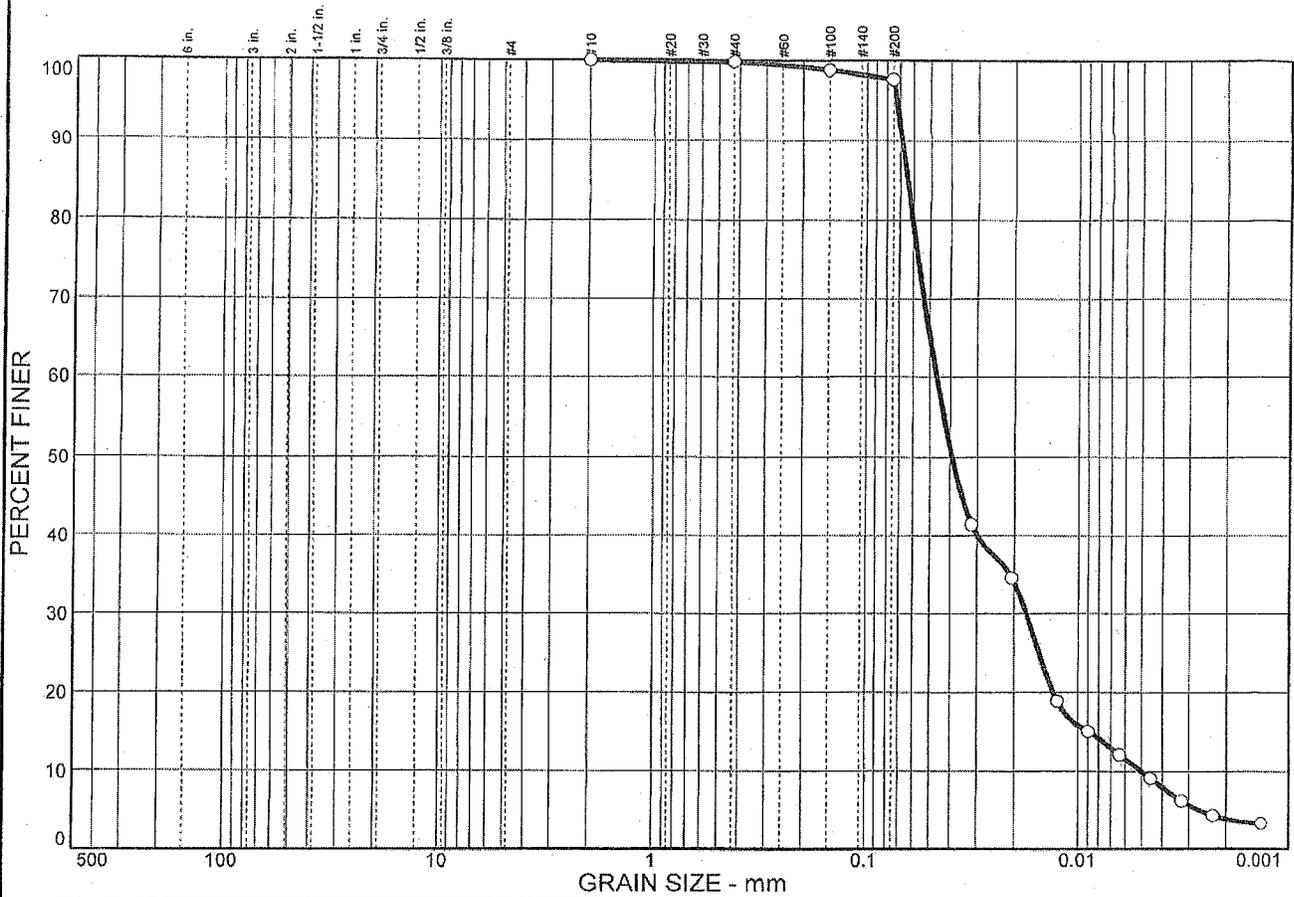
Particle Size Distribution Report

% COBBLES	% GRAVEL	% SAND	% SILT	% CLAY
0.0	0.0	2.4	87.7	9.9

SIEVE SIZE	PERCENT FINER	SPEC.* PERCENT	PASS? (X=NO)
#10	100.0		
#40	99.8		
#100	98.8		
#200	97.6
