NYSDOT Maintenance Facility Relocation & Redevelopment Feasibility Study

February 2016
Updated August 2016

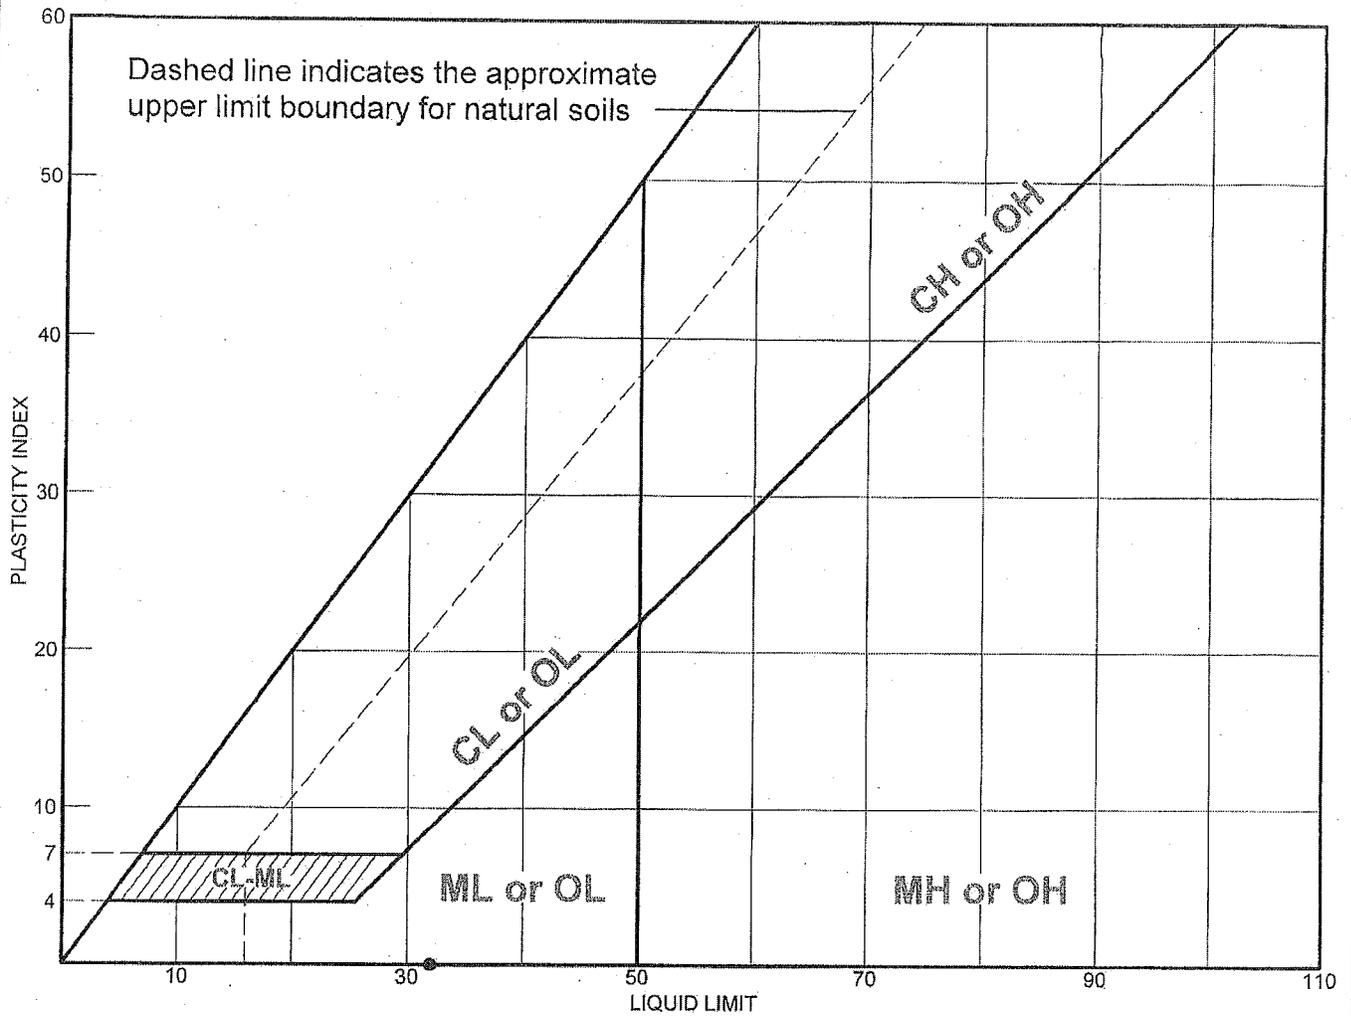
LIQUID AND PLASTIC LIMITS TEST REPORT

MATERIAL DESCRIPTION	LL	PL	PI	%<#40	%<#200	USCS
Silt	32		NP	99.8	97.6	ML

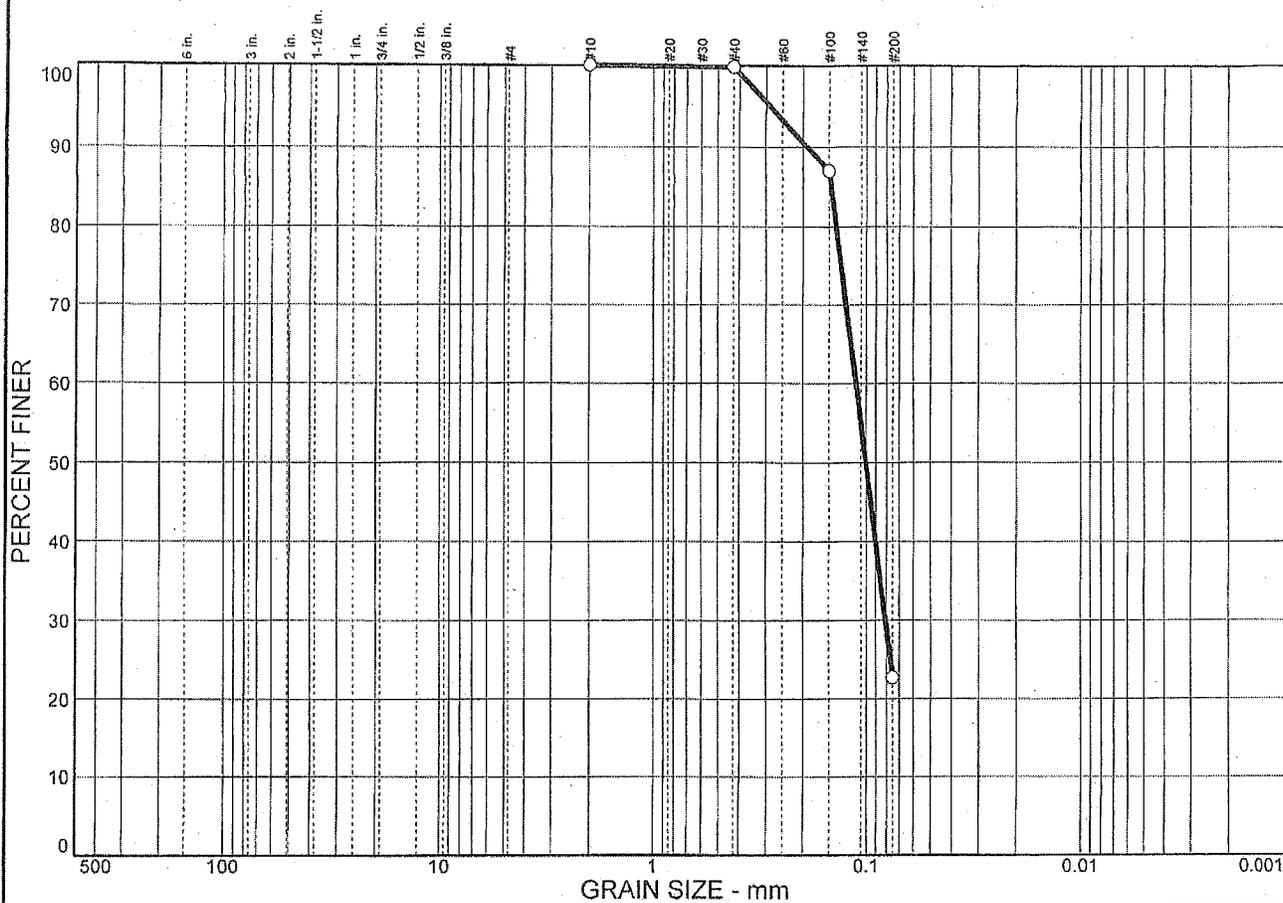
Particle Size Distribution Report

% COBBLES	% GRAVEL	% SAND	% SILT	% CLAY
0.0	0.0	77.3	22.7

SIEVE SIZE	PERCENT FINER	SPEC.* PERCENT	PASS? (X=NO)
#10	100.0		
#40	99.8		
#100	87.0		
#200	22.7

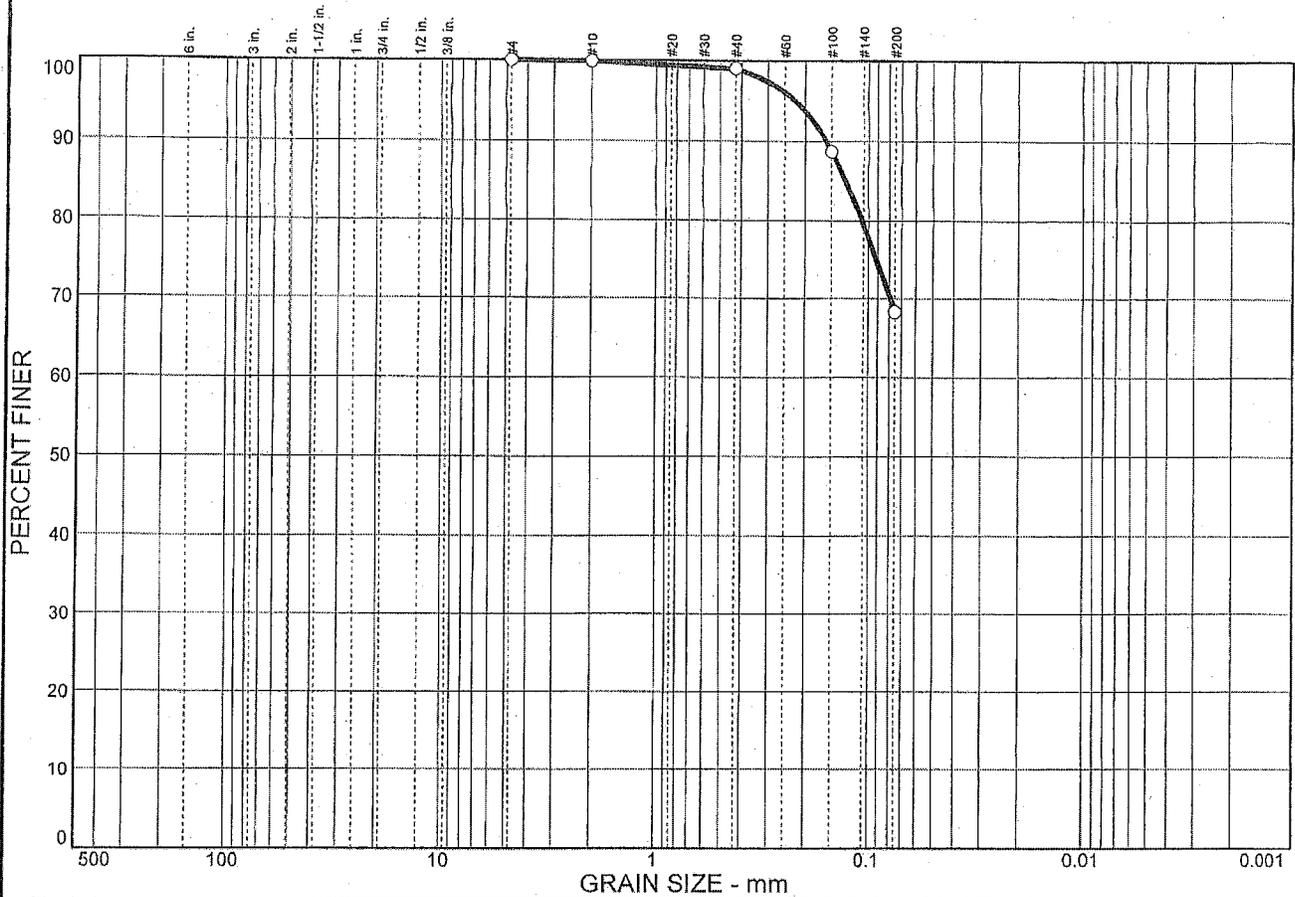
Particle Size Distribution Report

% COBBLES	% GRAVEL	% SAND	% SILT	% CLAY
0.0	0.0	31.7	68.3

SIEVE SIZE	PERCENT FINER	SPEC.* PERCENT	PASS? (X=NO)
#4	100.0		
#10	99.9		
#40	99.0		
#100	88.7		
#200	68.3

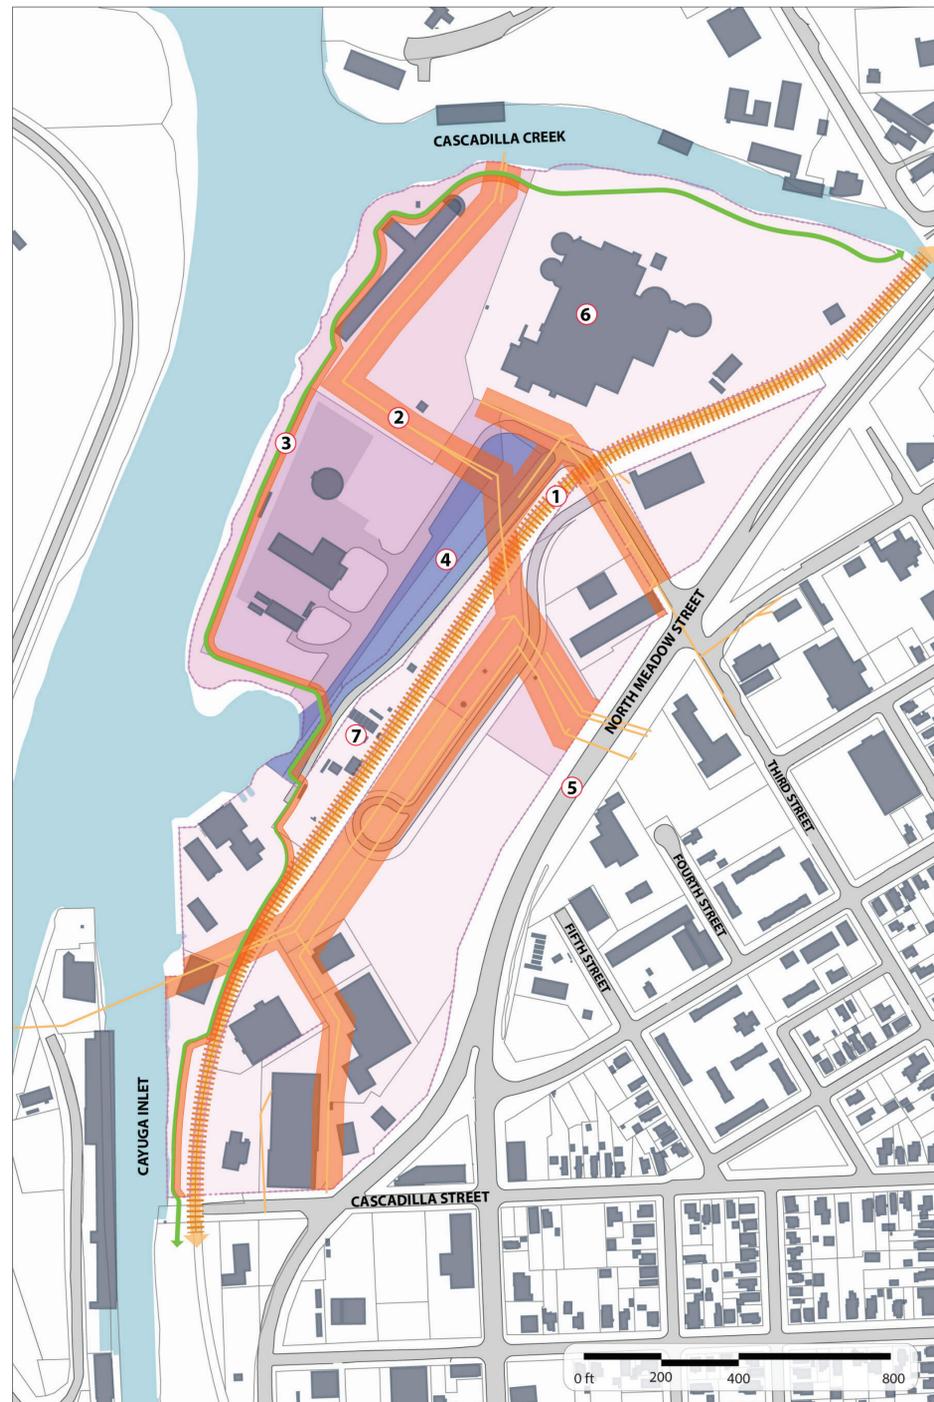
ISSUES & CONSTRAINTS DIAGRAM

- 1. RAILROAD TRACK
- 2. OVERHEAD POWER LINES & SETBACK REQUIREMENTS - BUILDING HEIGHT RESTRICTIONS
- 3. CAYUGA WATERFRONT TRAIL - 15' SETBACK REQUIREMENT
- 4. DRAINAGE WAY
- 5. ARTERIAL ROADWAY
- 6. SEWAGE TREATMENT PLANT
- 7. ANDREE PETROLEUM

- Limited access
- Railroad line and signalized crossing
- Overhead utility lines
- Undesirable adjacent land uses
- Poor soil conditions
- Isolation from adjacent neighborhoods, downtown and colleges

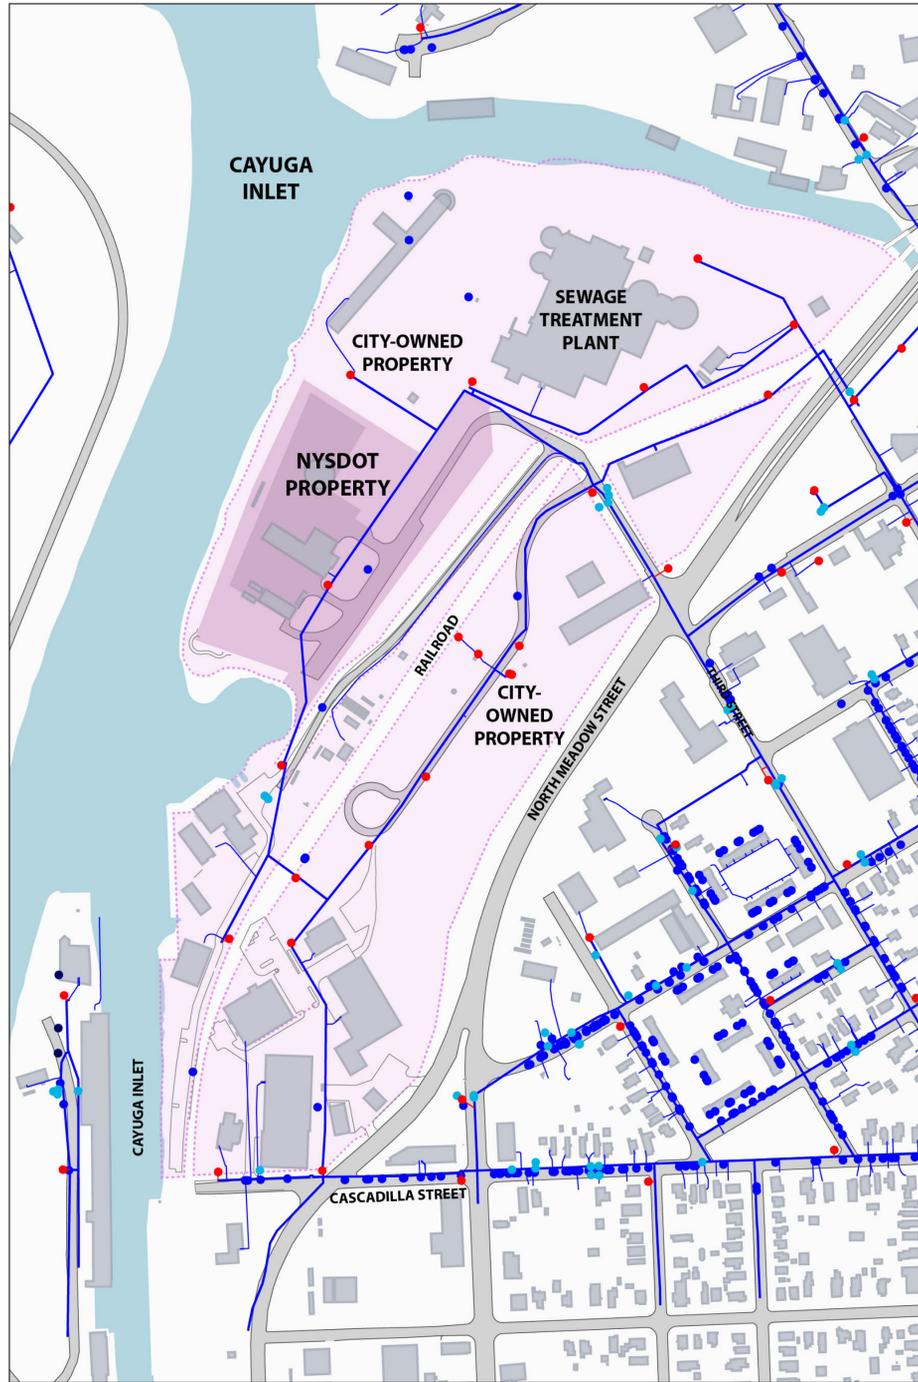
INFRASTRUCTURE - WATER

- Water Main Line
- Water Lateral Line
- Water WYE Main
- Abandoned Water WYE
- Stub Water Service Valve
- Hydrant Branch
- Hydrant

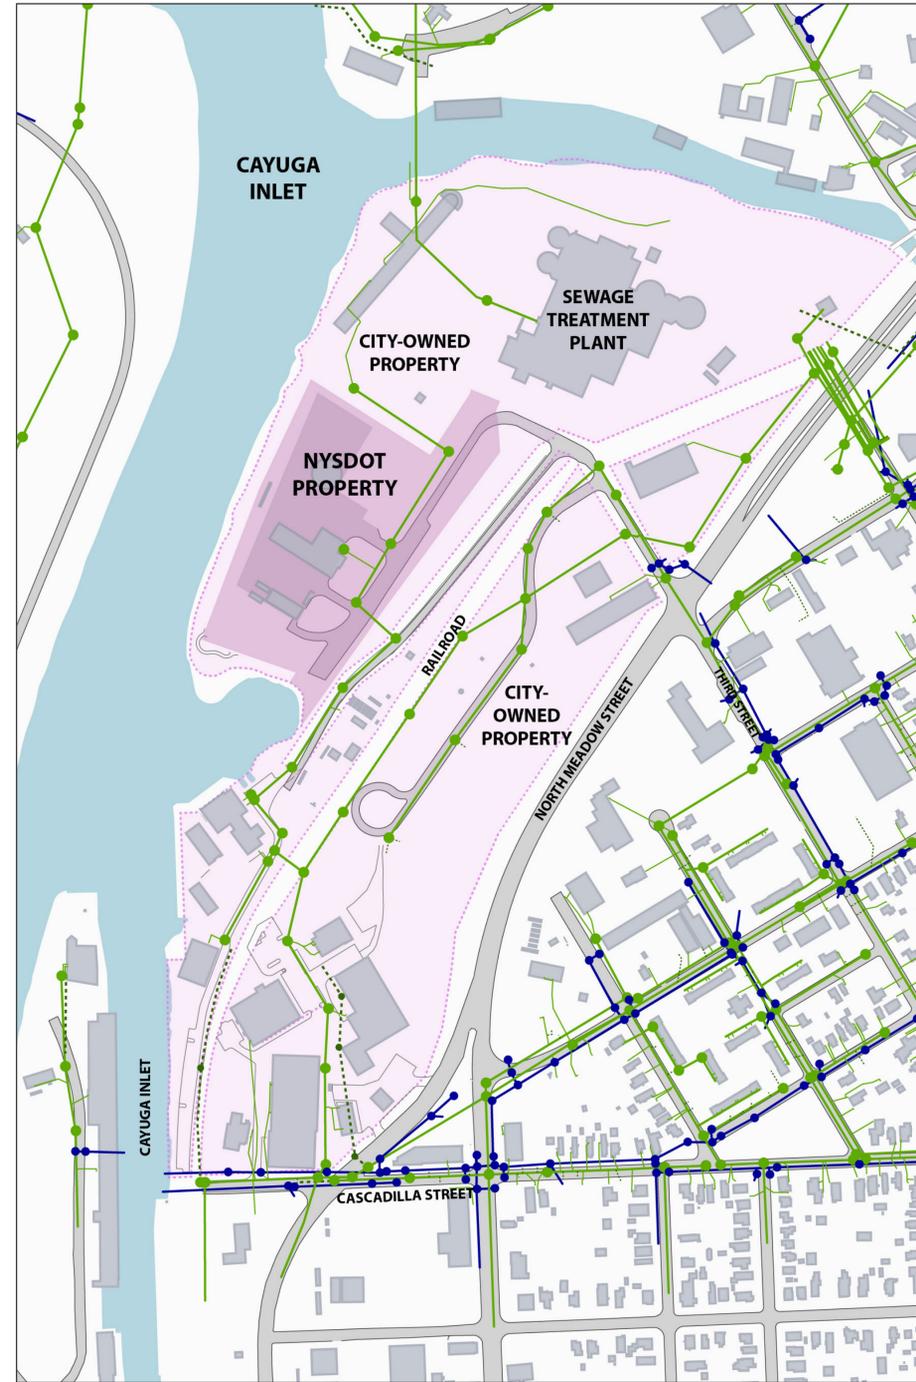
INFRASTRUCTURE - STORM AND SEWER

- Storm Pipe
- Storm Structure
- Sewer Main Line
- Sewer Lateral Line
- Sewer Manhole
- Abandoned Sewer Main Line
- Abandoned Sewer Lateral Line
- Abandoned Sewer Manhole

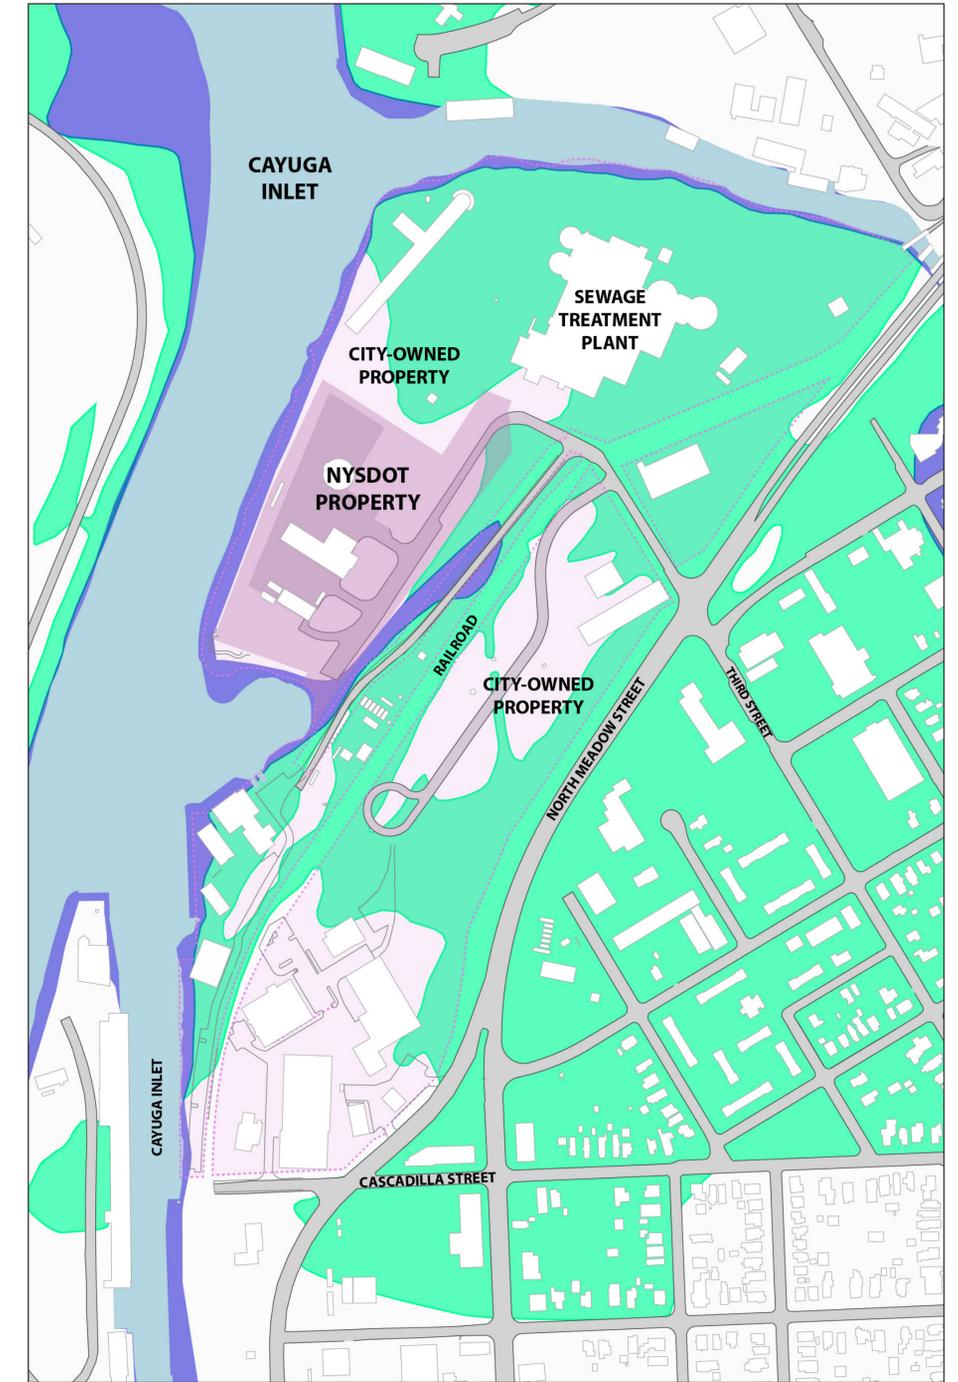
FEMA FLOOD ZONES

- Cayuga Inlet
- 100 Year Flood Zone
- 500 Year Flood Zone

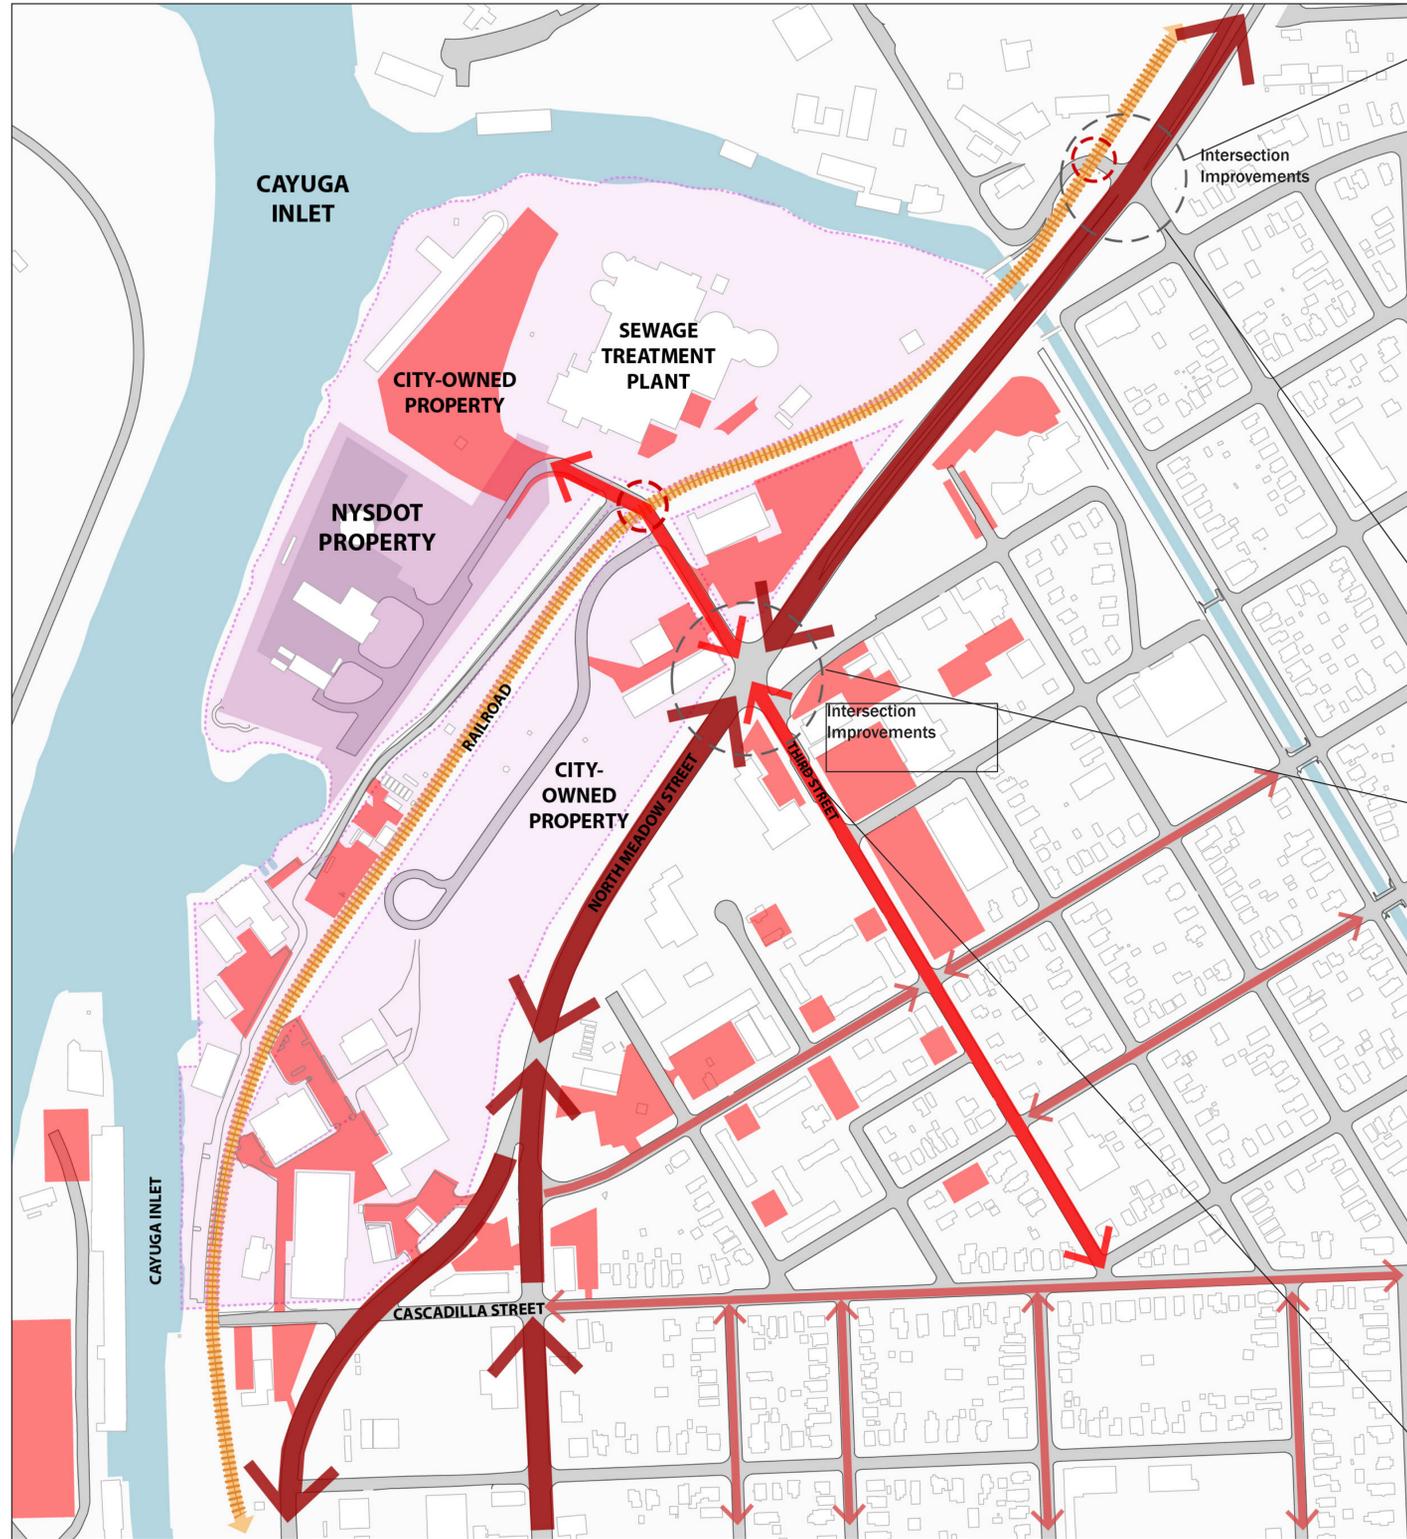
VEHICLE CIRCULATION AND VOLUMES

- KEY
- █ High Traffic Volumes
 - █ Medium Traffic Volumes
 - █ Low Traffic Volumes
 - Rail Crossing
 - Parking Lot
