# Tompkins County Walkability Assessment Methodology and Case Studies

September 24, 2007

- *Northeast Ithaca*
- *The Village of Trumansburg*

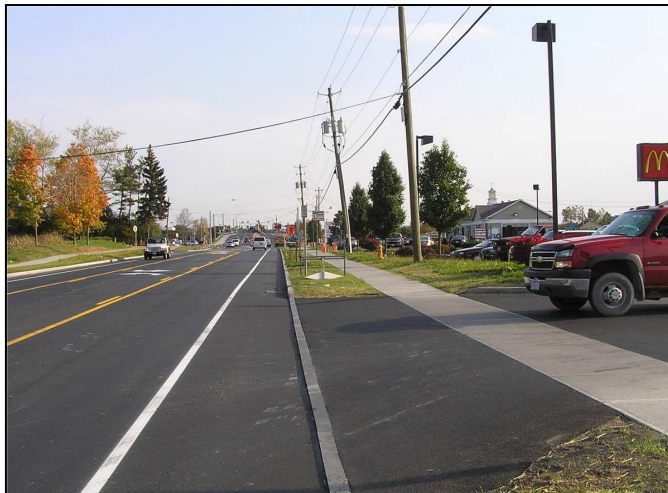
**Recently Improved Driveway and Sidewalk  
Along Arterial Street**

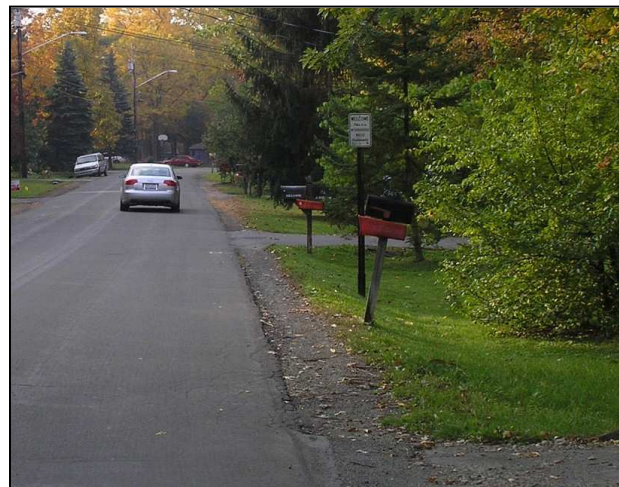
**Washed Out Shoulder Along Collector Road In Northeast Ithaca**

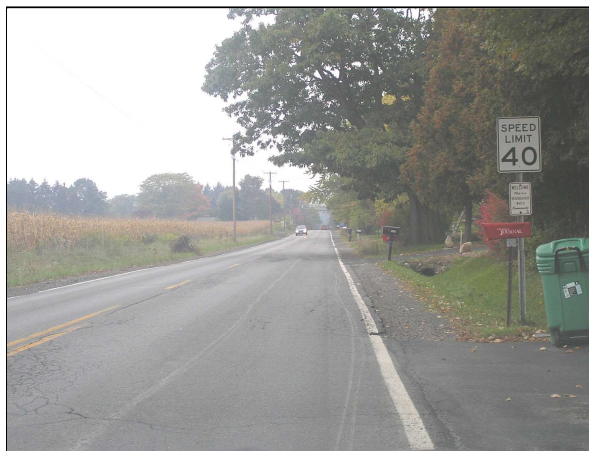
- **Hanshaw Road** is a two-lane roadway with generally gravel shoulders about 4' in width. The concerns for this roadway are excessive vehicular speed, no sidewalk, and a perception that this is an unsafe route for students walking to school.

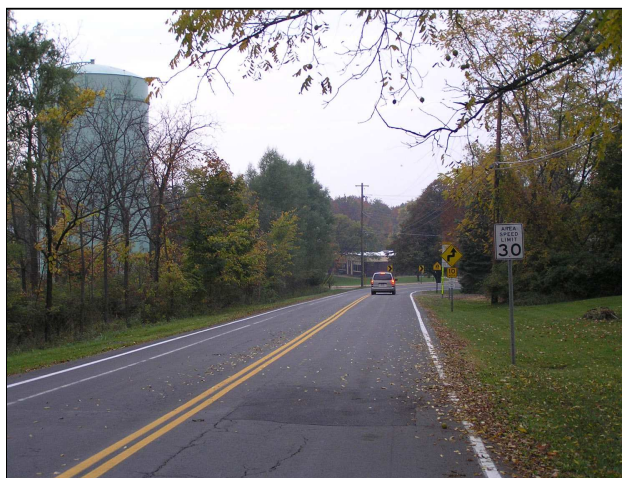
**East End of Winthrop Drive**

- **Winthrop Drive** is an east–west running two lane street that links Triphammer Road to Warren Road and passes along the north and east edge of Northeast Elementary School. Currently, a sidewalk exists along Winthrop from Triphammer to the northwest corner of the school property on the south side of the road. Where the sidewalk does exist, the crossing distance for pedestrians at intersecting roadways is very long, up to 60' in length, because the radii at the intersections are very large. Not only does the

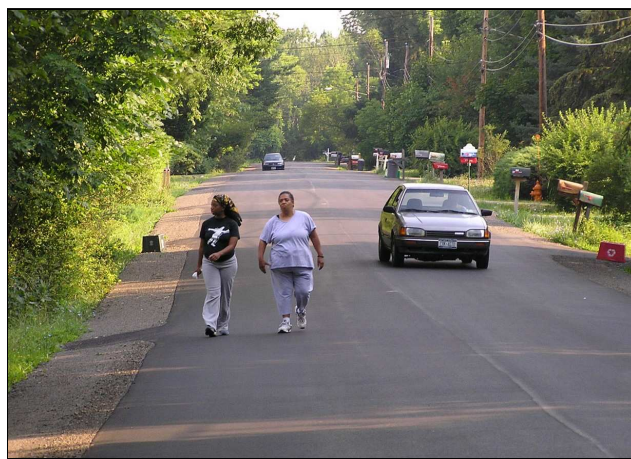
- **Muriel Street** is a north–south residential street that was improved in 2006 with new asphalt overlay and 3' gravel shoulder. The concerns are that vehicles travel at excessive speeds, the shoulders are not easily traversable and some plantings and brush interfere with sight distances and need to be cut back along the side of the road.

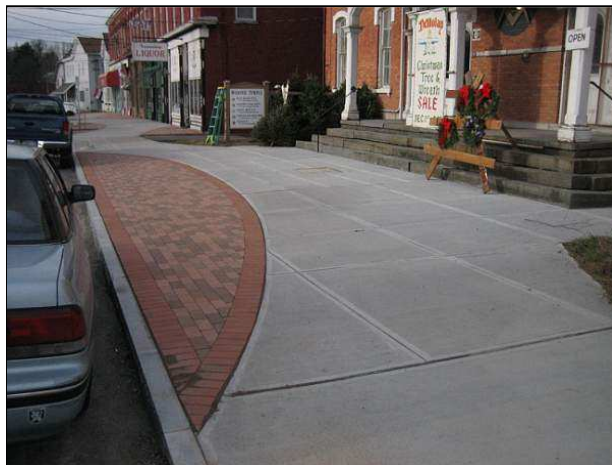
**Main Street Sidewalk Improvement**

Community members have been working together for more that ten years around the Main Street Project, which has the goal of redesigning and rebuilding Main Street. The Project includes new sidewalks and pedestrian amenities in the Village center. During the past year, much of the Main Street Project has been constructed and the vision of Village residents has largely come to fruition. With the momentum and experience gained from successfully implementing the Main Street Project, the Village is now looking ahead to other projects that will encourage walking and improve walking conditions in and around the Village. (See Map 2 on next page)

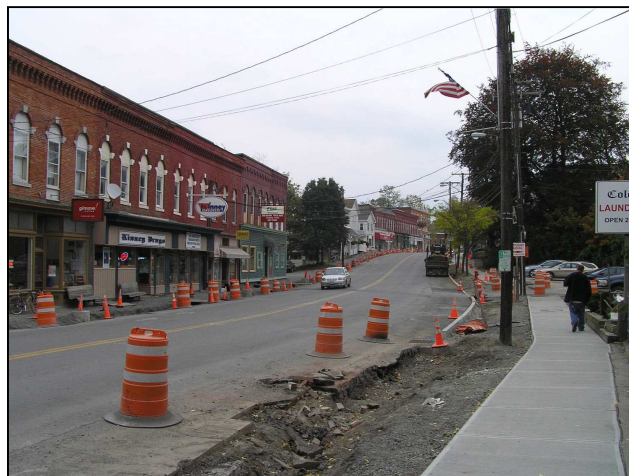
- The Village of Trumansburg's Main Street Project, after many years of planning, fundraising, and design, was constructed during the summer and fall of 2006. The project includes the installation of new curbs, sidewalks, benches and furnishings, and street trees and plantings in the Village center, all designed to improve traffic flow, increase main street vitality, and enhance pedestrian safety and comfort, and create a sense of place. Outside of the Village center toward the southeast, the project includes a sidewalk linkage between the Village center, the school complex and the fairgrounds. Also new sidewalk was added northwest of the Village center to the intersection of Hector Street.

**Main Street Under Construction**

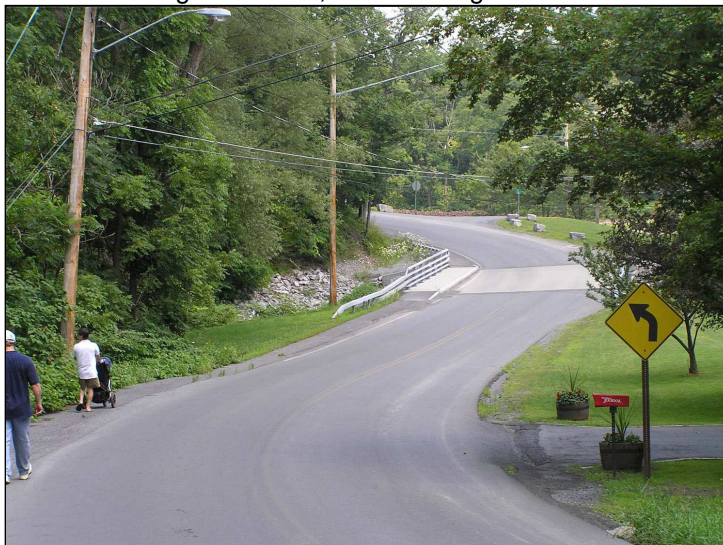
**Walking Along King Street**

Members of the steering committee and the project team also spent one afternoon walking many of the streets and slate sidewalks to observe the field conditions of the neighborhoods within the study area. This provided additional insight to the concerns and information discussed in the first meeting.

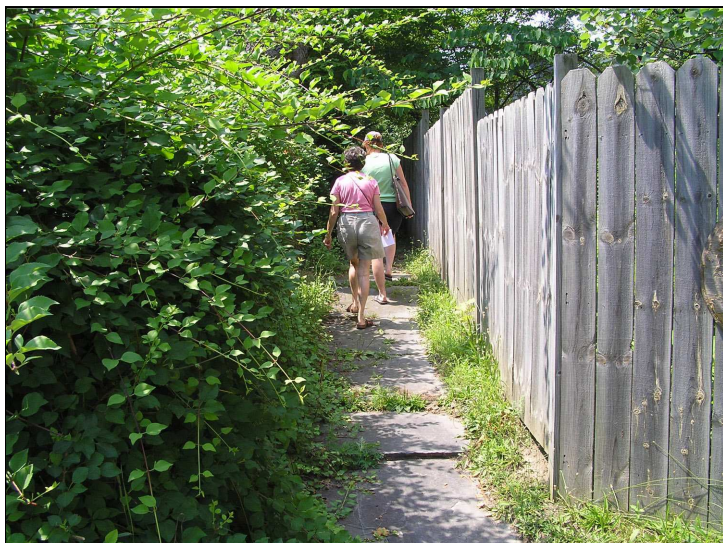
➤ Trumansburg had a well developed network of slate sidewalks in the late 19<sup>th</sup> and early 20<sup>th</sup> century that has deteriorated in quality and function during the past 50 years. The sidewalks consist of locally quarried 5' wide flagstone slabs separated from the road by an 8 – 10' grass tree lawn with street trees. In years past, the walks were continuous, crossing driveways and traversing from property to property. Over time the integrity and continuity of the walks have been compromised through differential settlement, cracking and flaking, removal at driveway crossings and vegetation encroachment. Some residents have erected fences and hedges at their property lines, breaking the continuity completely. While some residents are comfortable walking on the smooth road pavement, many would prefer not having to walk on Village streets with children in strollers or on scooters.

**Brush Overgrowth between Street and Sidewalk**

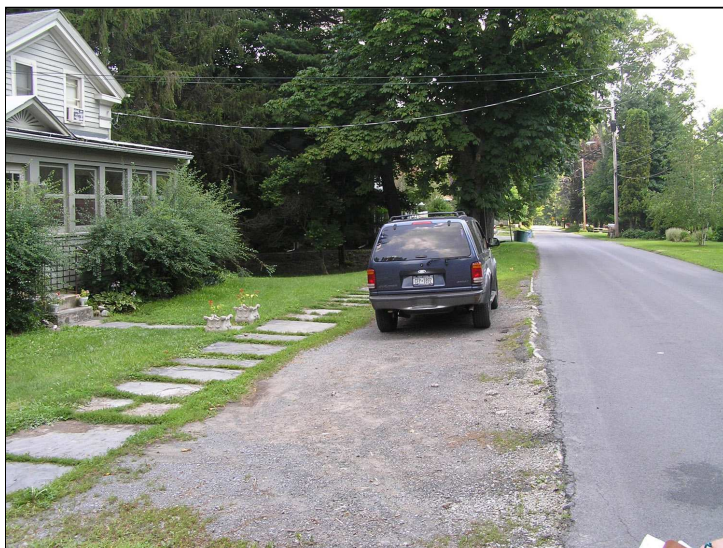
During the field visits with the steering committee and the workshop, many people were observed using the street instead of the sidewalk due to the sidewalk condition. During other site visits, by the consultants school age children were also observed using the street instead of the sidewalk. We can assume that during the winter months, given the condition of the some of the sidewalks, clearing the sidewalks for pedestrians is a difficult task.

**Non-Standard Parking Arrangement**

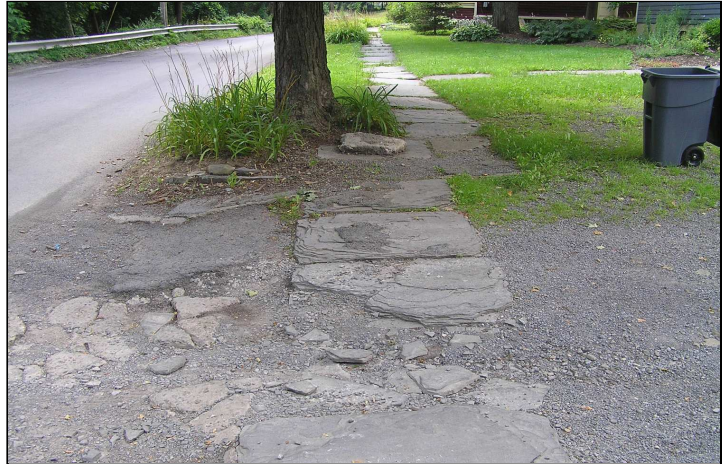
**Example of Sidewalk in Deteriorated Condition**
