APPENDIX A
PLANS, PROFILES & TYPICAL SECTIONS

FOREST HOME DRIVE OVER FALL CREEK

B.I.N. 3047450

In-Depth Inspection Report

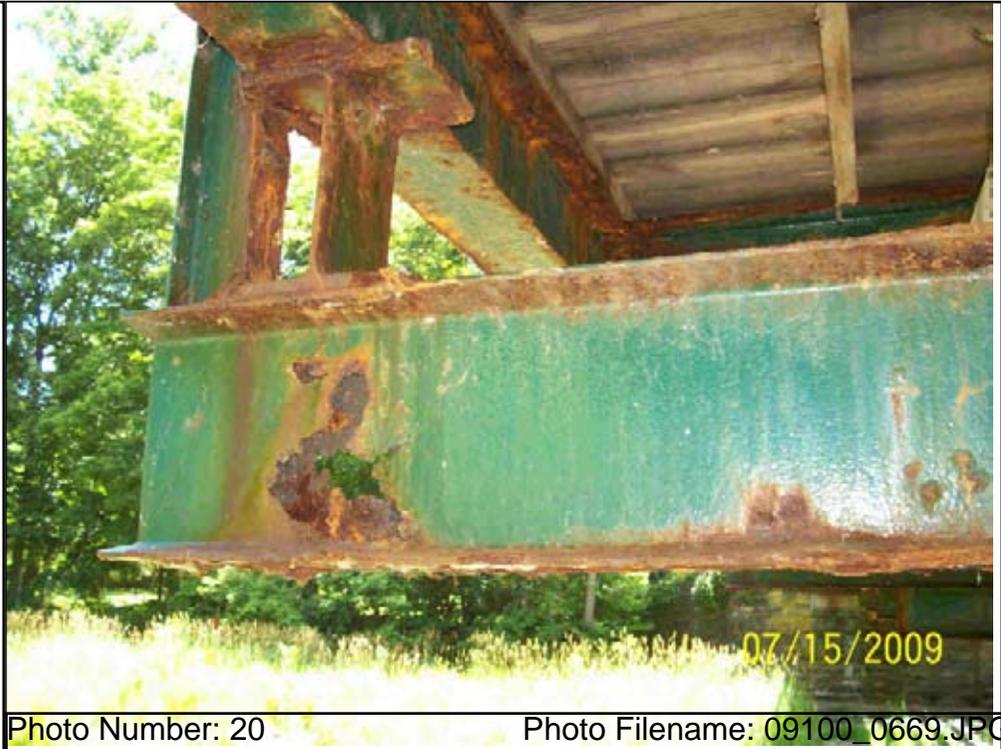
Photo Number: 20

Floorbeam #6 - begin and end channels each have a hole. End is worse, measuring approx 3 inches wide x 7 inches high. (Photo 20). At all of these locations, holes are directly below the right fascia sidewalk stringer (about 8 inches from the right side of the cantilever), reducing the bearing capacity of the cantilever. Safety flag #3X090012 (repeat flag) for this condition due to potential sidewalk failure.

Floorbeam #6, right side,
end channel

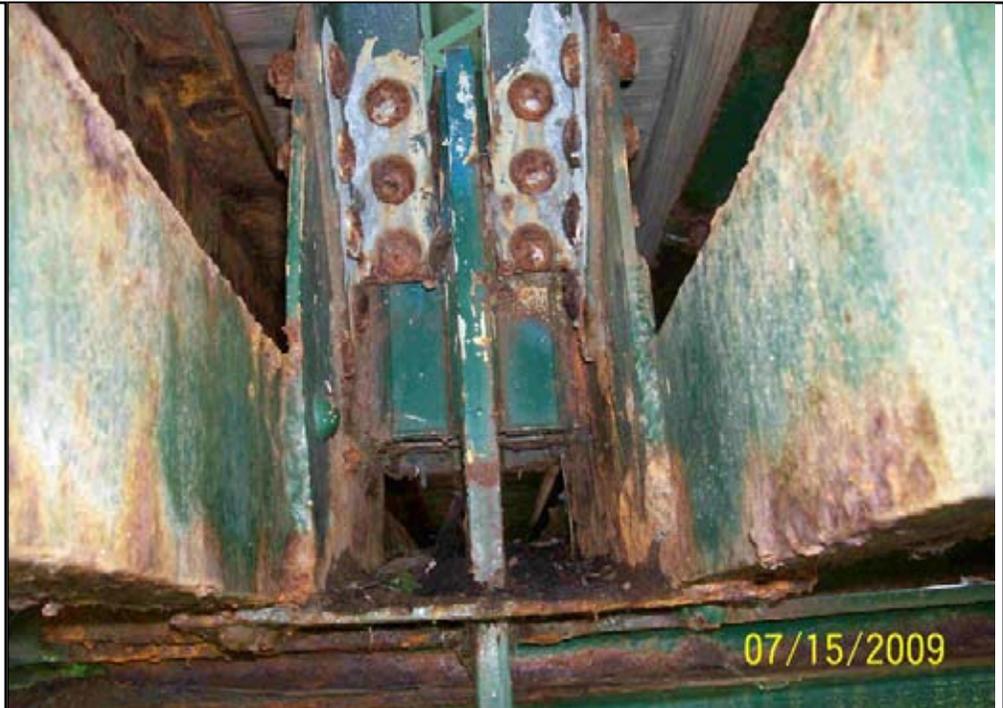
Photo Number: 23

L-1, right truss - No repair plates. Both plates have section losses along the lower portion of their inner faces (right side of left plate and left side of right plate) for entire length X about 7 inches high X 30% loss. (Photo 23).

Right truss, gusset plate
at L1

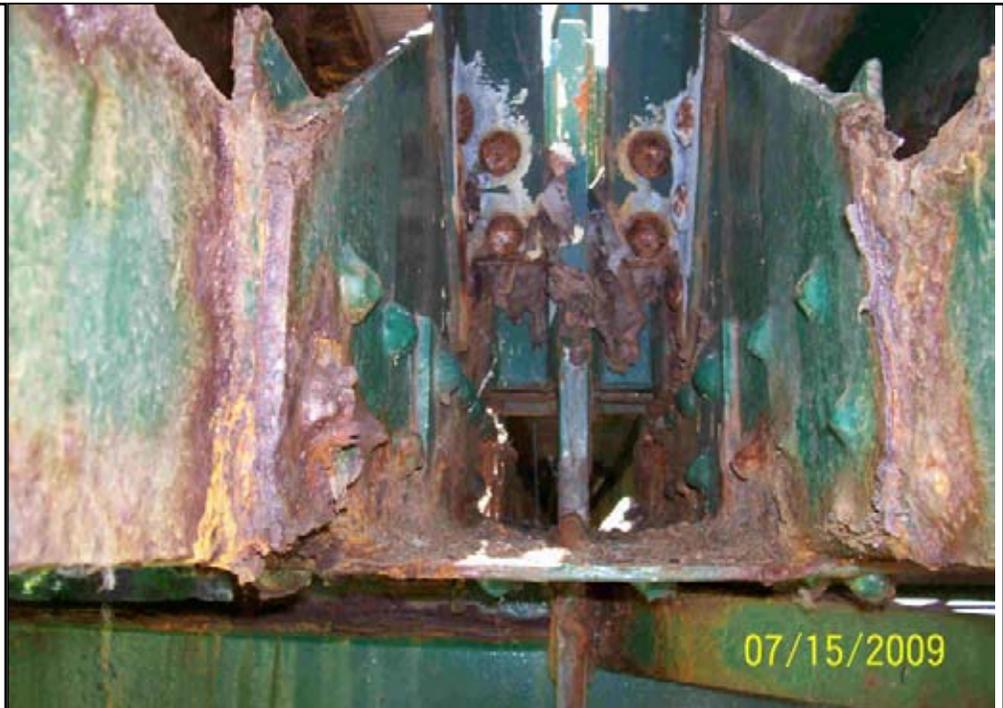
Photo Number: 24

L-2, right truss - Both plates have had small repair plates welded to their outer faces (left side of left plate and right side of right plate) above the truss lower chords, for various lengths and heights. Left gusset plate has minimal section loss, but right gusset plate has section loss along the lower portion of its inner face (left side) for entire length X about 7 inches high X 25% loss. (Photo 24).

Right truss, gusset
plates at L2

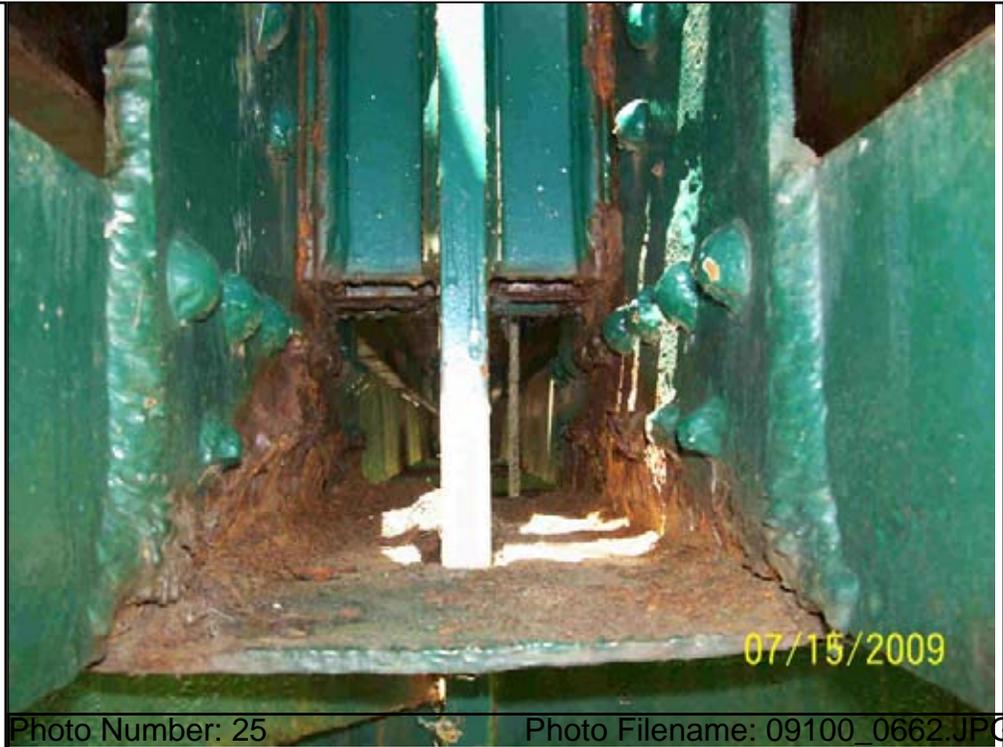
Photo Number: 25

L-3, right truss - Both gusset plates have had small repair plates welded to their outer faces (left side of left plate and right side of right plate) above the truss lower chords, for various lengths and heights. Both gusset plates have section losses up to an estimated 30%. (Photo 25).

Right truss, gusset
plates at L3

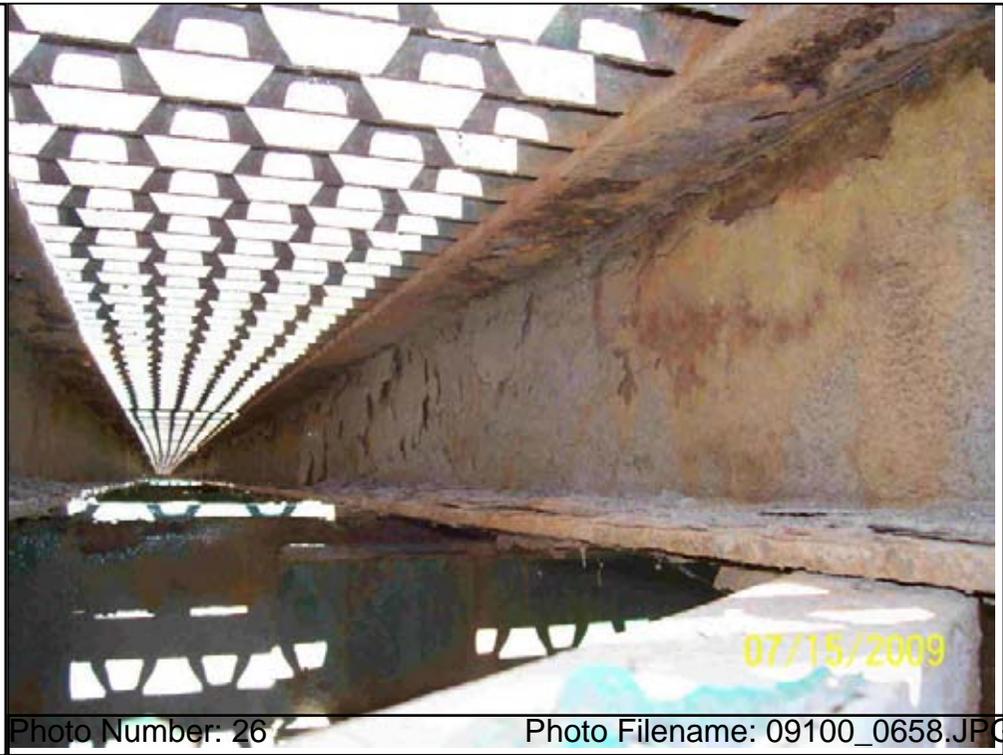
Photo Number: 26

Stringers - are peeling paint along their entire length, resulting in surface corrosion. Estimated stringer section loss is approximately 5 to 10% overall. (Photo 26).

Stringer # S-7, panel #1

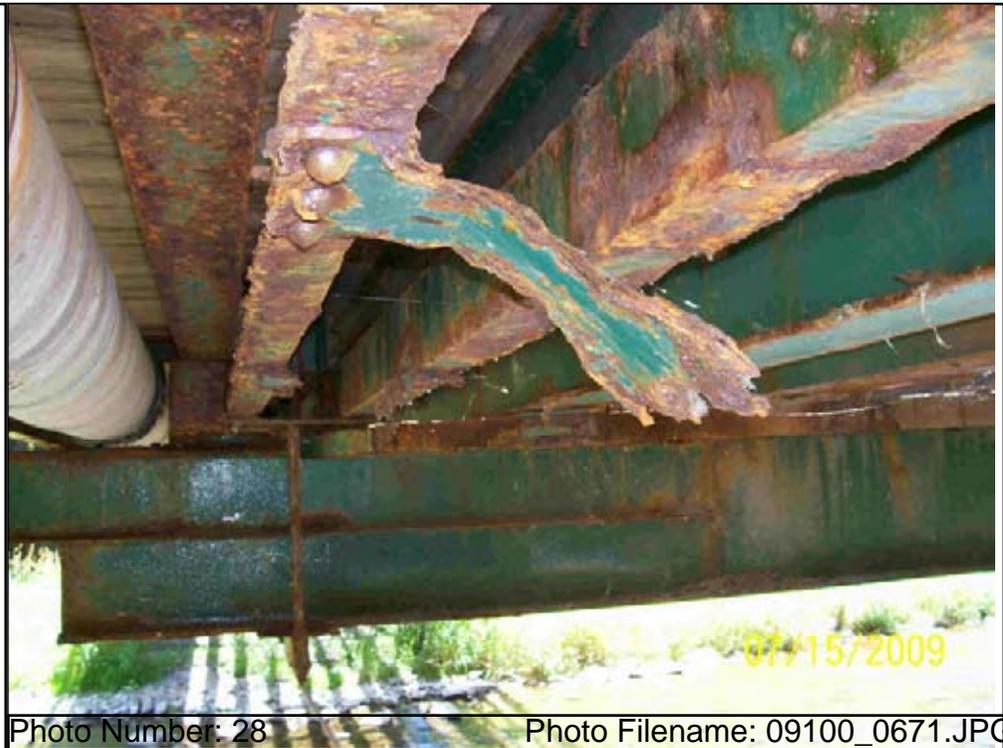
Photo Number: 28

Span 001 -- Superstructure: Secondary Members -- Rated 3, Was 3
Referenced Photos: "27", "28", "29", "30", "31", "32", "33"
2009 - At both trusses, several tie plates for the lower chord are rusted through and/or bending away from lower chord channels due to pack rust. (Photo 27). The begin and end panels (L0-L1 and L6-L7) are worst (Photo 29). Some of the plates on the right truss L6-L7 are missing rivets and completely separated from the lower chord due to pack rust (Photo 28).

Right truss, L6-L7 near
end

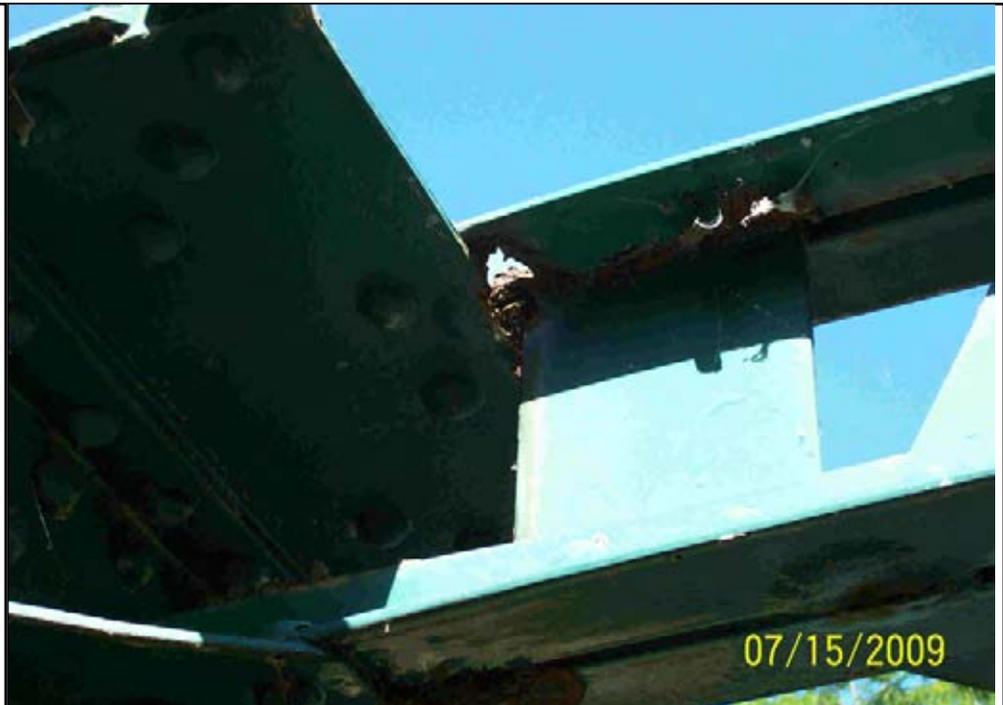
Photo Number: 30

All of the upper lateral struts and cross bracing have pack rust and crevice corrosion with section loss underway at all truss connections, and some of these members have lost up to 1/2 the width of an angle leg. Several of the struts have small holes in the horizontal leg of their angles, where they tie into the connection plates. The holes are as follows;

Top lateral strut at U-3,
left side

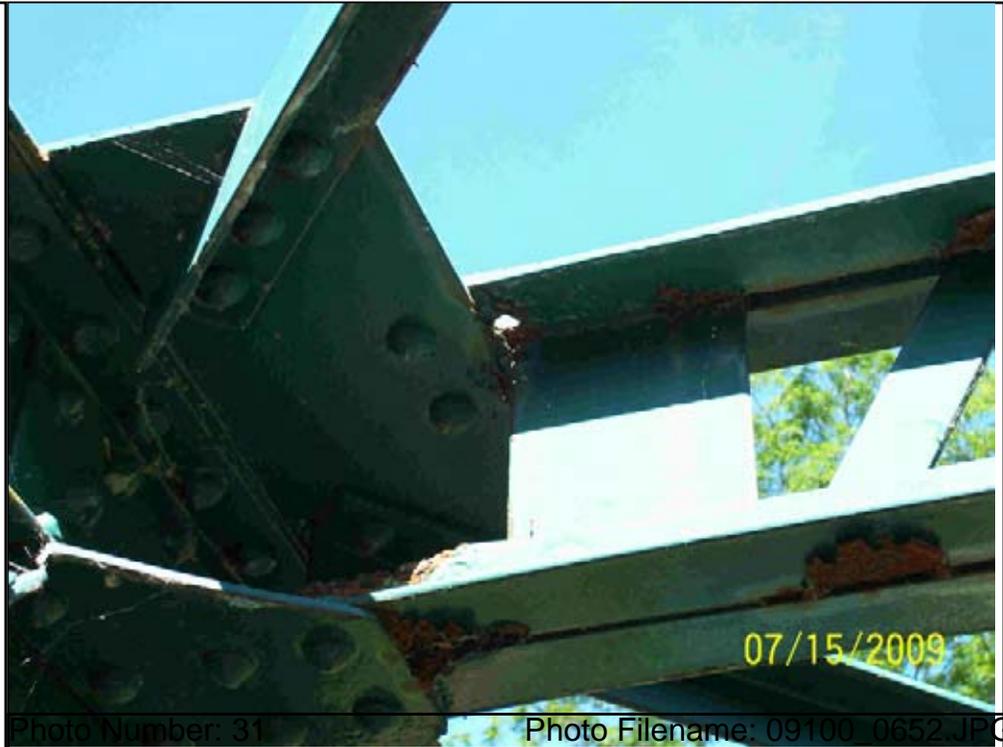
Photo Number: 31

Top lateral strut at U-4,
left side

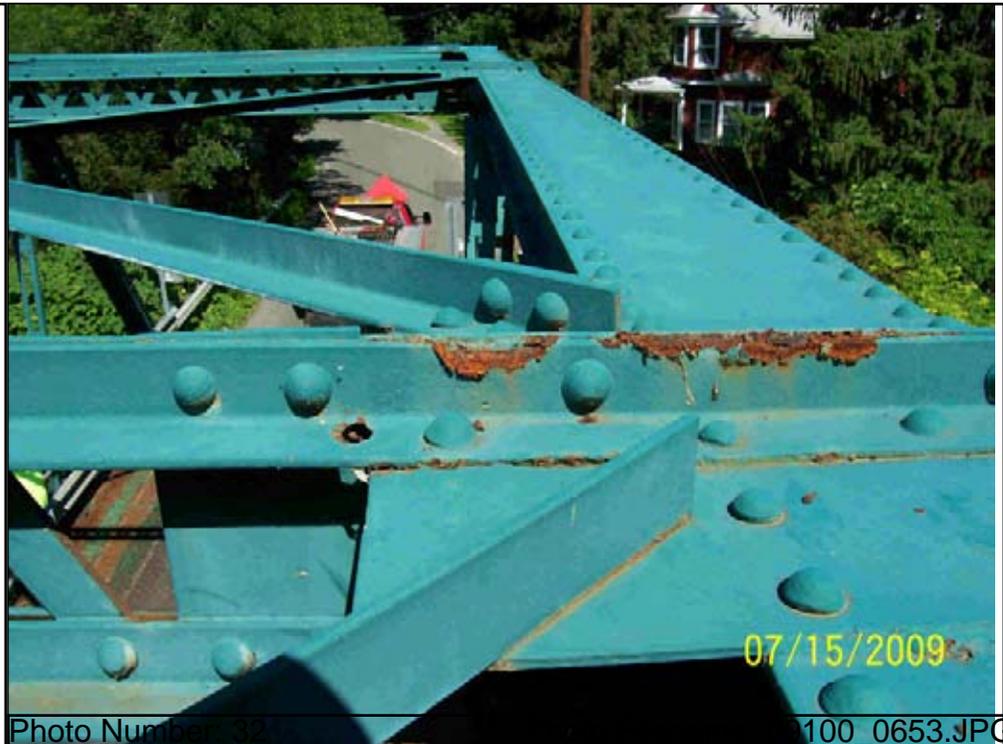
Photo Number: 32

Top lateral strut at U-4,
right side

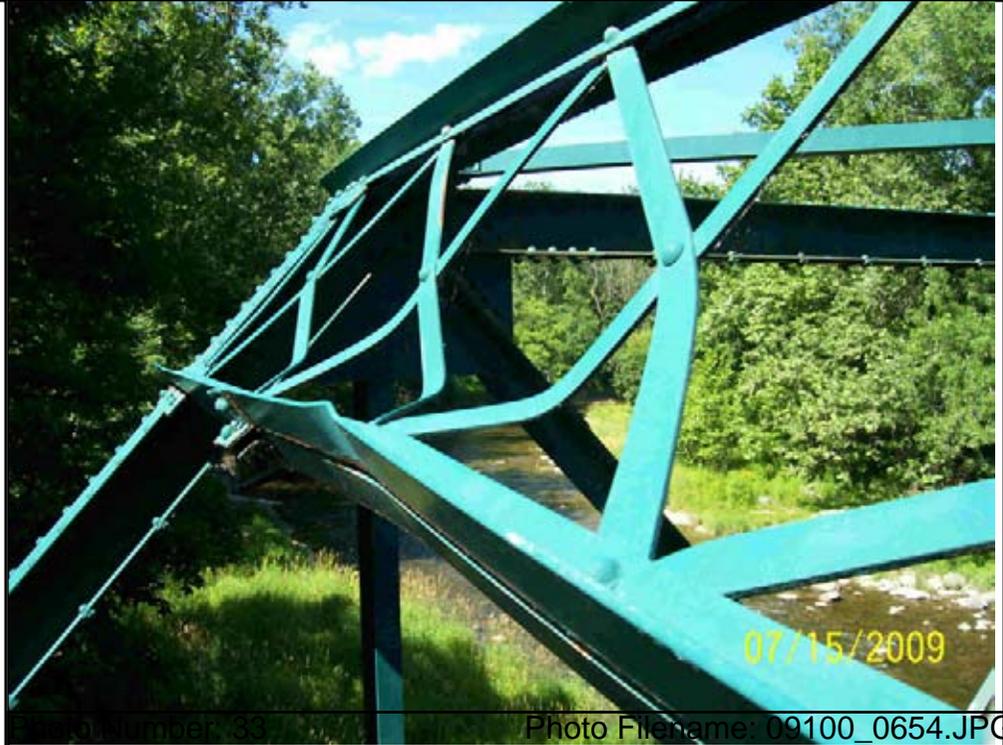
The begin portal bracing has impact damage to its lower chord and lacing bars (Photo 33)..

Begin portal

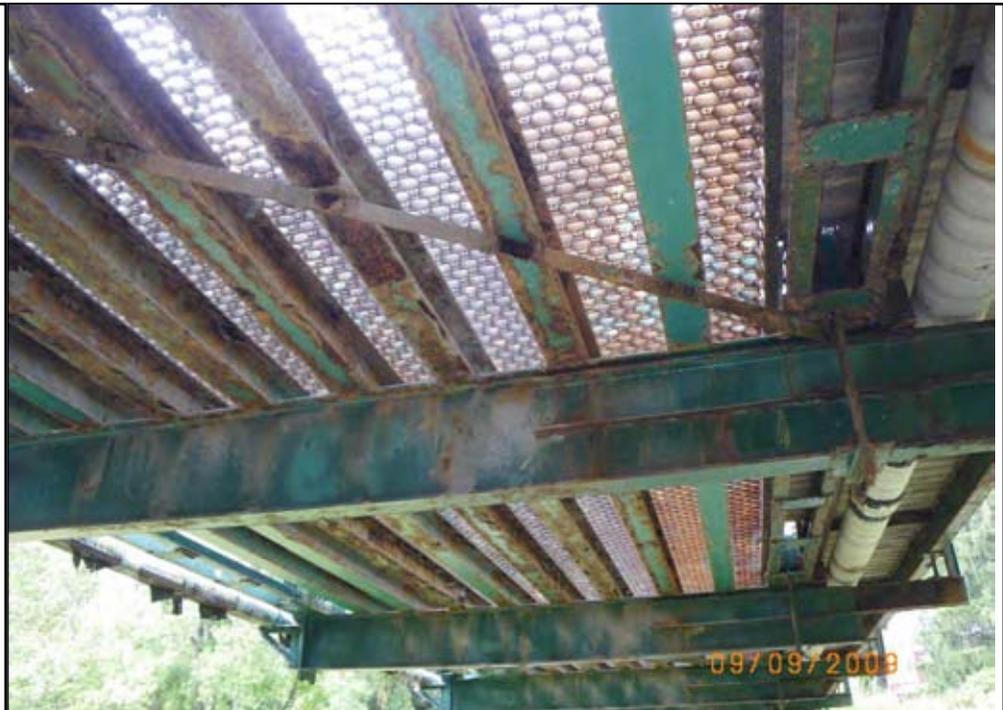
Photo Number: 34

Span 001 -- Superstructure: Paint -- Rated 2, Was 2
Referenced Photos: "34", "35"
2009 - Paint over the below-deck portion of the superstructure is peeling away from the stringers, and peeling or missing from lower member connection points, resulting in surface rust, pack rust, and section losses in several locations. (Photo 34).

Underside of
superstructure

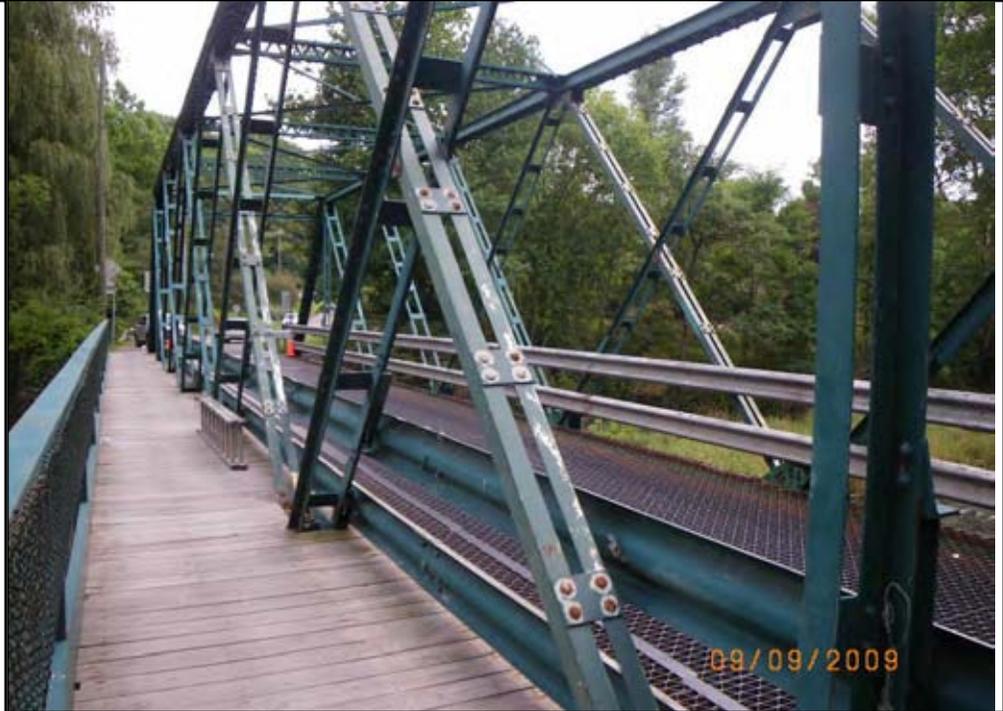
Photo Number: 35

Above deck portion would rate '4', with paint peeling from about 20% of area and rusting on rivet heads and lower part of truss verticals and diagonals. (Photo 35).

Superstructure above
deck

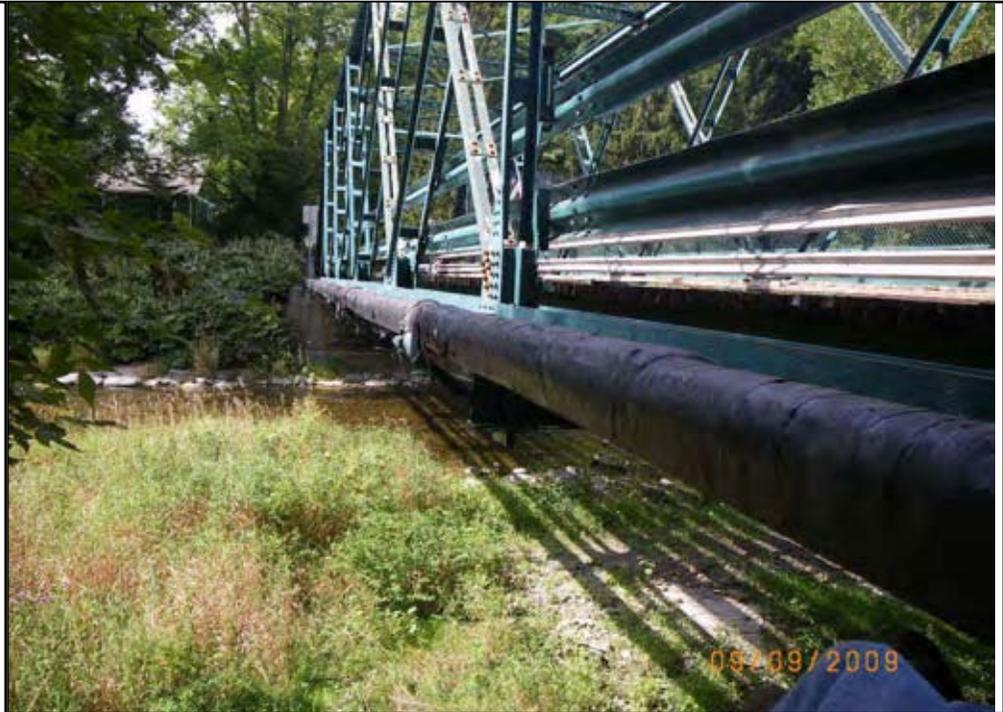
Photo Number: 36

Span 001 -- Utilities: Utilities and Support -- Rated 4, Was 4
Referenced Photos: "36"
2009 - Left side utility has its pipe insulation torn in several locations. Hangers for all the utilities are rusting with minor section loss.

Utility at left fascia

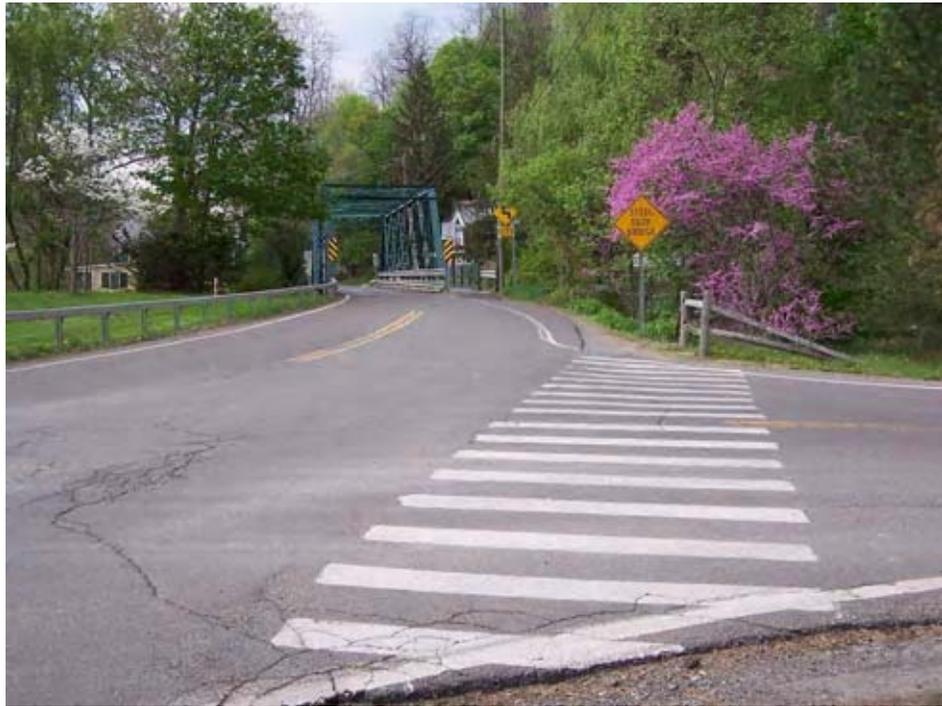
Description:
Begin Approach

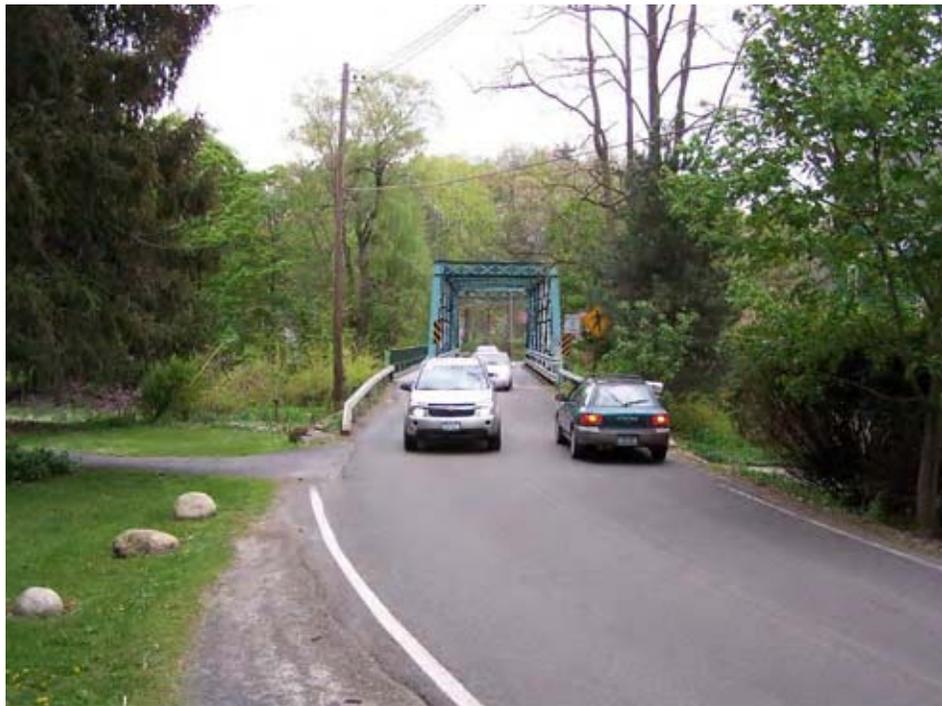
PHOTO NO. 2

Description:
End Approach

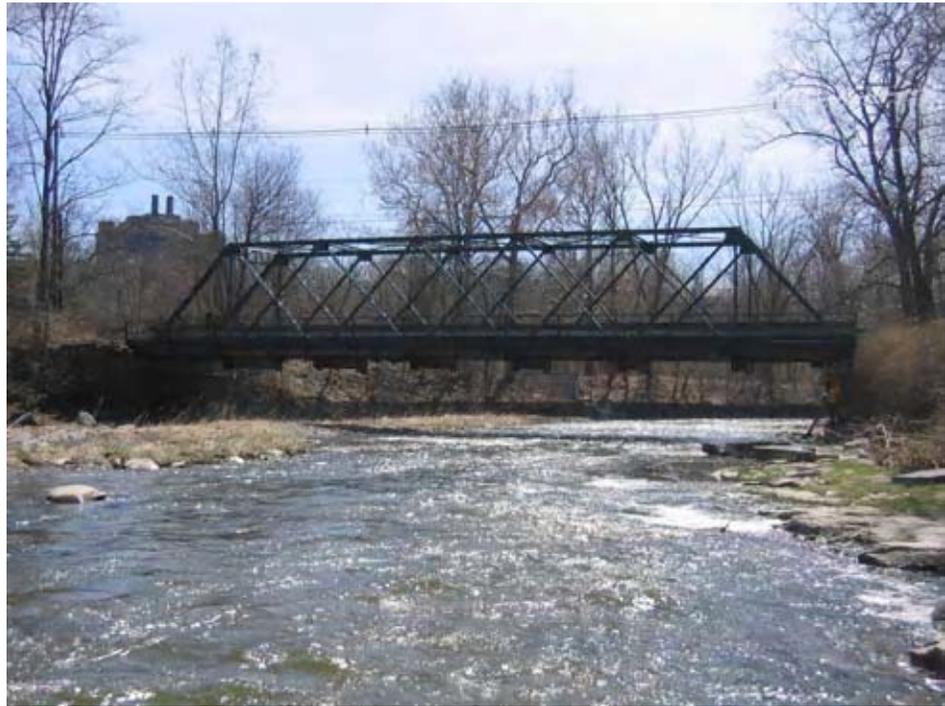
Description:
Upstream elevation
of bridge (looking
downstream).

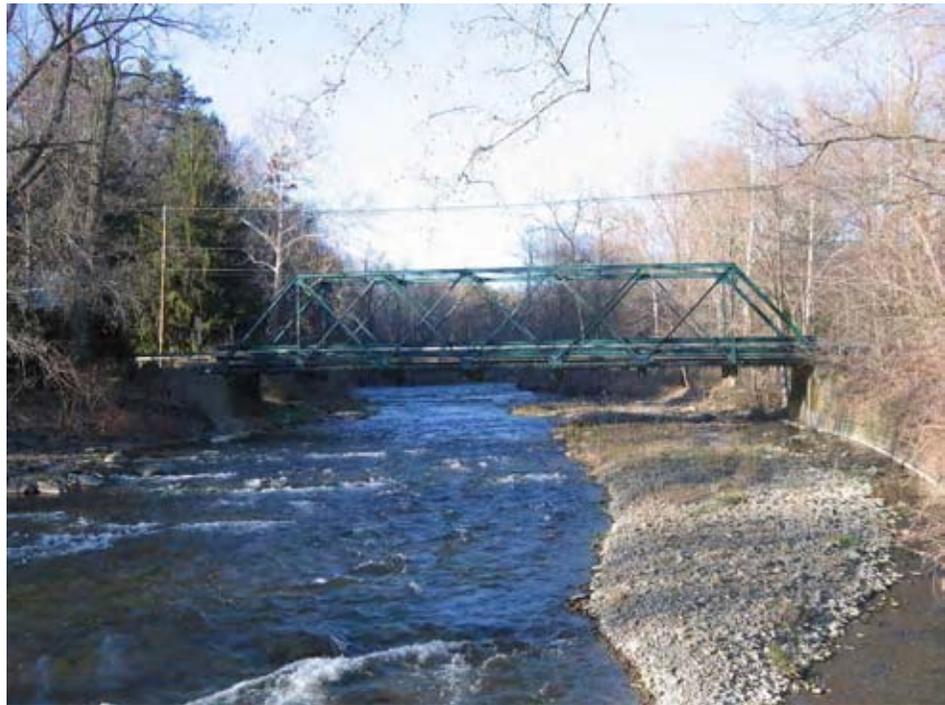
PHOTO NO. 4

Description:
Downstream
elevation of bridge
(looking upstream).

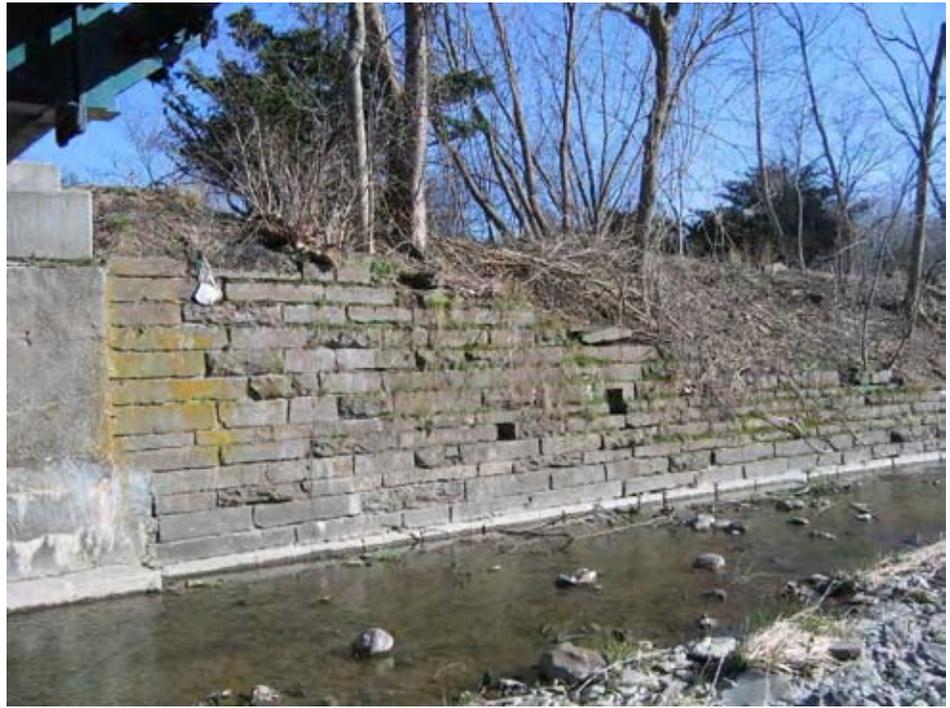
The downstream wingwall at the Begin Abutment merges with a retaining wall along the channel bank that extends far downstream. The upstream stone masonry wingwall at the Begin Abutment has cracks through stones and mortar throughout and a pile of loose stones at the end of the wall.

Description:
Downstream wingwall/retaining wall at Begin Abutment.

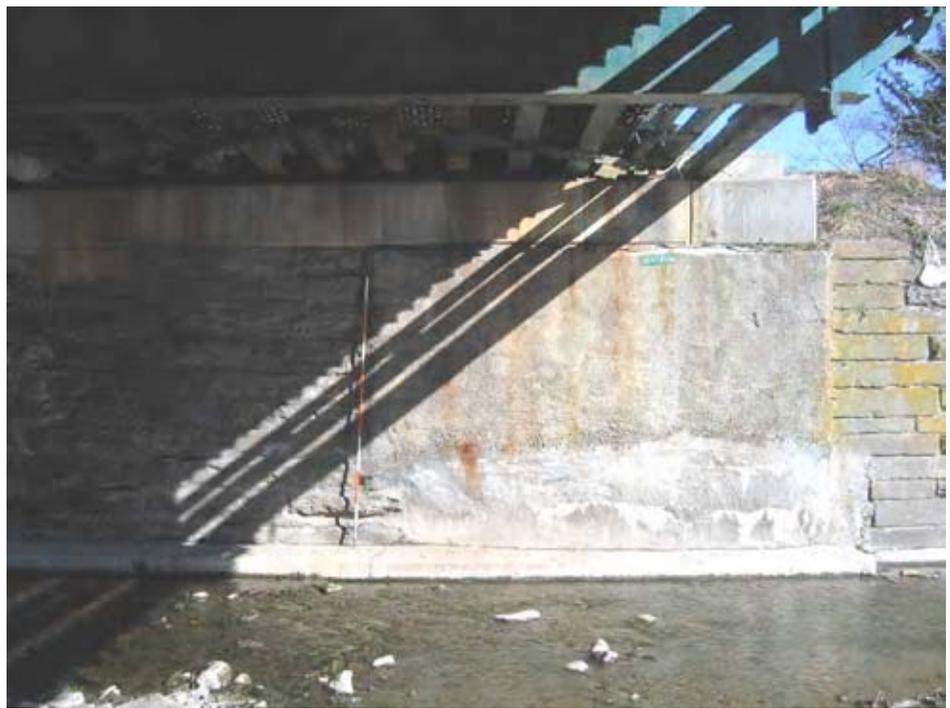
PHOTO NO. 8

Description:
Begin Abutment Stem – 50% of stone masonry abutment is covered with shotcrete.

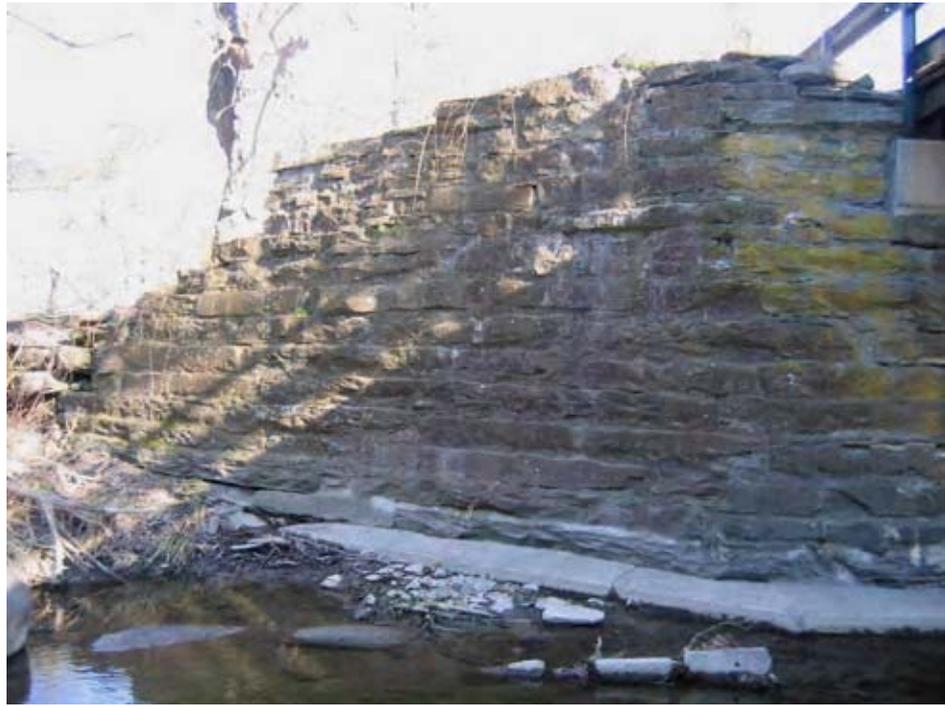
Description:
Upstream wingwall at Begin Abutment.

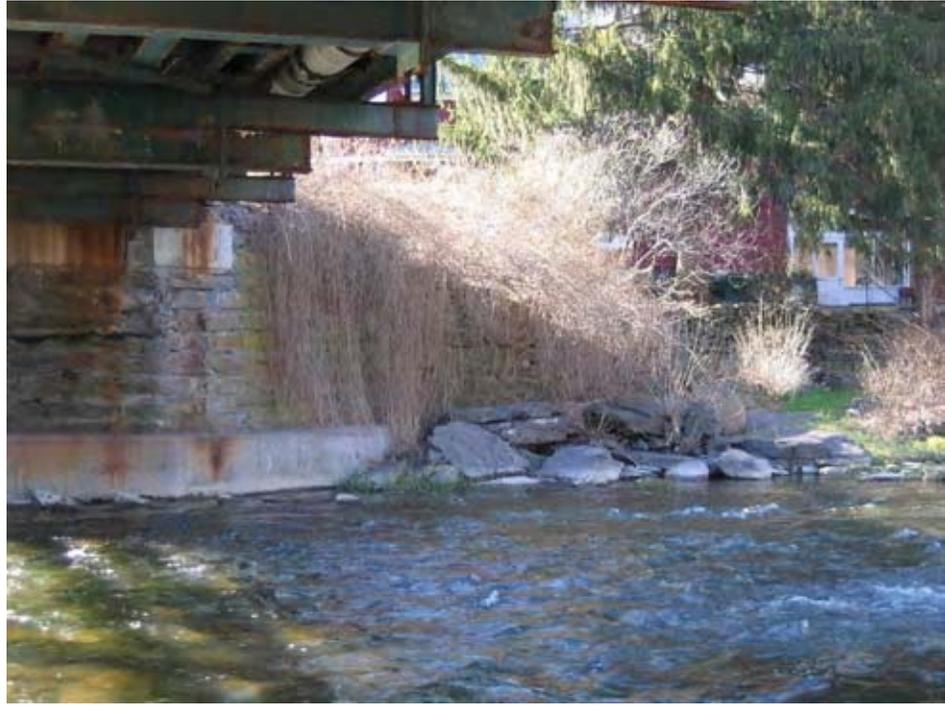
PHOTO NO. 10

The downstream U-wing at the End Abutment is covered with shotcrete. The upstream stone masonry wingwall at the End Abutment has cracks through stones and mortar with areas of missing stones and mortar loss.

Description:
Upstream wingwall at End Abutment.

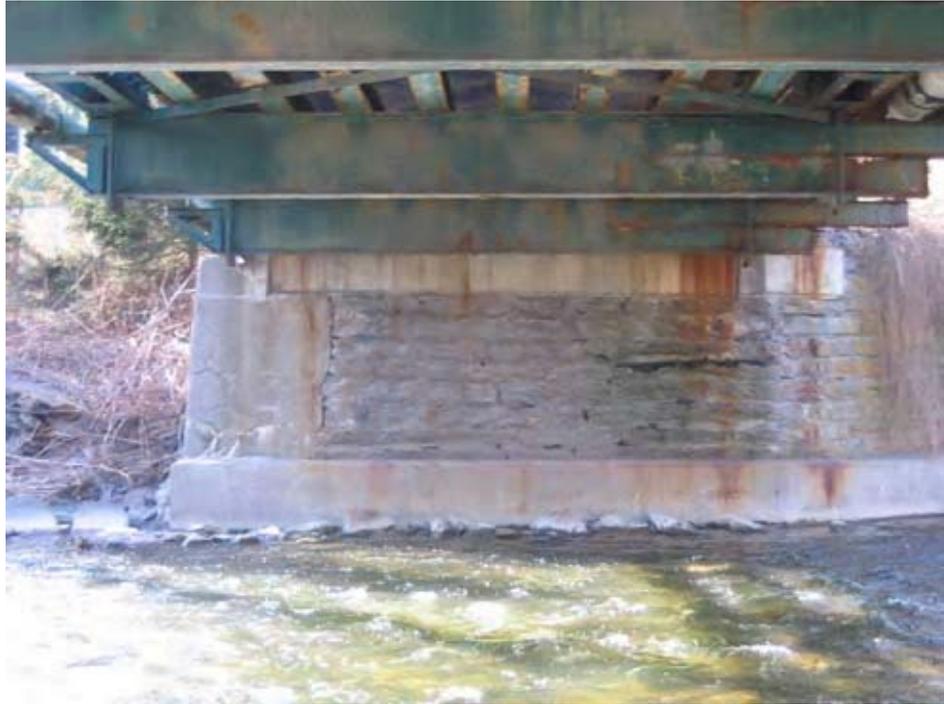
Description:
End Abutment Stem – 20% of stone masonry abutment stem is covered with shotcrete.

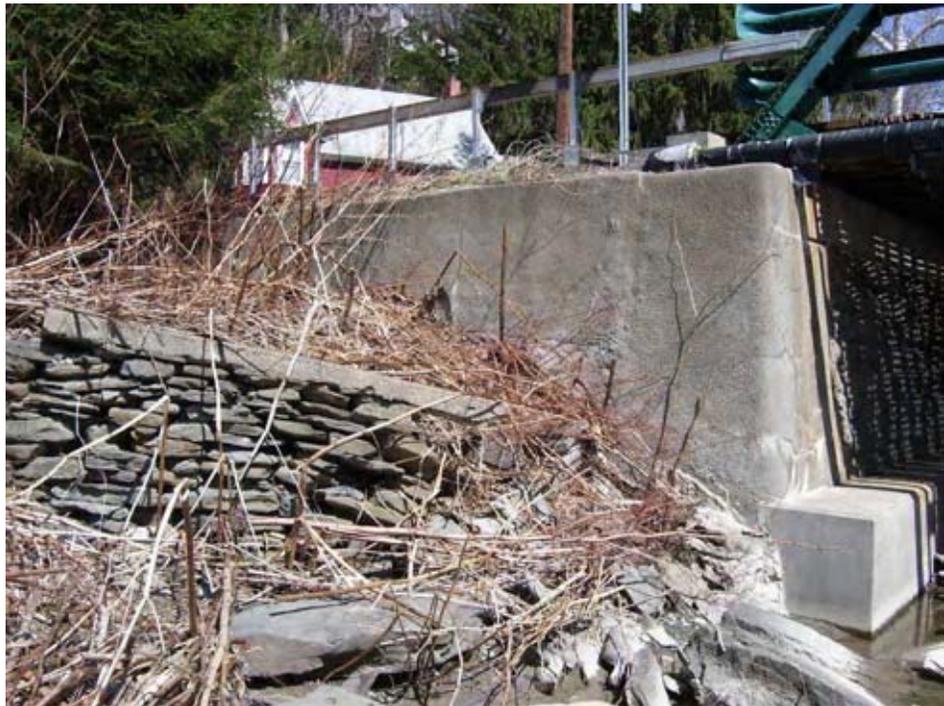
PHOTO NO. 12

Description:
Downstream wingwall at End Abutment – completely covered with shotcrete.

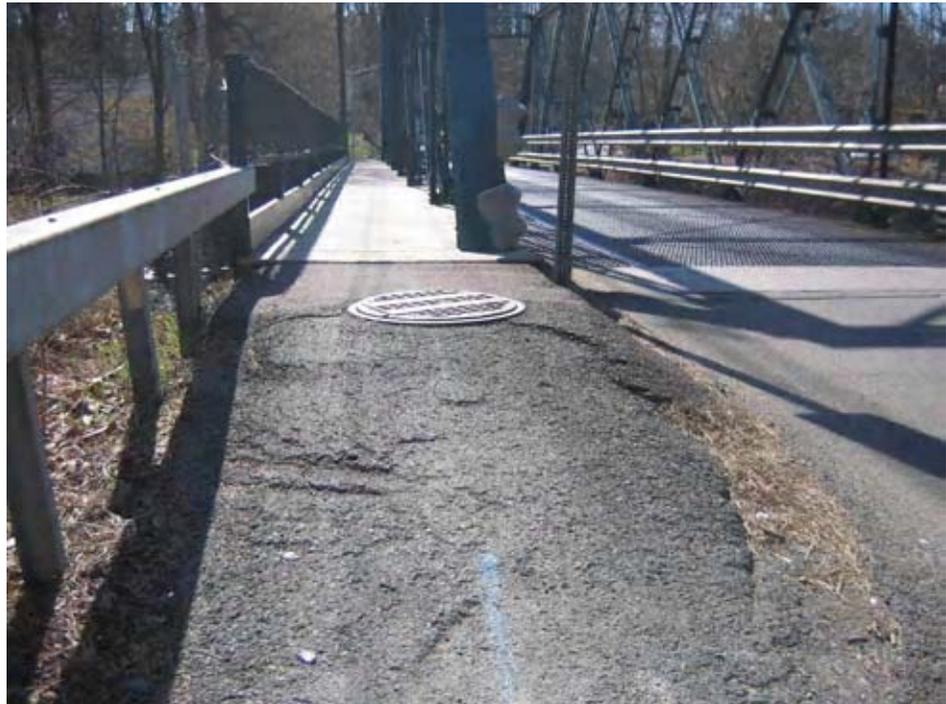
Both asphalt approaches exhibit moderate to heavy wear with areas of transverse and longitudinal cracking. The sidewalk approaches are constructed of built-up asphalt in poor condition. The asphalt is cracked, uneven, and breaking off at the edges.

Description:
Approach to
sidewalk at End
Abutment (typical
both ends of
sidewalk).

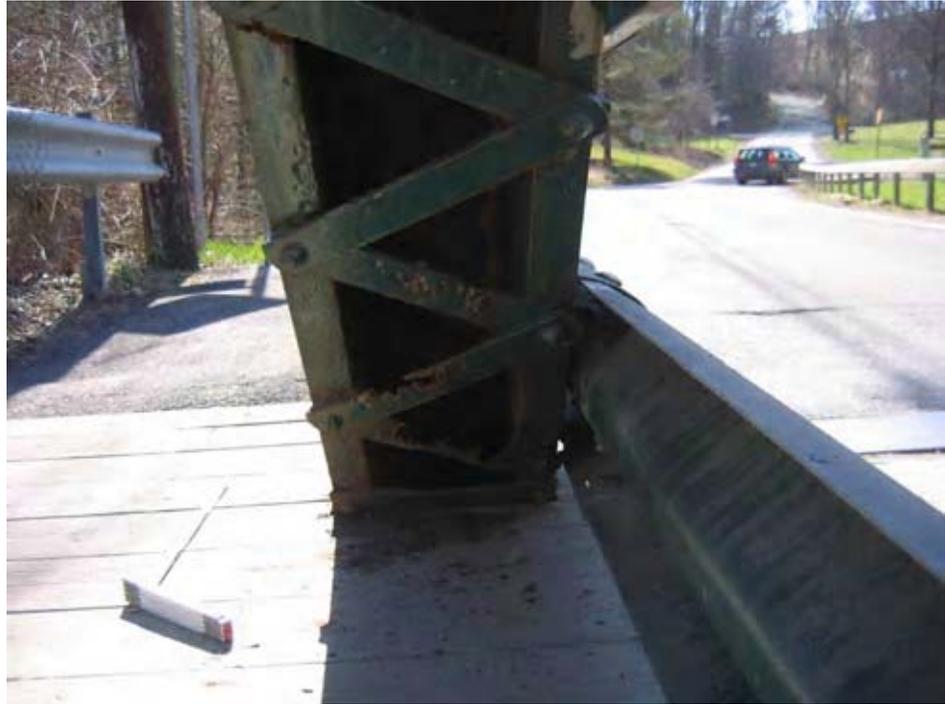
Description:
Lacing exhibits
areas of 100%
section loss.

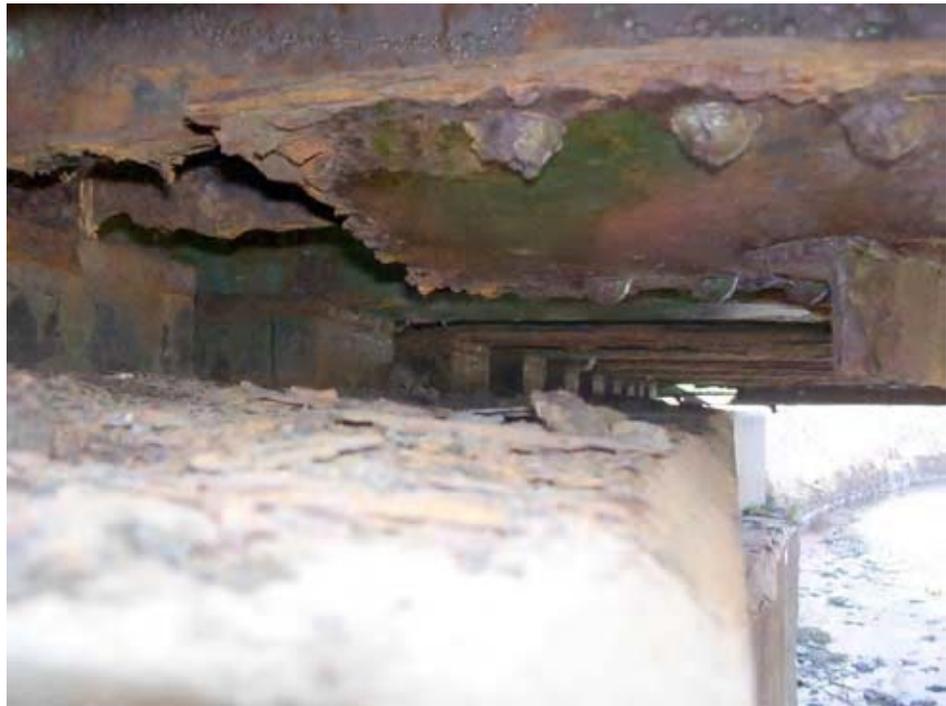
Description:
Right truss bearing and stringer bearings at Begin Abutment.

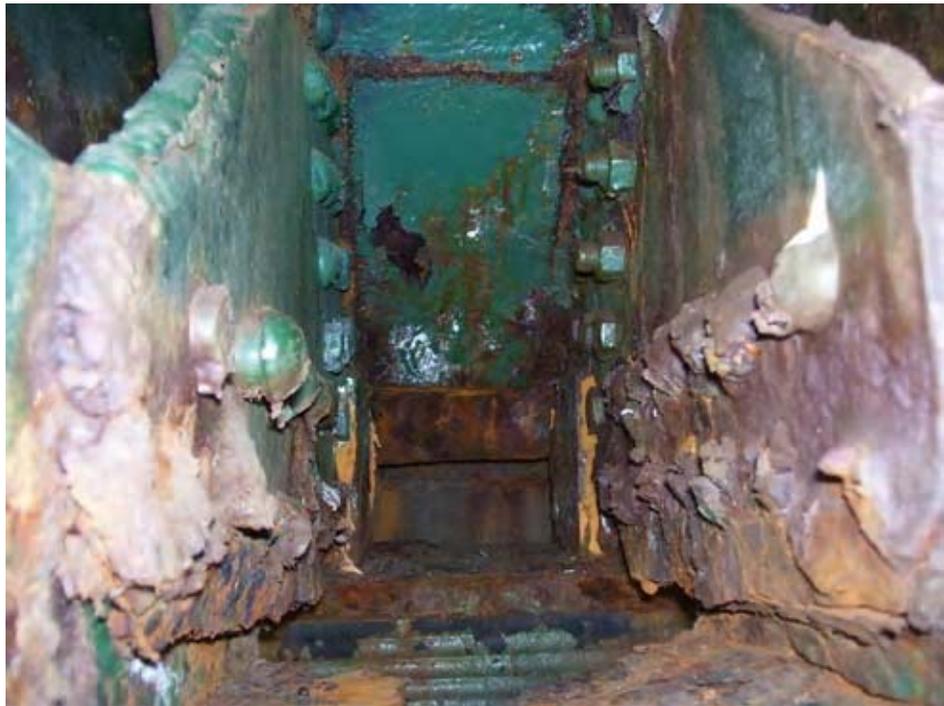
Description:
Heavy deterioration with areas of 100% section loss to bottom plate and rivets.

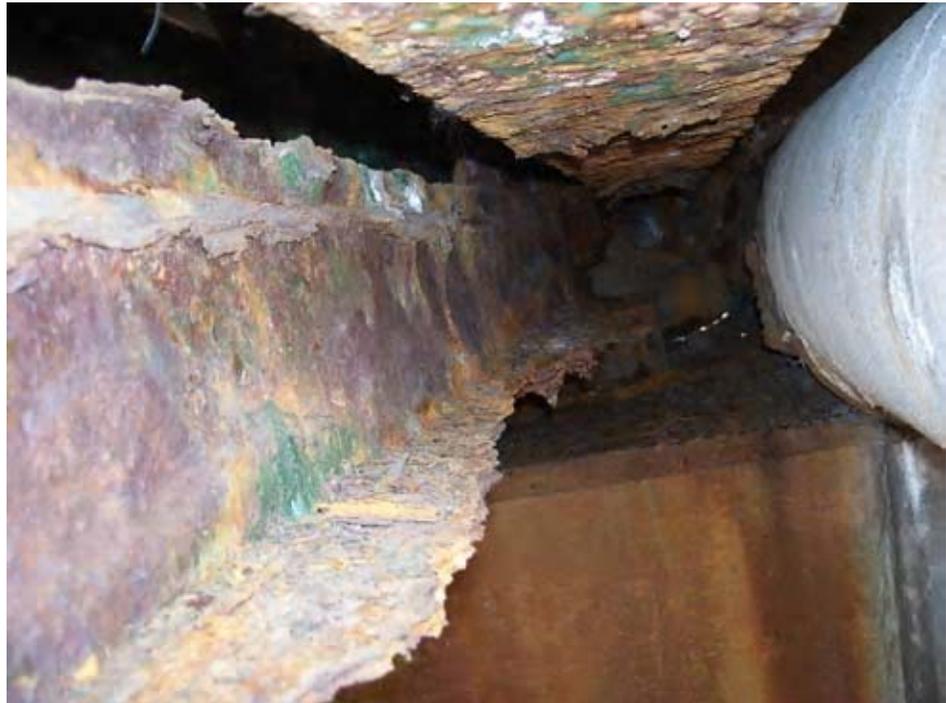
Description:
Severe deterioration
to bottom flange of
bottom chord
channel with areas
of 100% section
loss.

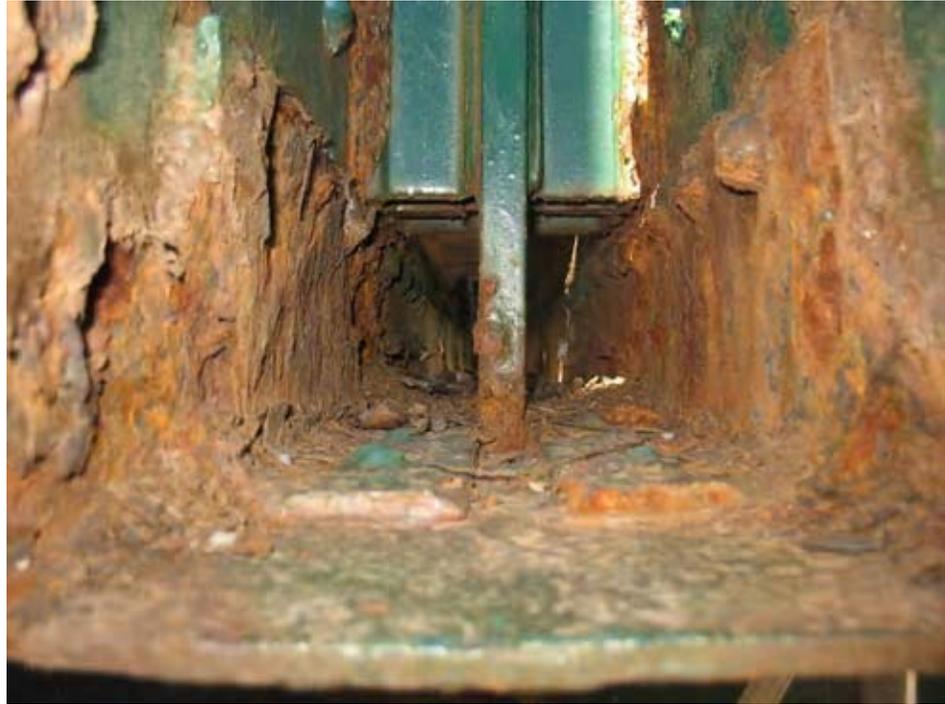
Description:
Typical condition of bottom chord between angles.

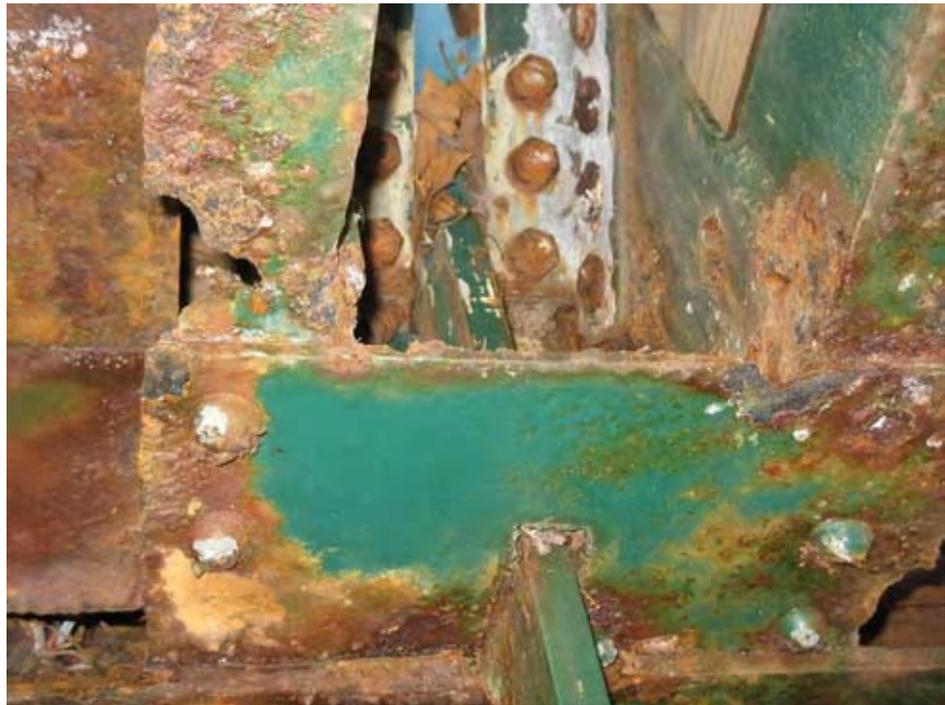
PHOTO NO. 47

The primary members below the deck are in poor condition. The bottom chord members of both trusses are heavily corroded with heavy delamination and areas of 100% section loss. The corrosion and section loss is more severe on the right (upstream) truss. The end points of the trusses at the Begin and End Abutments exhibit heavy rust and delamination with section loss to the bottom chord, gusset plate and rivets. Previous welded repairs are also heavily corroded. The end point of the right truss at the End Abutment is the most severely deteriorated. The bottom flanges of the angles of the built-up bottom chord exhibit 100% section loss along most of their length. The bottom plate between the angles and the gusset plates and rivets at the end point connection are also severely deteriorated.

Description:
Bottom chord exhibits heavy deterioration with delamination and areas of 100% section loss.
